TREE REPORT

29 PEMBROKE RD
LONDON
W8

MAY 2000

REF: IBR125001

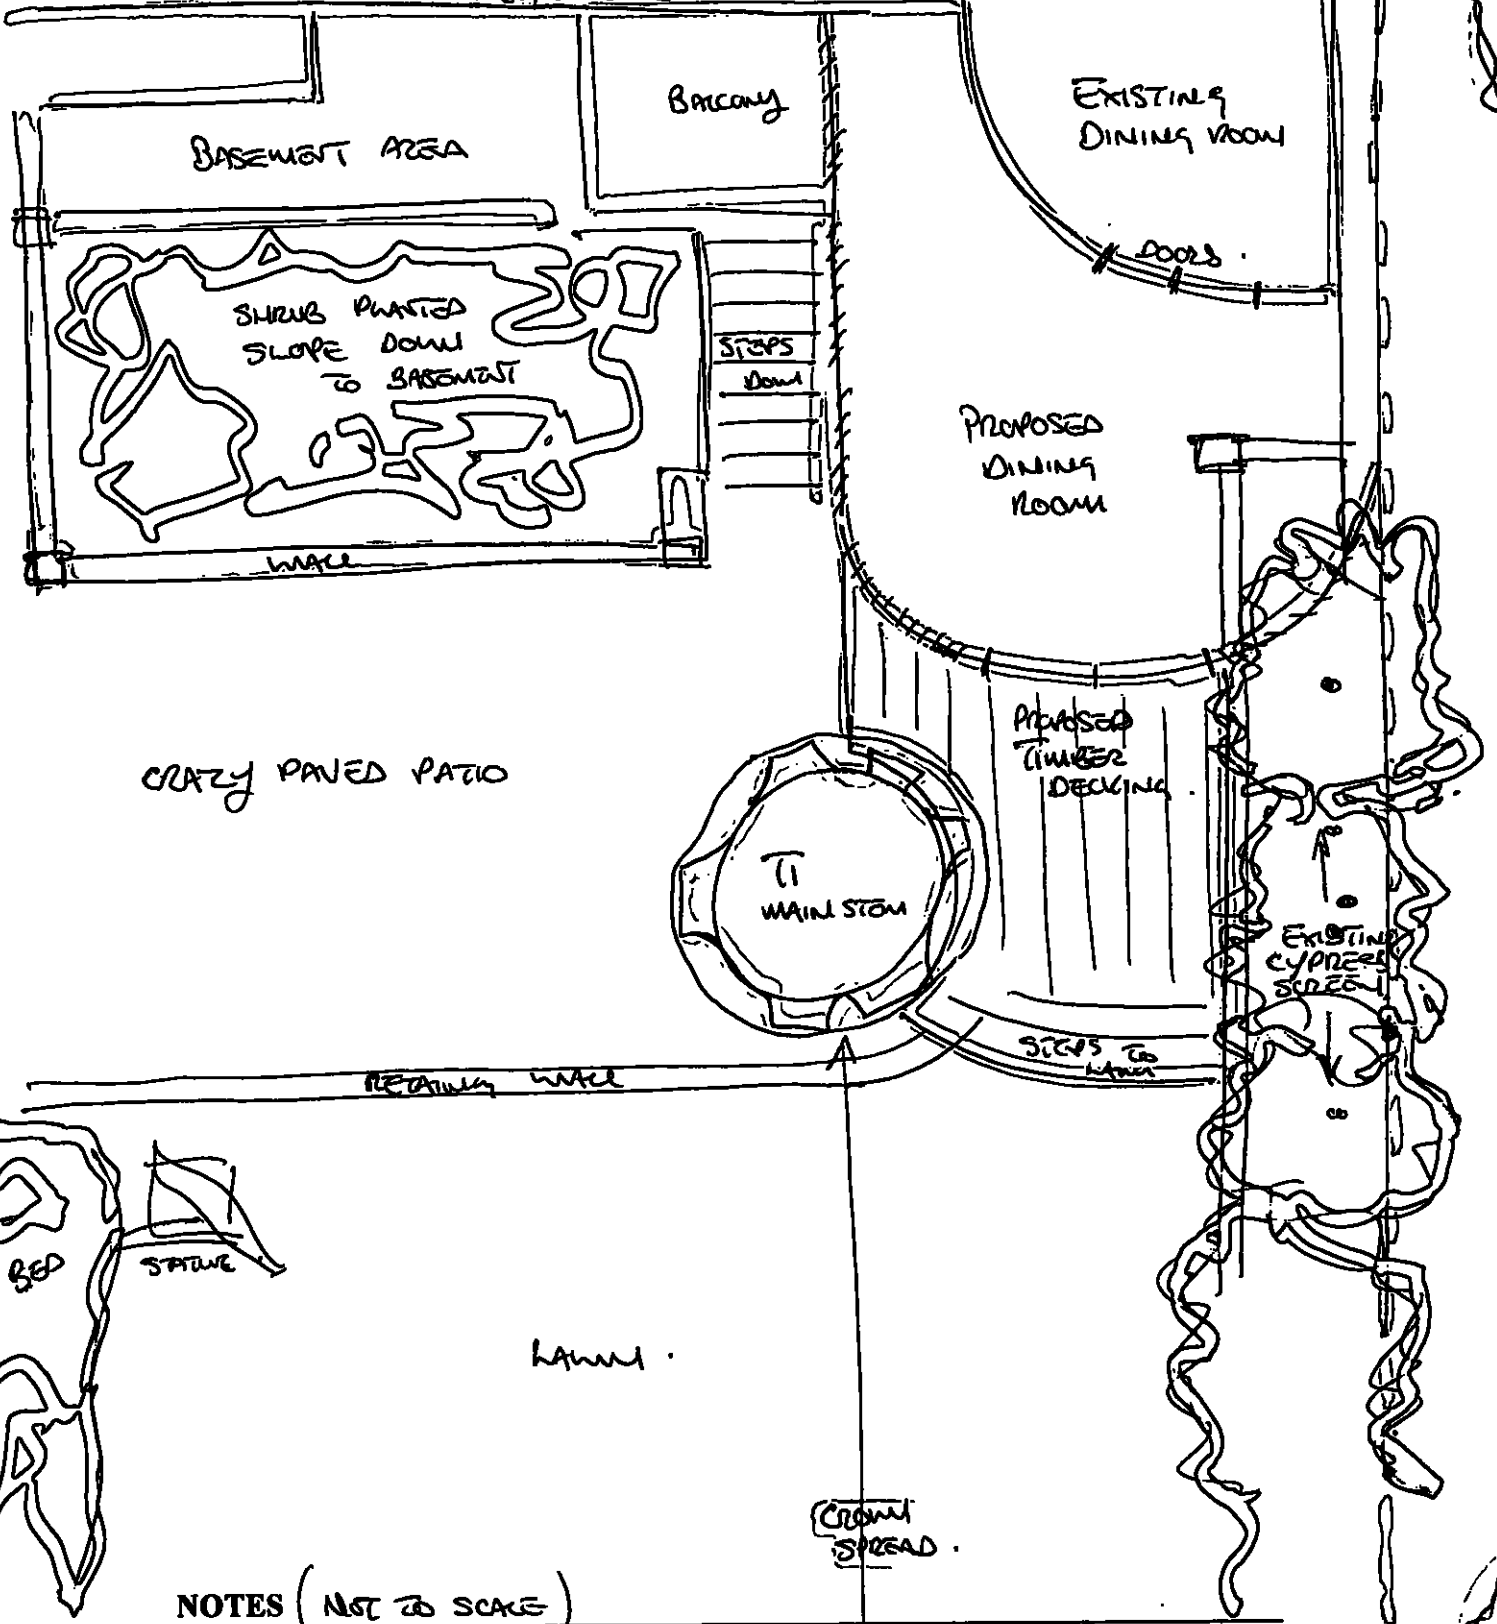
SITE ; 29 Pembroke Road, London, W8

T1, London Plane 32m Ht. This is a fine specimen with a crown height of 15m; crown spread of 25m, stem diameter at breast height is 144cm, broadleaf. The tree's base is 3m from the rear of the existing dining room extension, and 4.5 from the original elevations of the property.

The crown overall is well balanced and healthy and shows evidence of previous thinning works. No works, which would have been detrimental to the tree's root system, have been carried out within the garden. The containing walls to the basement levels show no signs of distortion, cracking or evidence of root invasion.

We would also suggest that from the tree's point of view, it may be desirable to re-lay the existing patio area with a semi permeable surface, more able to cope with any movement caused by root and trunk expansion. The distortion of the paved area adjacent to the tree is likely to have been caused by the heavy growths of Ivy which until recently grew up the main stem. These roots are still in evidence and show that the Ivy was large, mature and vigorous, and would undoubtedly have contributed to the distortion of the paving. We do not consider this a feature of any significance or concern.

The only concern we have is that during construction work the highest consideration is given to the tree's well being. To this end, we would recommend that the excavation and removal of the existing patio area immediately around the tree is done entirely by hand, and that the subsoil beneath this layer is also excavated by hand down to the point at which the major tree roots are identifiable. It is only at this point through careful hand removal of soil, that piles can accurately be drilled to avoid major structural roots.

Following initial works, the subsoils should be remade, ideally with the original spoil removed from the excavations, and the surface immediately beneath the foundation beams is re-laid with a free draining medium, able to provide soil gas/air exchange.

During the piling operations, we also consider it extremely important that no cement, lime wash or drilling lubricant is allowed to pollute the soil around the tree's buttress root system.

Beyond the new extensions main walls, we understand that there is a proposal for decking to be placed around two sides of the tree. This will also provide an opportunity for the removal of the current hard surfacing immediately adjacent to the tree, and its replacement with soft, permeable material.
