Cheltenham Estate

CONSERVATION MANAGEMENT PLAN

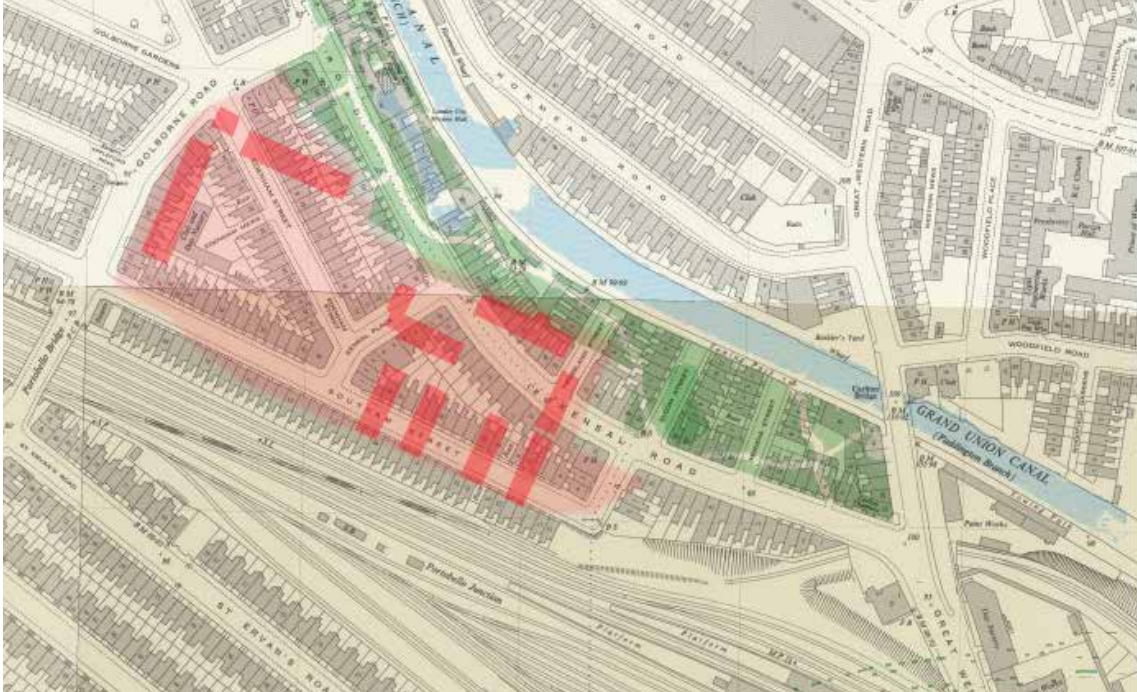
1. The layout of the current Estate superimposed onto the previous street pattern - HTL 2015

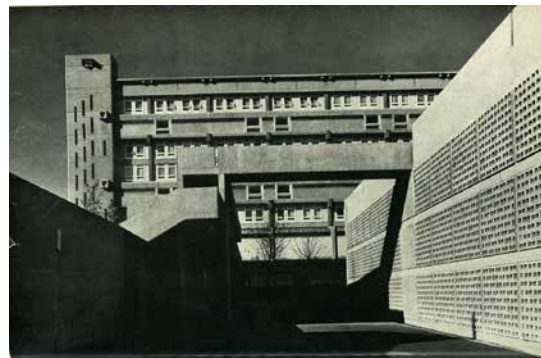
5. View to Block B past podium car park structure - AJ 1973

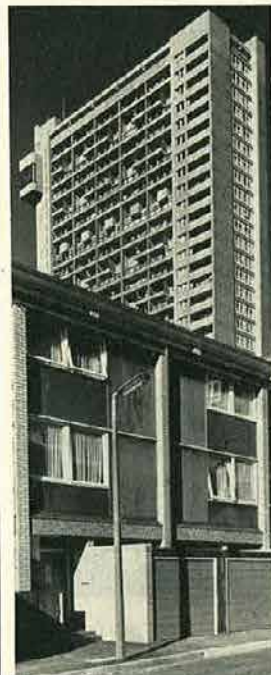
was responsible for the decision not to have double-glazing, either. As the level of noise is quite acceptable really, when the windows are shut, I imagine that double-glazing would effectively eliminate noise disturbance altogether.

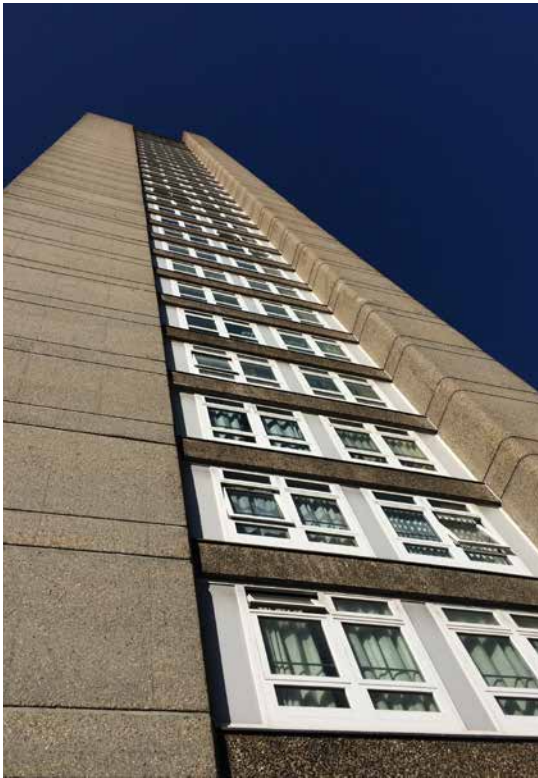
1. East facade of Trelick Tower with replacement windows - HTL 2015

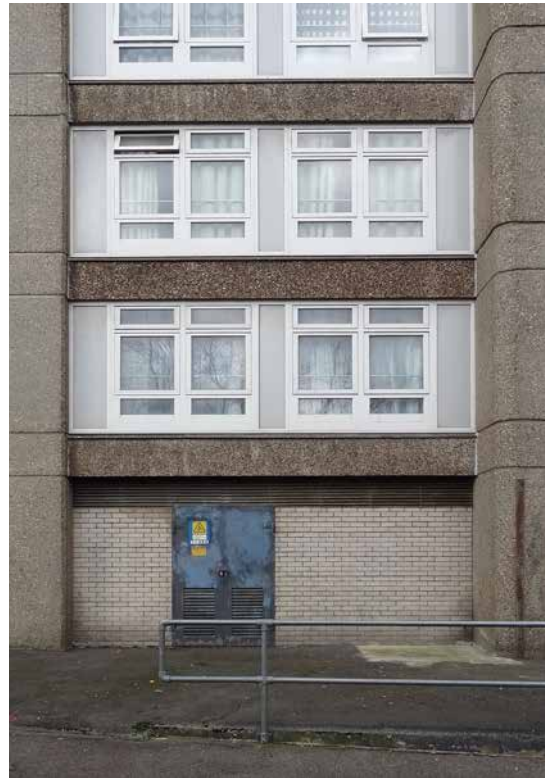
2. Trelick Tower replacement windows - HTL 2015

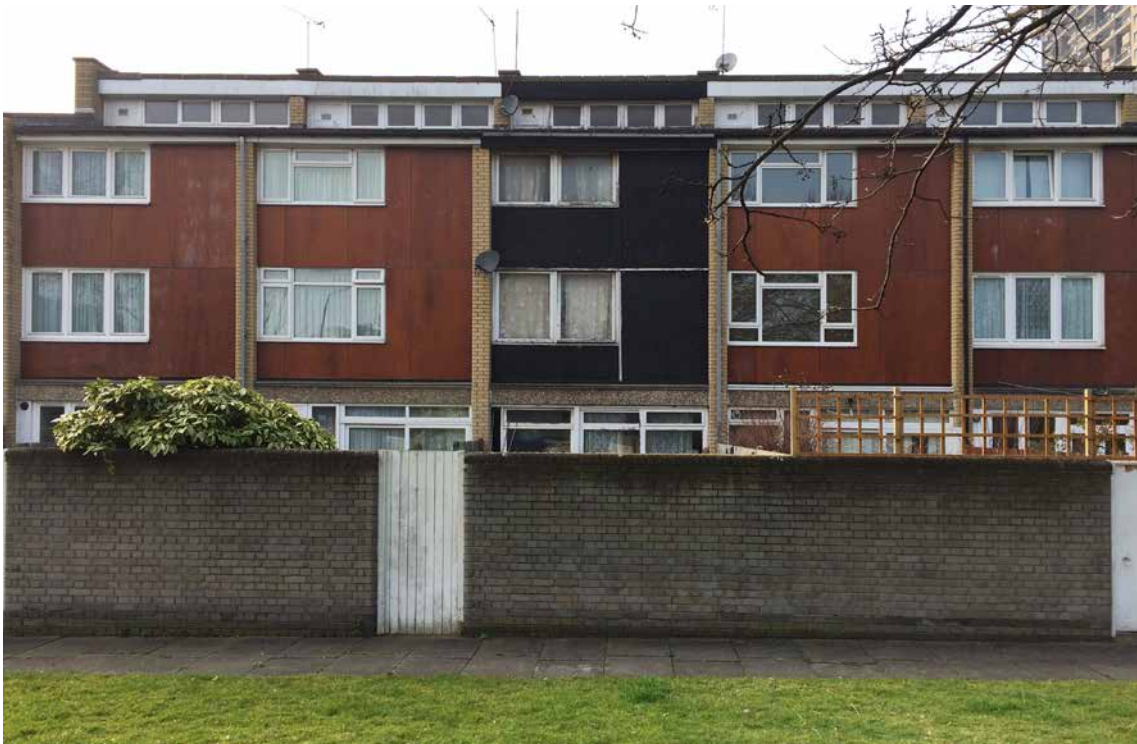
3. Replacement windows and cladding to Block D housing. Note original timber windows and black-stained ply cladding to central dwelling - HTL 2015

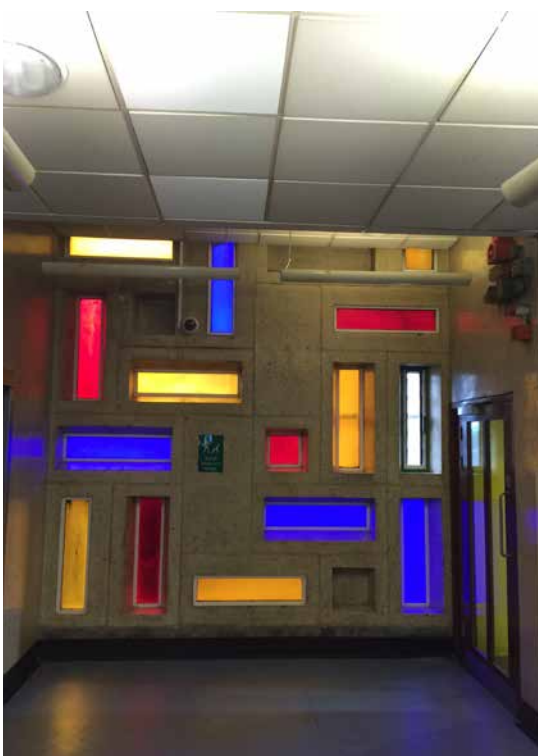
3. Replacement coloured glass panels in the entrance lobby - HTL 2015

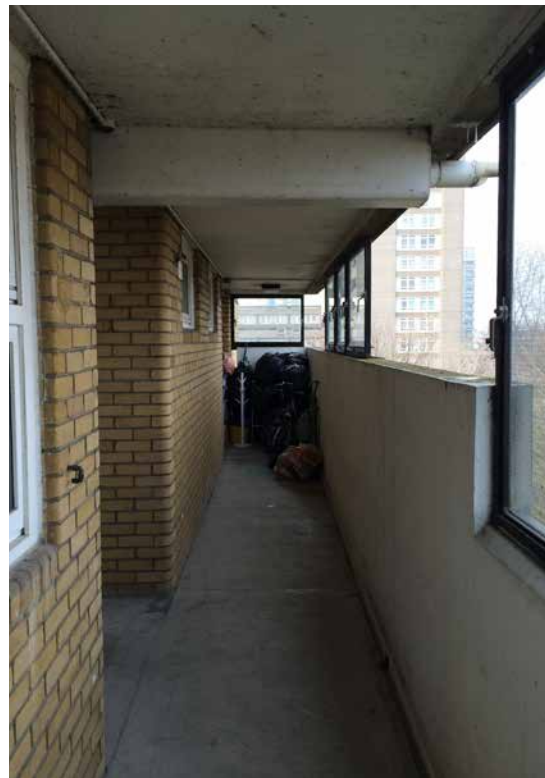
3. Boiler flues to external walkways on block E - HTL 2015

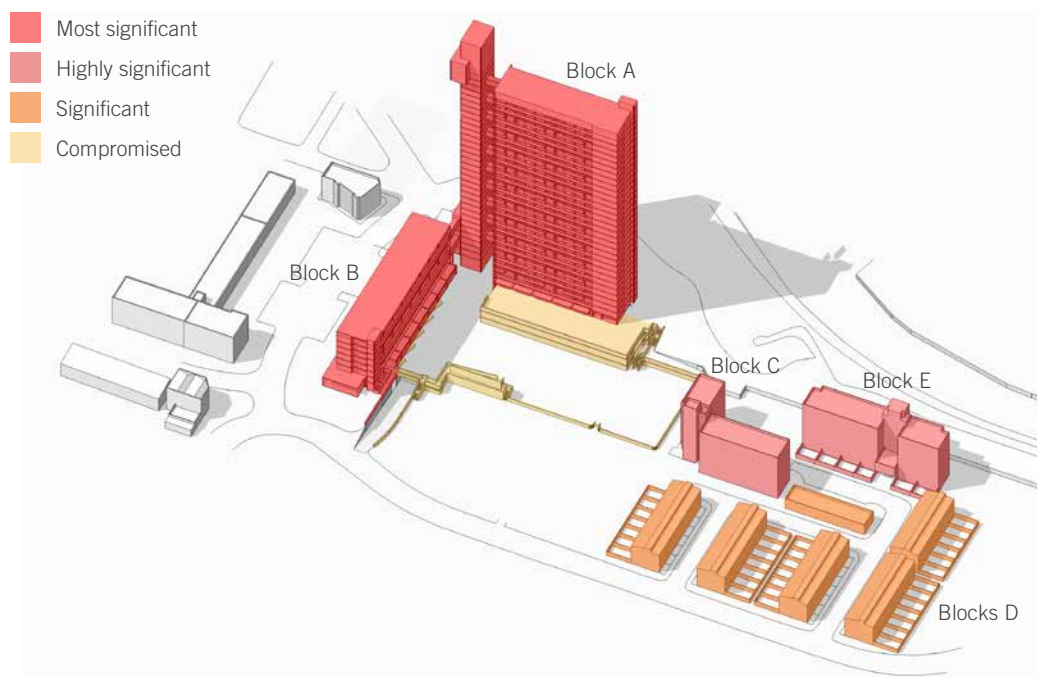
1. Diagram indicating varying significance of remaining fabric - HTL 2015

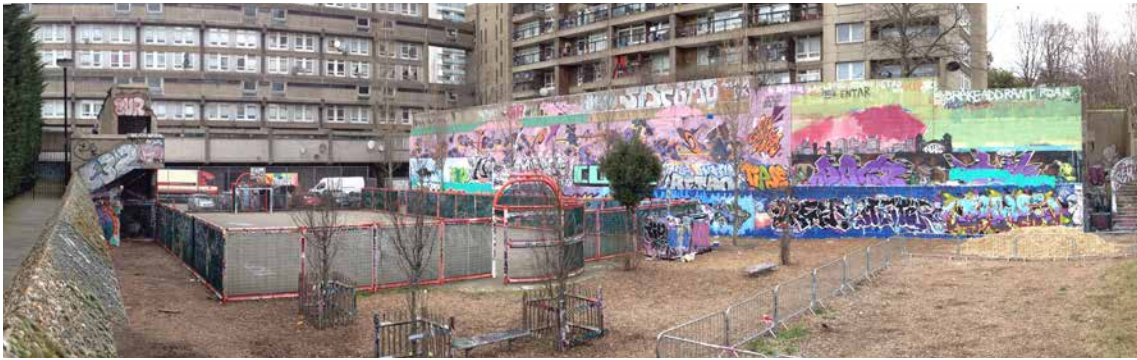
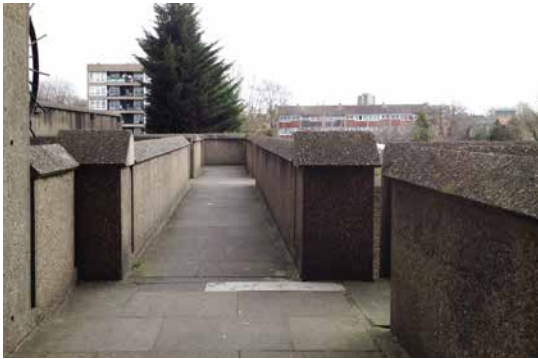
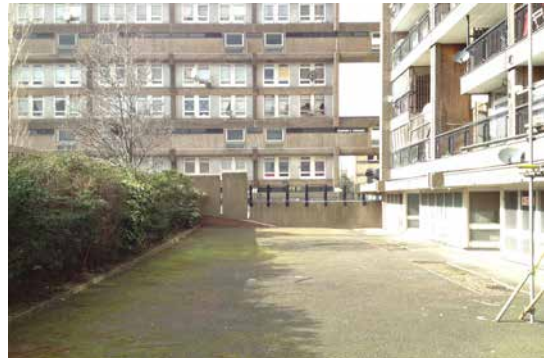
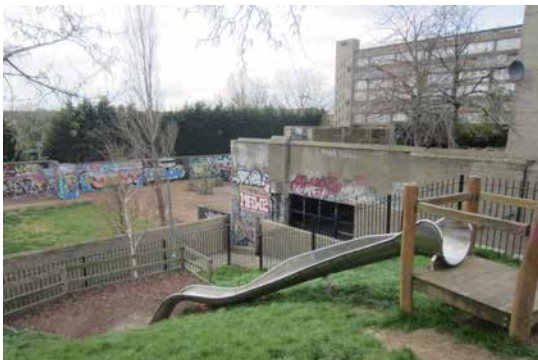
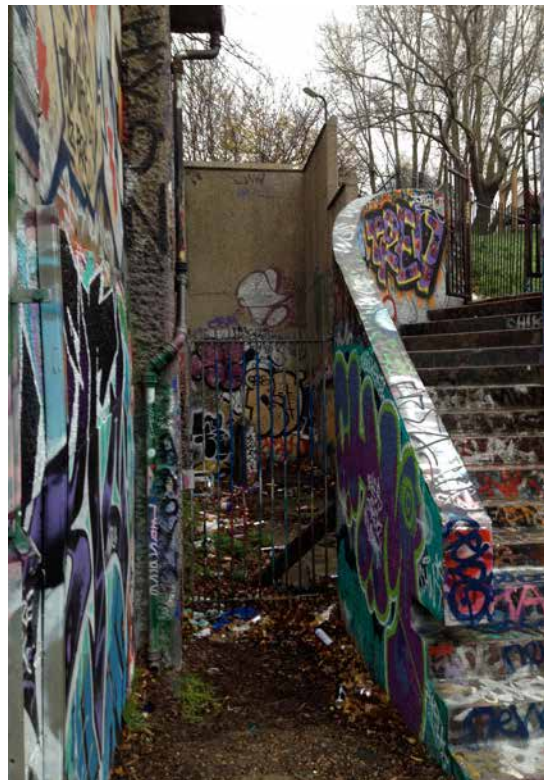
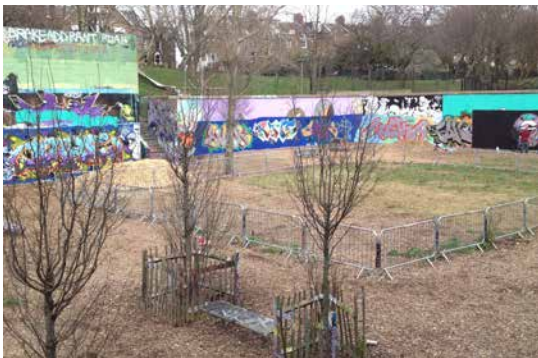
1. Under used external areas at the base of Blocks A and B - HTL 2015

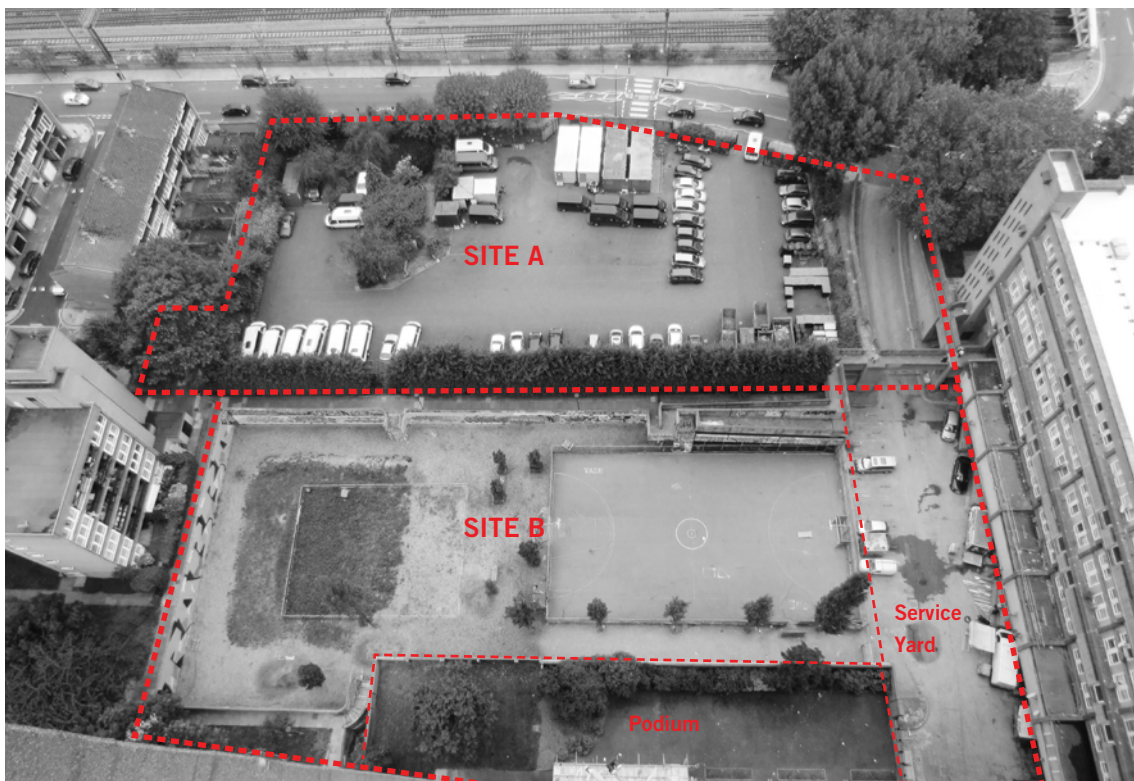
3. View from Block A towards development sites A and B - HTL 2015

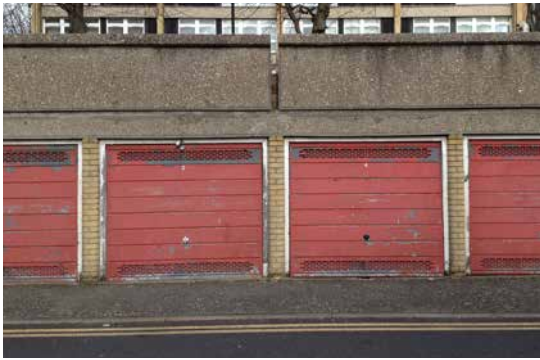
1. Garage elevations - HTL 2015

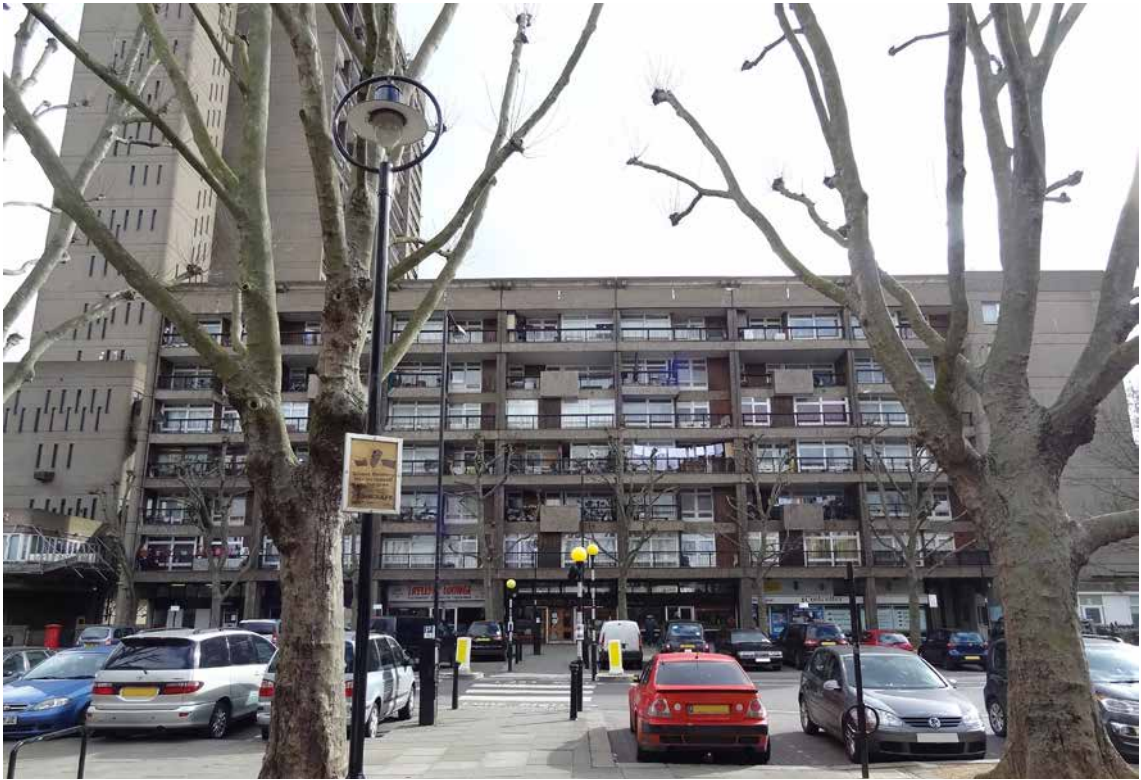
5. West elevation of Block B - HTL 2015

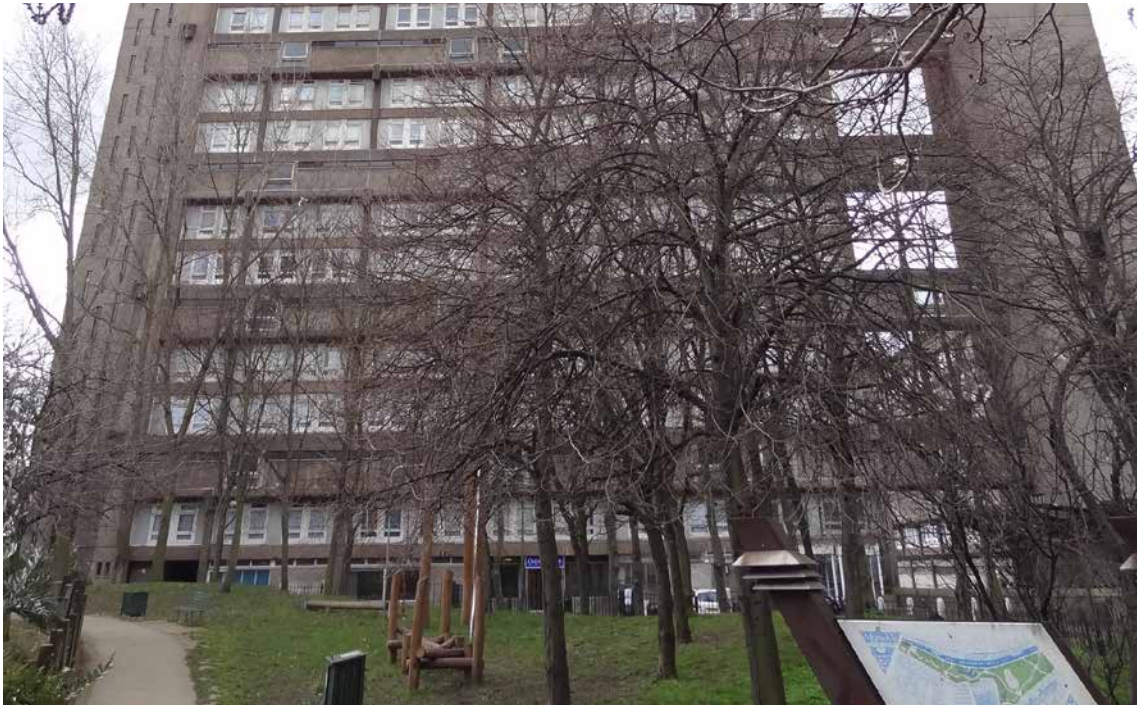
3. North elevation of Block A from Meanwhile Gardens - HTL 2015

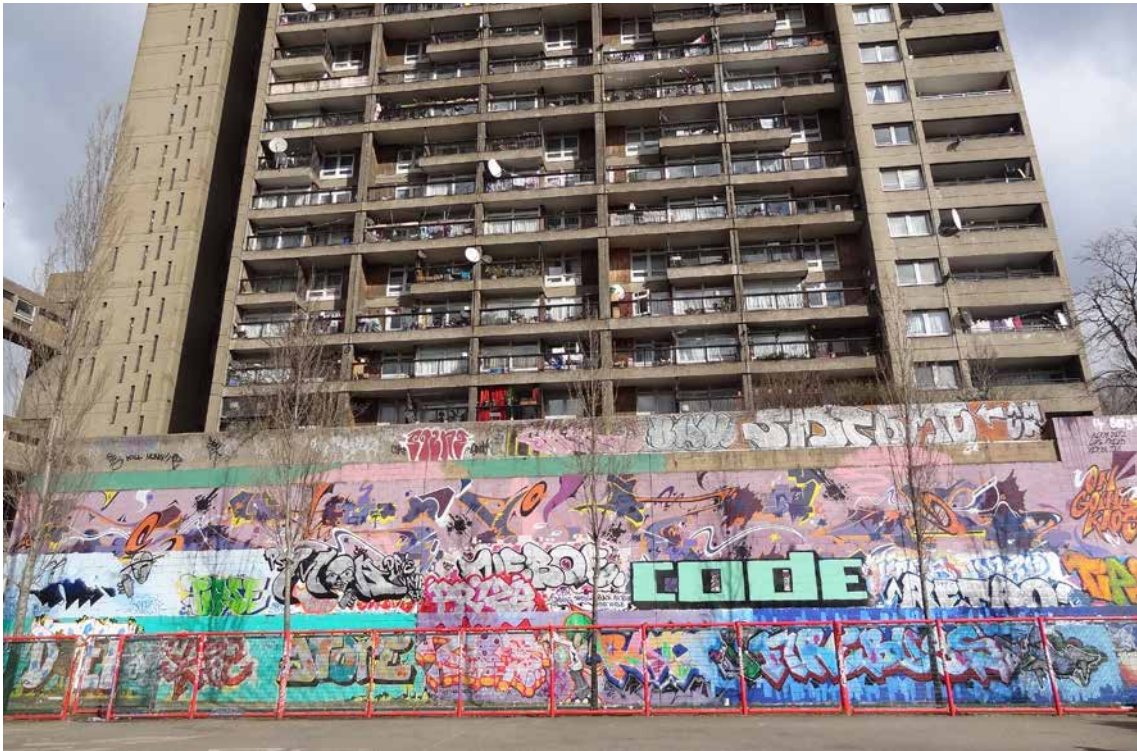
3. The south elevation of Block A and current podium from the ball court - HTL 2015

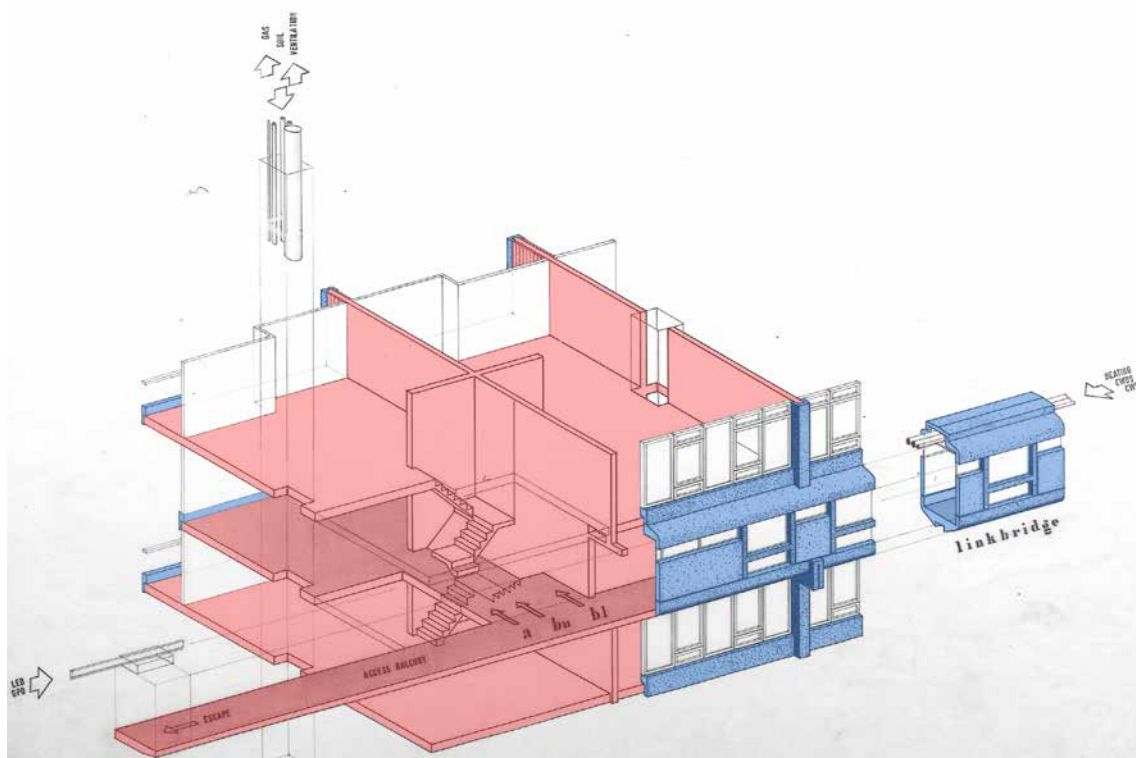
2. 3D drawing indicating assembly of pre-cast concrete components to access galleries - Goldfinger

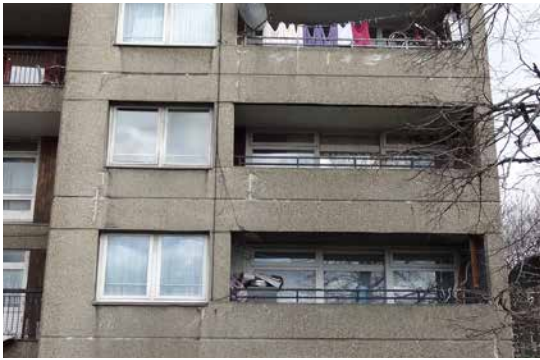
3. In-situ cast external walls with day joint - HTL 2015

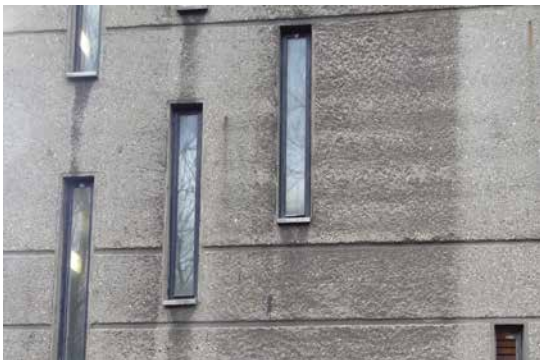
9. Typical staining - HTL 2015

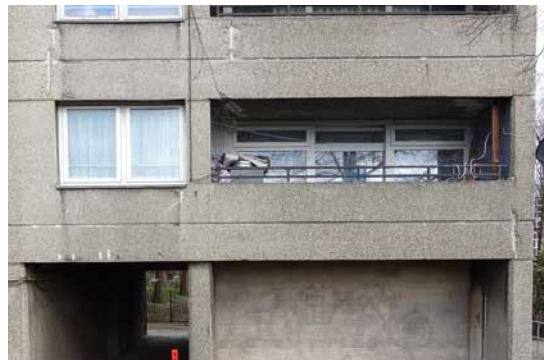
10. Example of localised damage + repairs - HTL 2015

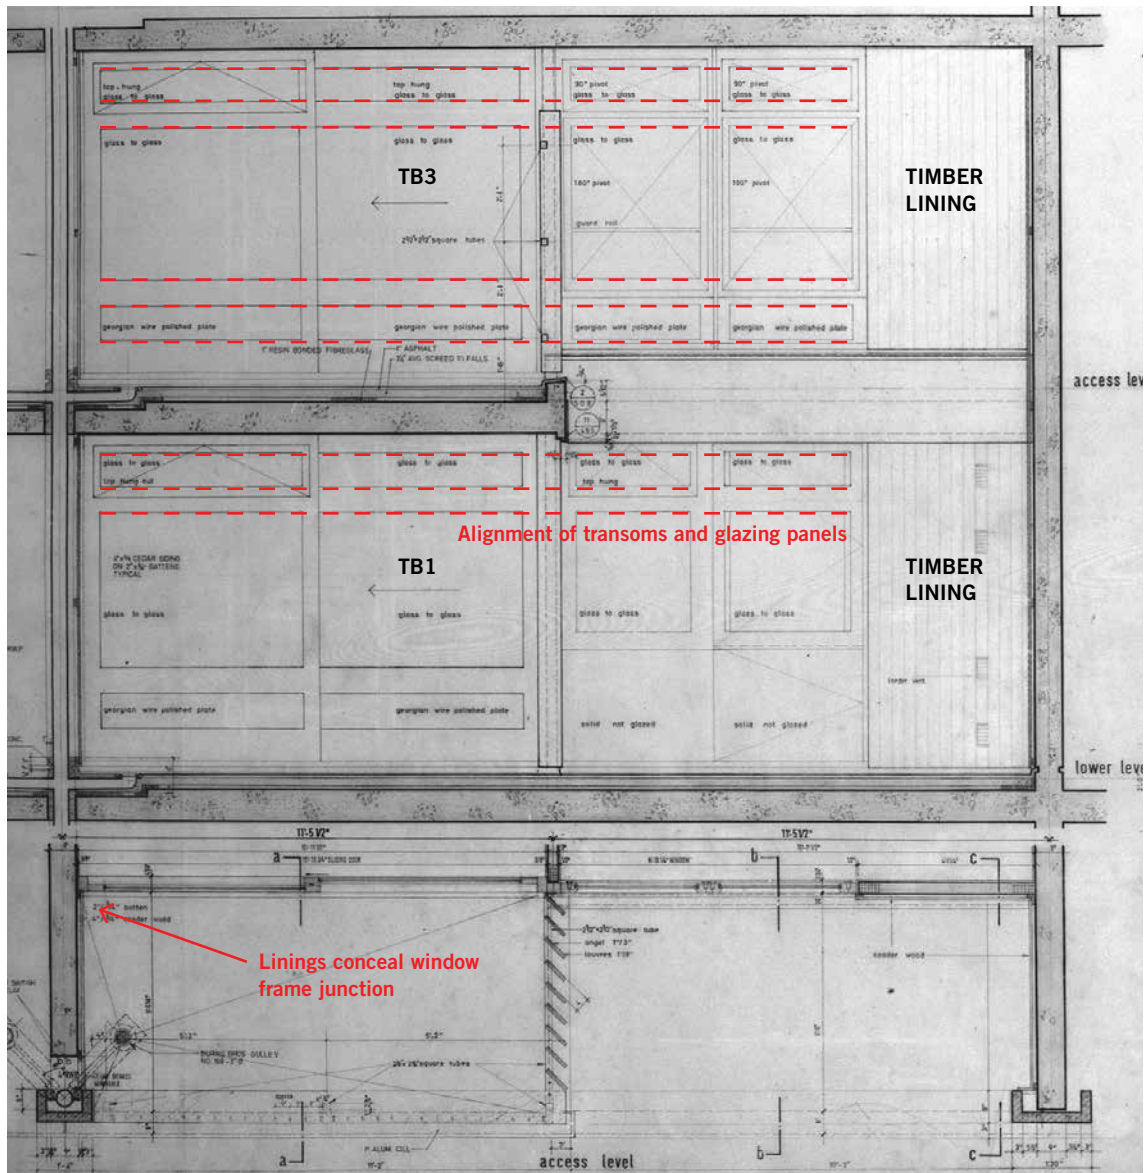
5. Typical 'double bay' elevation of main living spaces of 1 and 2 bed flats (including balcony plan) - Goldfinger

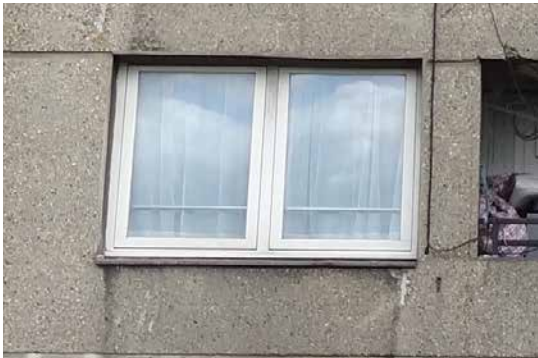
7. Type TC1 - HTL 2015

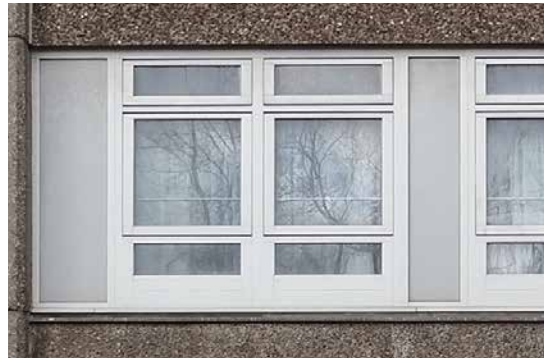
8. 2006 replacement window - HTL 2015

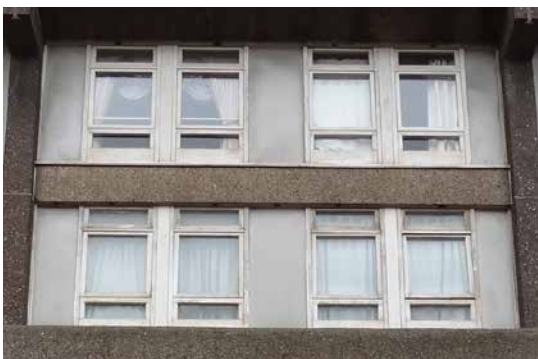
9. Exposed windows on Block A north elevation - HTL 2015

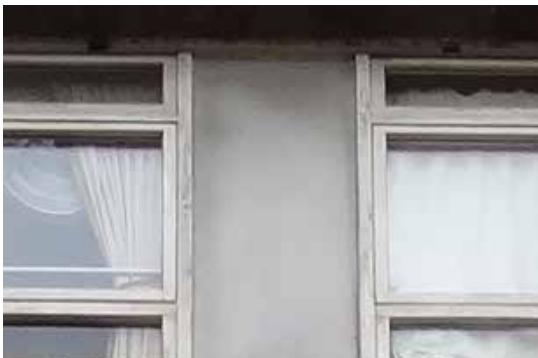
11. Staining to metal faced spandrel panels - HTL 2015

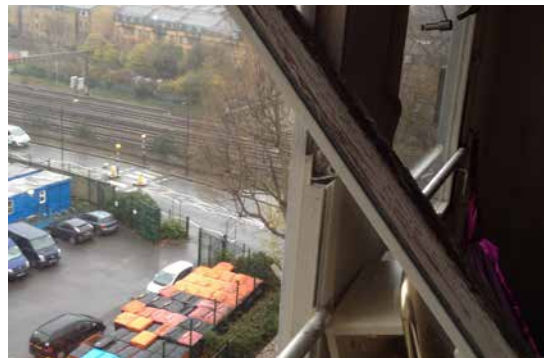
12. Centre pivot opening mechanism - HTL 2015

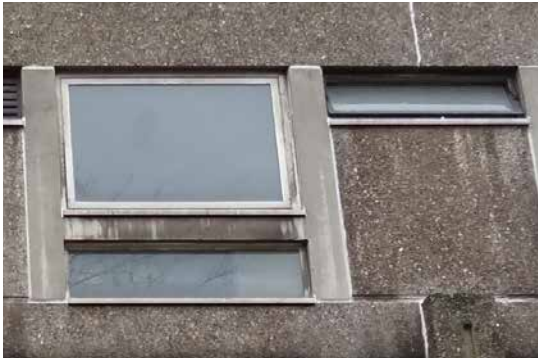
1. Windows to access galleries/ bridge links - HTL 2015

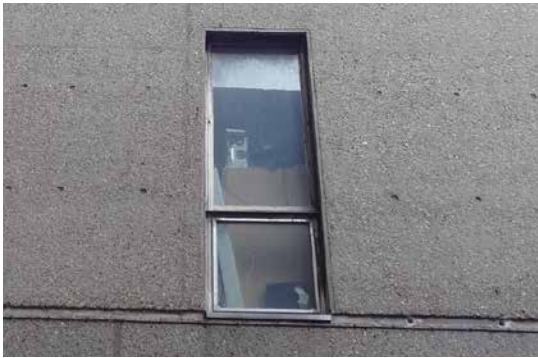
9. Window to Block B north gable end elevation - HTL 2015

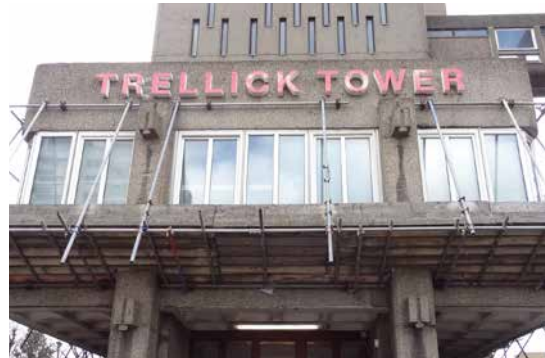
10. Replacement windows to residents' room - HTL 2015

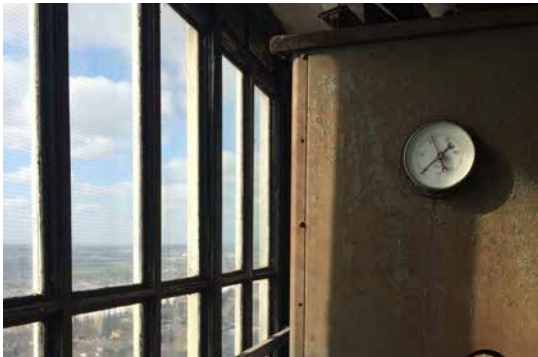
11. Glazing to boiler room internal view - HTL 2015

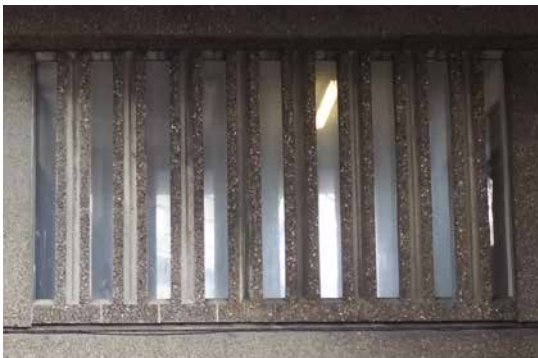
13. Replacement glazing to concrete fins in entrance lobby

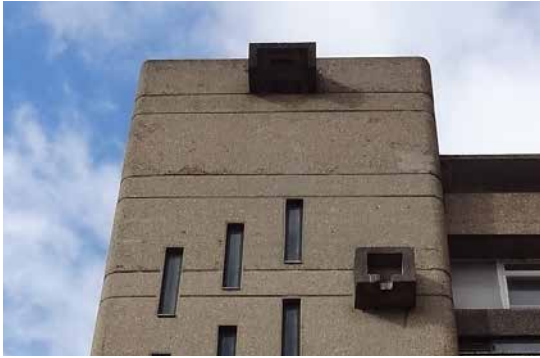
5. Floodlight and extract grille hoods - HTL 2015

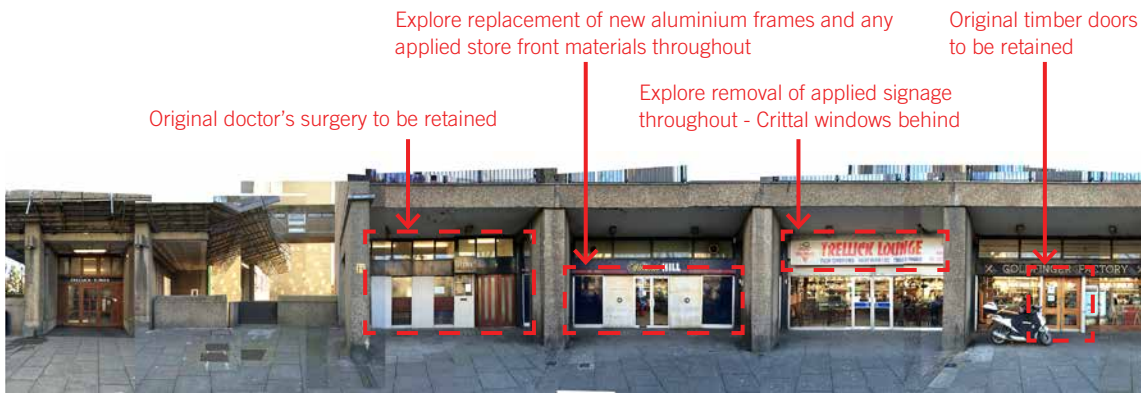
1. West elevation Block B - HTL 2015

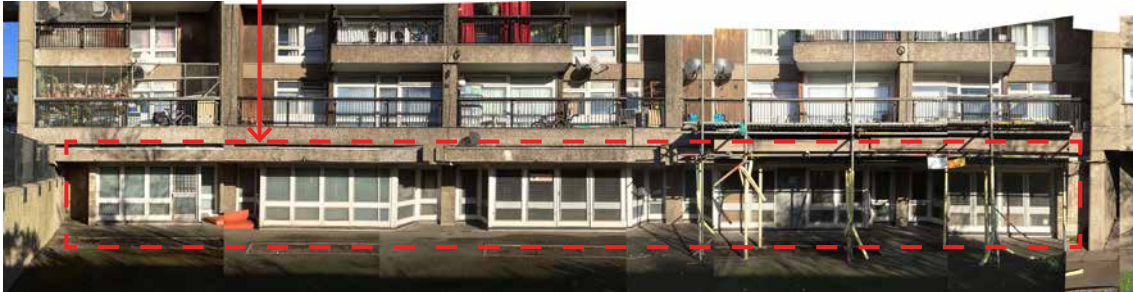
1. South elevation Block A - HTL 2015

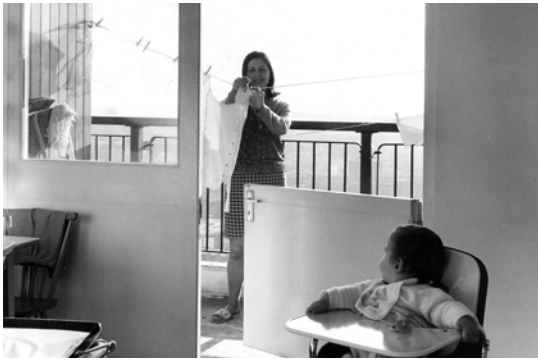
1. 1970s photograph of kitchen - RIBA

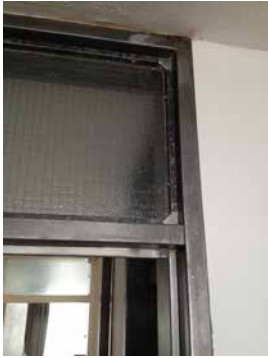
11. Fanlight above door frame - HTL 2015

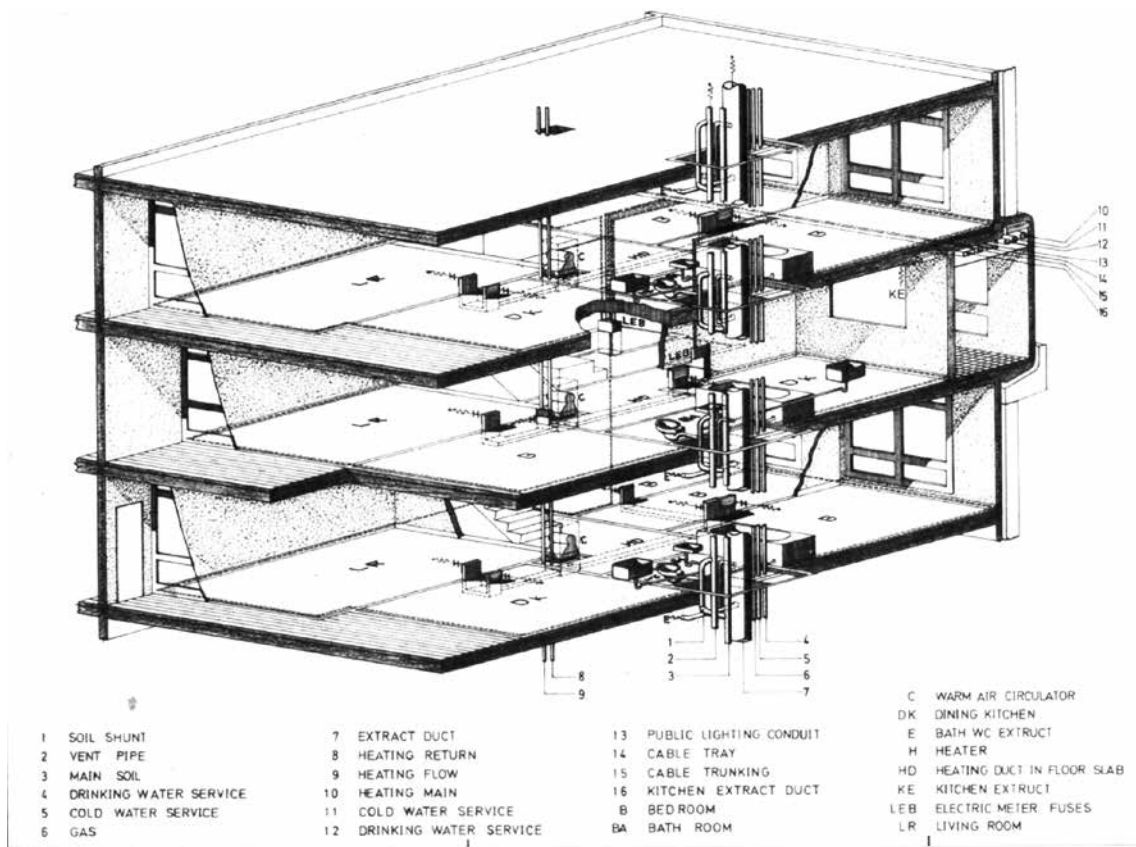
1. Services diagram indicating central riser and services route within access galleries - AA

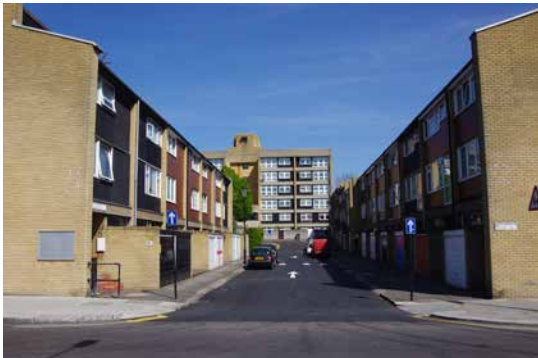
3. View of Blocks E and D from Elkstone Road - HTL 2015

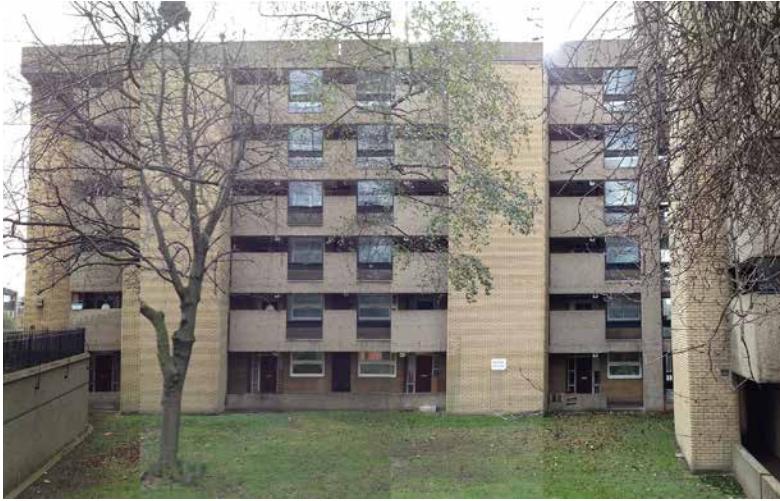
1. Block C, north elevation - HTL 2015

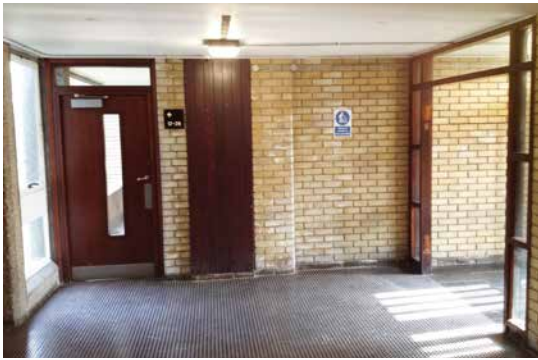
1. Entrance lobby - HTL 2015

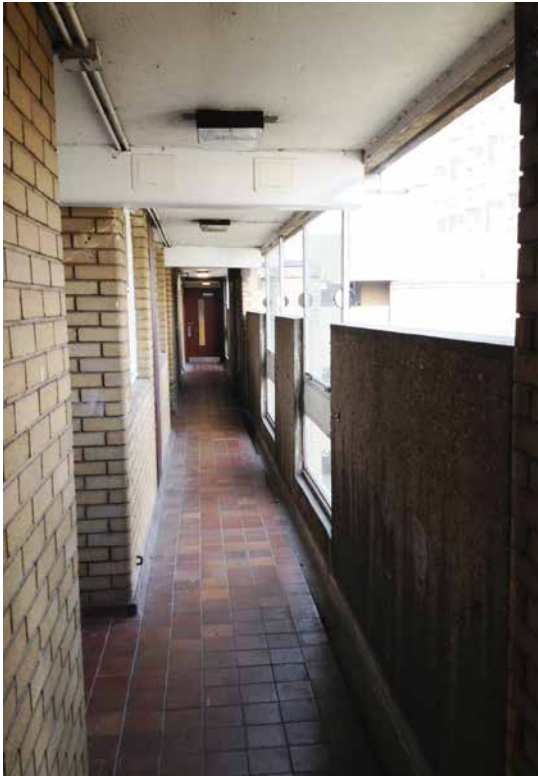
7. Boiler flue on access gallery - HTL 2015

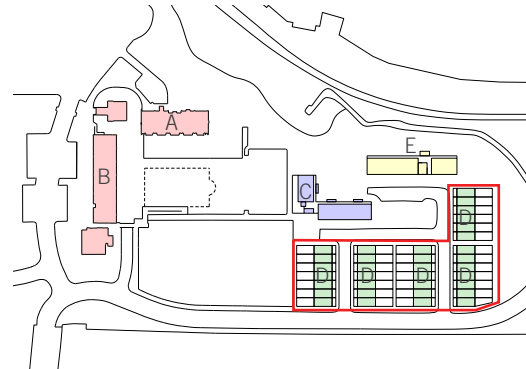
Loadbearing yellow brick	C
Precast concrete components	C
Original timber windows	B
Stained plywood panels	D
PVCU windows	E
Other alterations	E

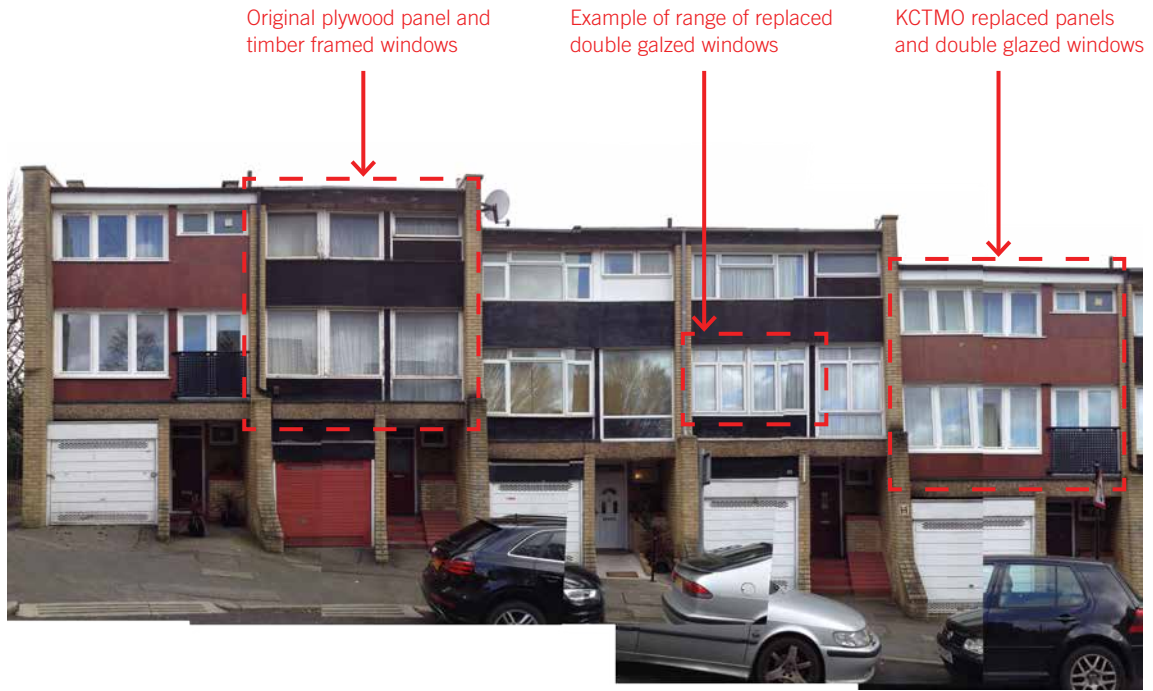
1. Stepping west photographic elevation - HTL 2015

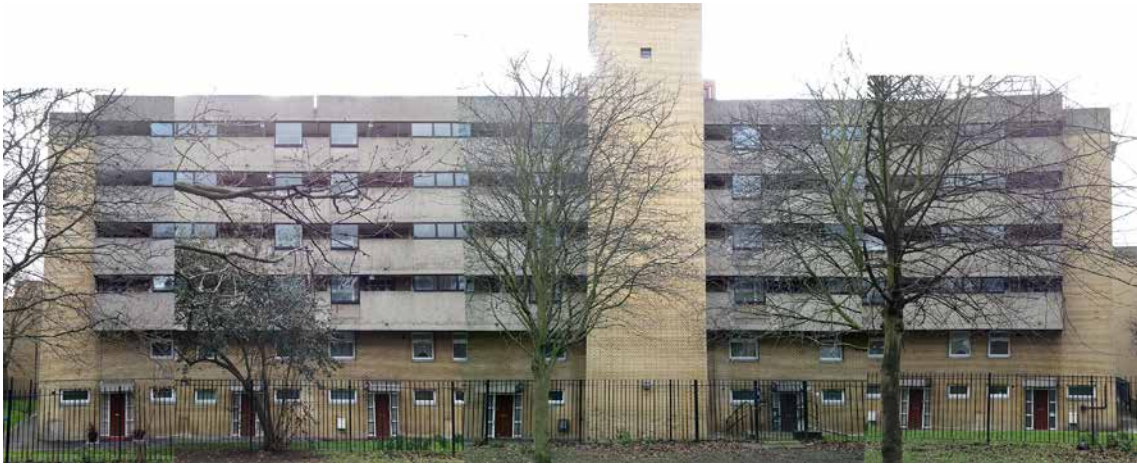
1. Block E north elevation - HTL 2015

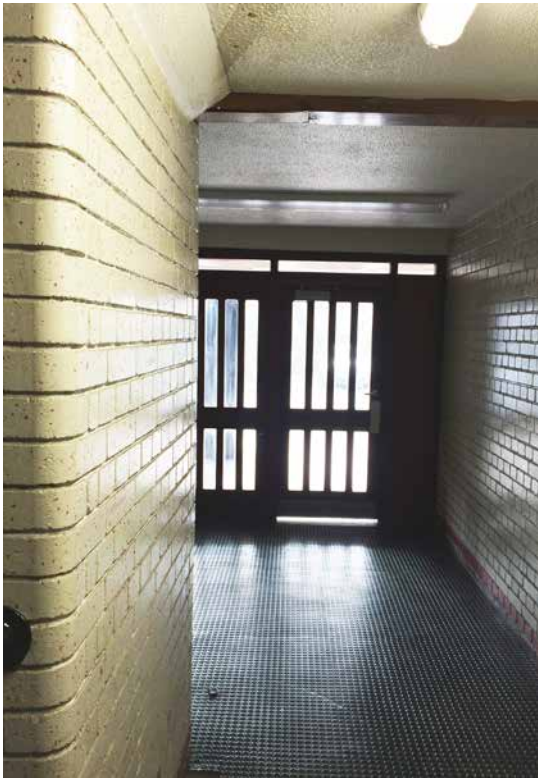
1. Main entrance lobby - HTL 2015

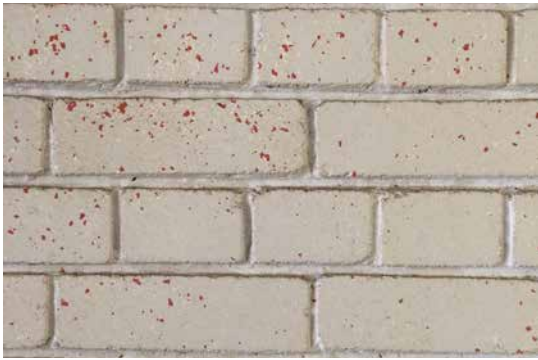
5. Anti-graffiti paint to walls - HTL 2015
