# Trellick Tower Condition Report

Prepared on behalf of  
Kensington and Chelsea TMO  
292a Kensal Road  
London  
W10 5BE

Job No: 27364  
Date: June 2015

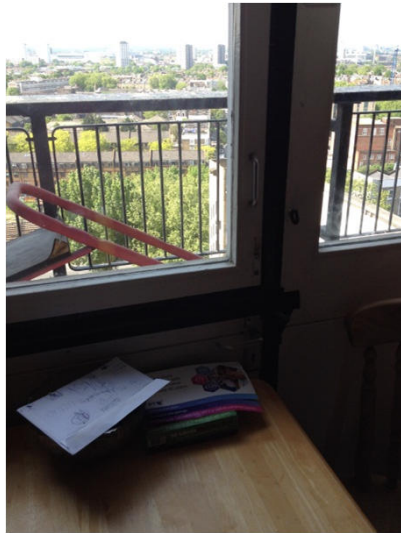
Photo 1 – Typical kitchen window

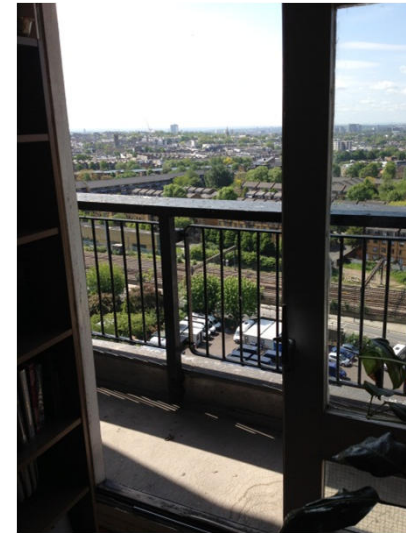
3.1.3 Timber windows are generally difficult to operate with mechanisms either seized or broken particularly to the balcony areas owing to the size of the window profiles and associated

Photo 2 – Sliding balcony door

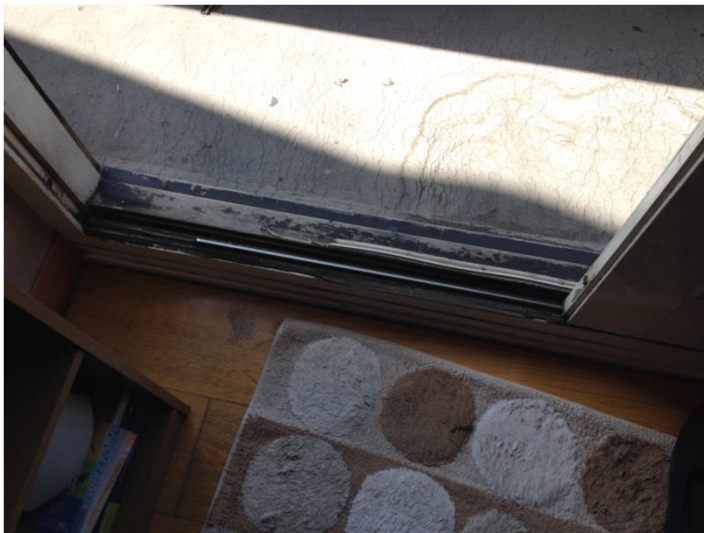
Photo 3 – Sliding balcony door mechanism

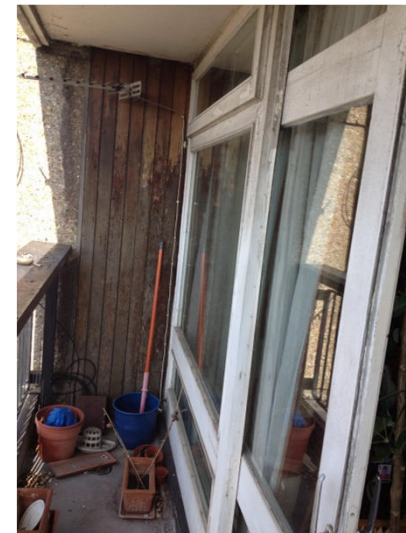
Photo 4 – Balcony door

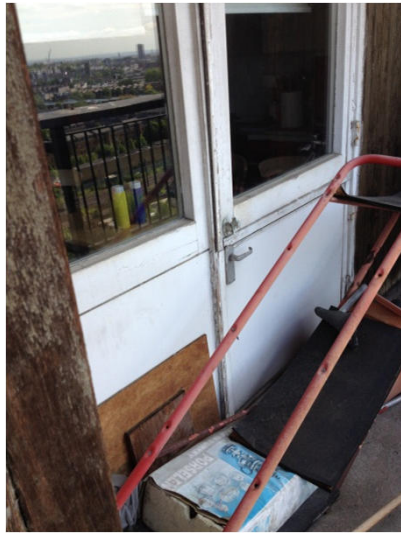
Photo 5 – Kitchen stable door

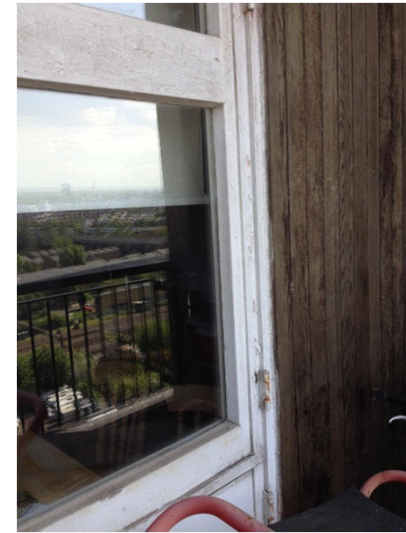
Photo 6 – Kitchen door and timber cladding

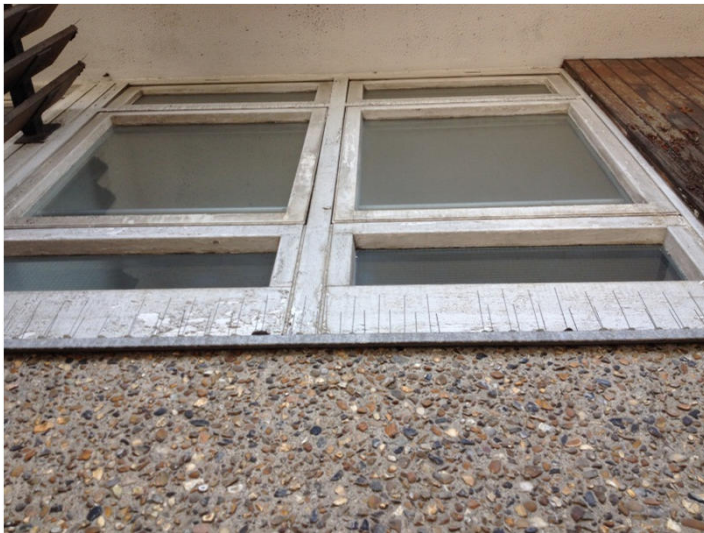
Photo 7 – Upper level window to balcony area

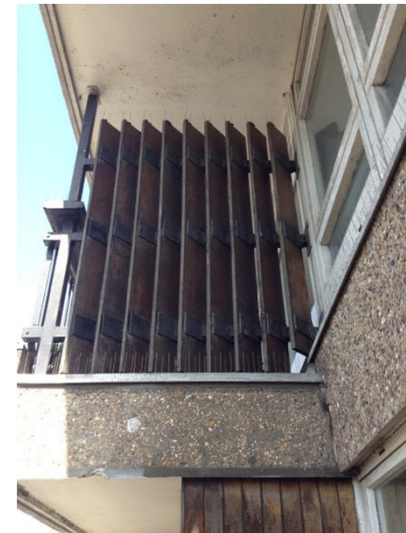
Photo 8 – Balcony timber balustrading

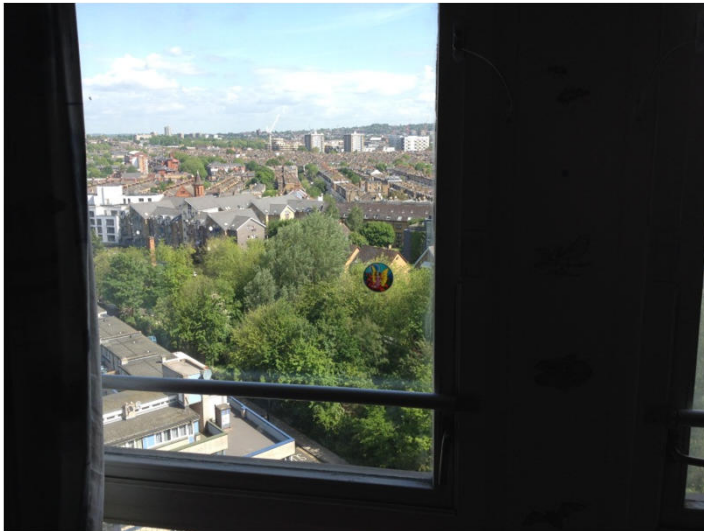
Photo 9 – Bar restrictor to north elevation window

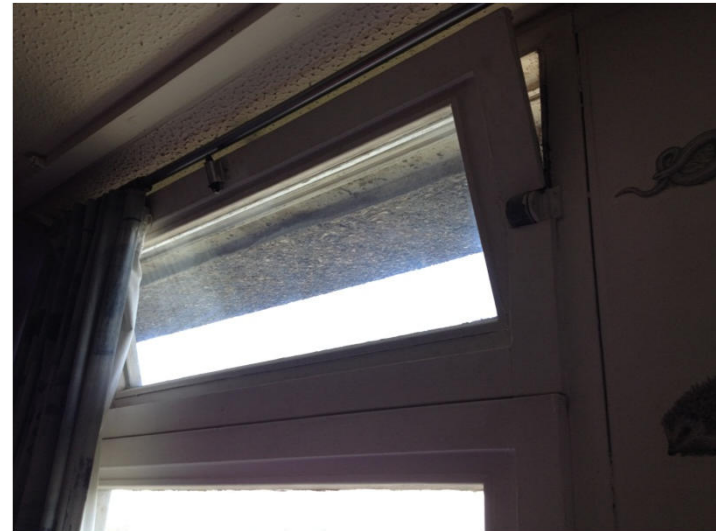
Photo 10 – Centre pivot operating mechanism

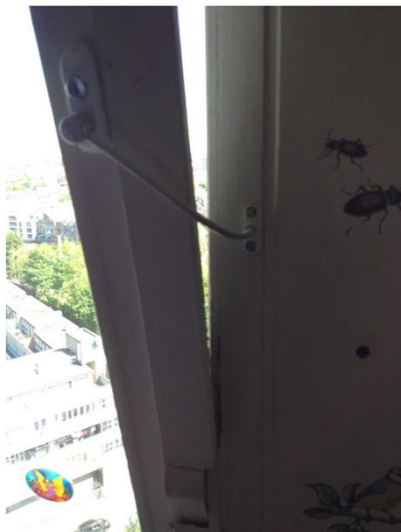
Photo 11 – Jackloc cable restrictor

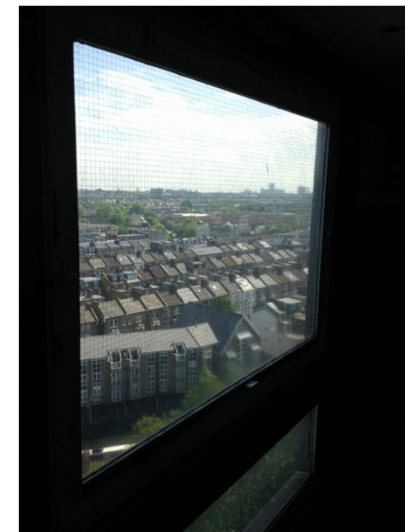
Photo 12 – Communal area window

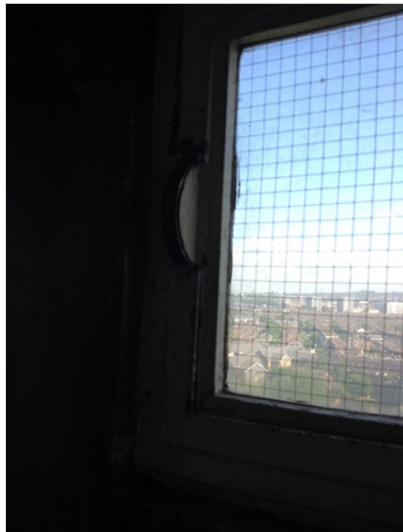
- 3.2.4 The windows contain Georgian wired glass with no evidence of broken glazing observed in the limited areas inspected.
- 3.2.5 It was not considered these windows had been decorated for from some time and potentially not since installation. Internally, many of the frames had little paint coverage exposing the metal substrate.

Photo 13 – Georgian wired glass to communal window

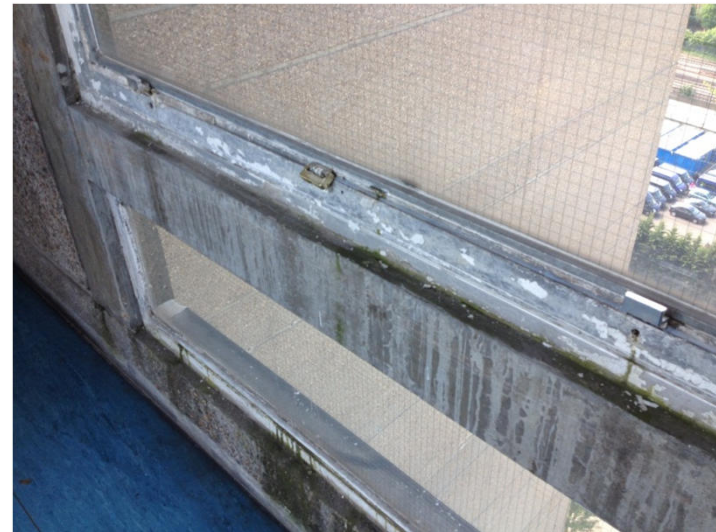
Photo 14 – Internal face of communal window to link bridge

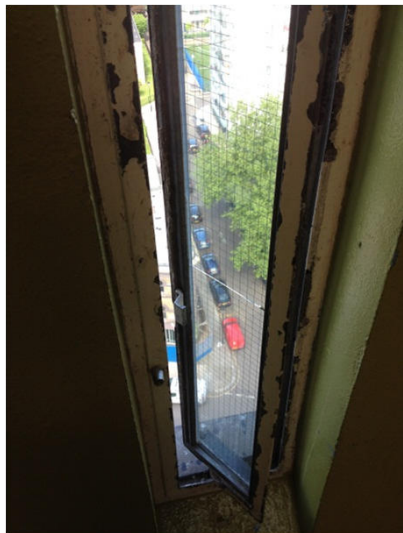
Photo 15 – Service tower window

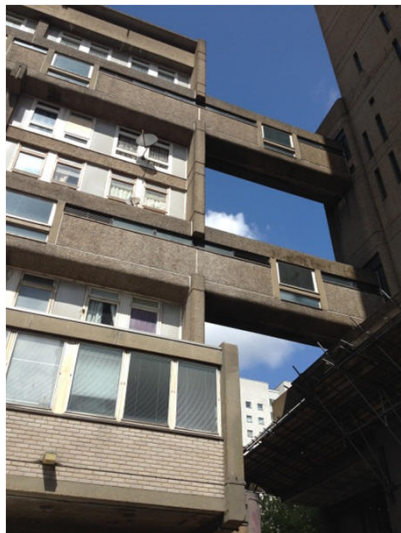
Photo 19 – Links between Block B and service tower

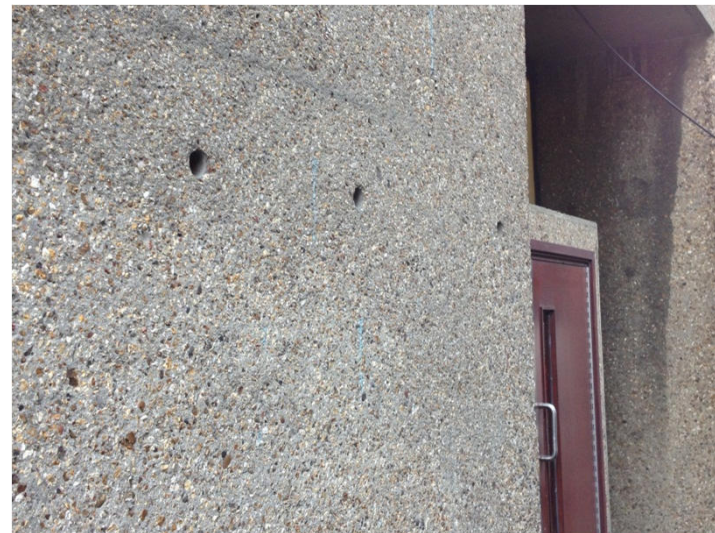
- 3.3.1 The building is of concrete framed construction with an exposed aggregate finish.
- 3.3.2 From ground level it is clear that various concrete defects exist. Areas of corroded reinforcement and spalled concrete is visible particularly around balcony edges. Pockets of blown concrete are also clearly evident to the Service Tower with protective measures

Photo 20 – Blown concrete to reinforcement

- 4.4.8 **Concrete** – Spalled, loose and dangerous areas of concrete require immediate attention in respect to presenting a health and safety risk in regard to potential falling debris. As a minimum, we therefore recommend that a full and intrusive concrete survey is undertaken which will develop the survey overview currently being progressed by Avalon. This will establish the extent of repair work which should be evidenced and supported by photographic references, hammer testing and sampling to establish levels of carbonation and general overview condition of the concrete structure.

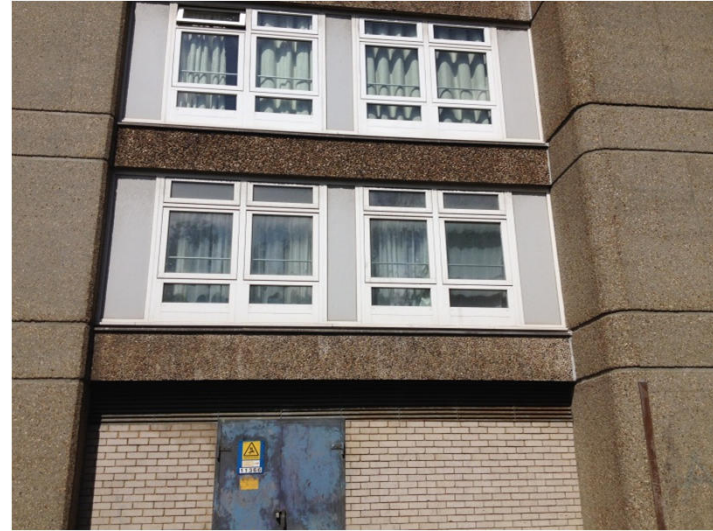
- 4.6.6 Finally, we note that replacement windows have been installed to the East elevation of Block A and South elevation of Block B in timber to match the size, profile and fenestration of the existing windows as directed by the Local Planning Authority and Conservation Groups. Works to these elevations are therefore excluded. Based on this precedent that has been set for the block, we have assumed a similar directive is likely to be enforced in respect to any future works ensuring a consistent approach and aesthetic treatment to all elevations. Should the replacement of windows in timber and crittal be considered, the following costs are projected as an enhancement to Option 2.

Photo 22 – Replacement window to Block A East Elevation

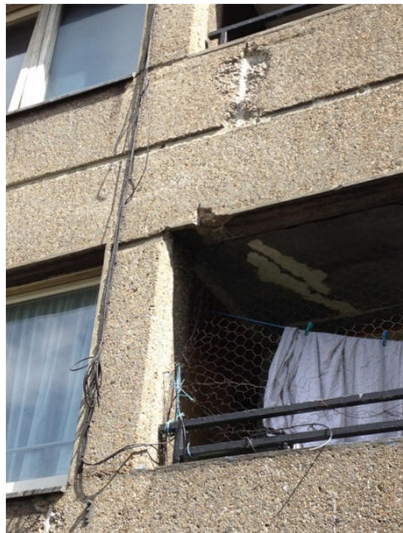
Photo 23 – Concrete disrepair example

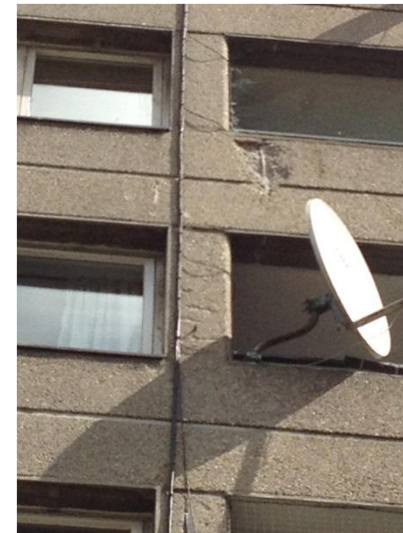
Photo 24 – Concrete disrepair example

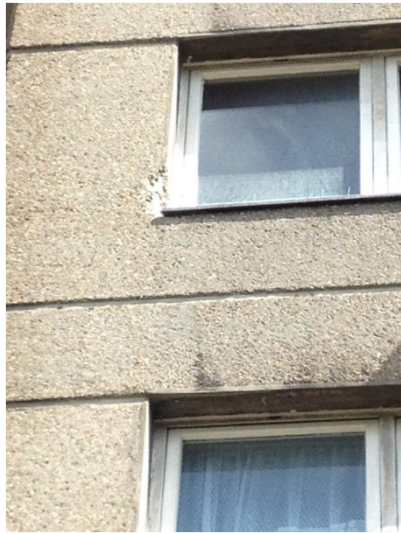
Photo 25 – Concrete disrepair example

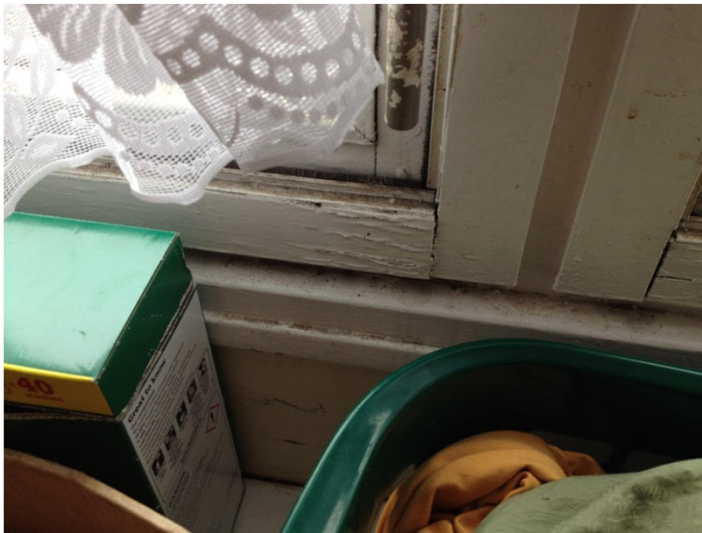
3.1.2 Timber windows and doors to private balcony areas are in a varied but fair condition however there is evidence of significant timber decay to the timber windows on the south elevation of Block A.

Photo 27 – Timber decay to kitchen window

- 4.4.6 Repair works will not receive a guarantee or warranty owing to the nature of the work.
- 4.4.7 Owing to the fully exposed location of the kitchen windows to the south elevation of Block A and evidence of extensive timber decay observed in accessed flats, we recommend these units are replaced on a "like for like" basis which we understand is to be the likely dictate from the Local Planning Authority and Conservation Area interest groups.

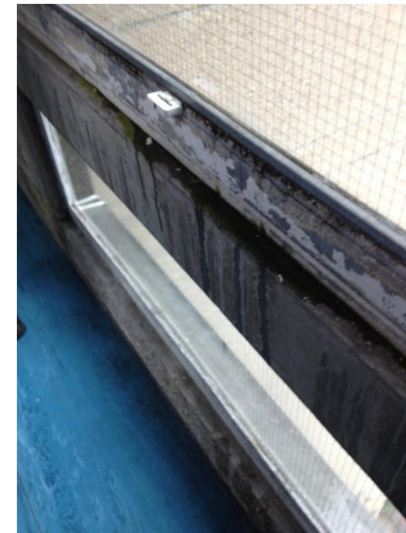
- 3.2.2 Historically, it appears various windows have been screwed shut as observed on the main communal walkways of Block A.
- 3.2.3 These windows are generally in a poor condition, particularly as noted on the Link Bridges where repair work has been executed historically in respect to applying mastic sealant to glass, frame and structure abutments in order to prevent water ingress. However clearly this is only a short term solution and considered an inadequate repair owing to the observation of ponding water on the communal flooring.

Photo 28 – Evidence of water ingress to communal area link bridge window

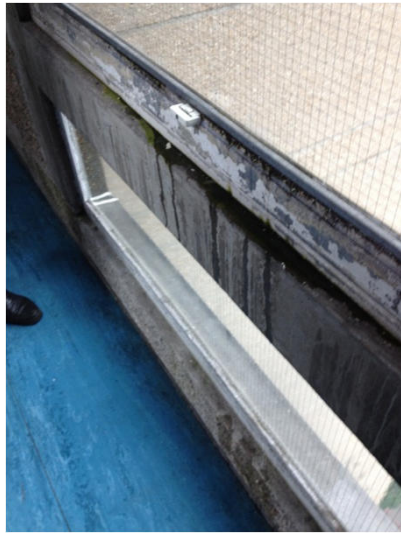
Photo 29 – Evidence of water ingress to communal window

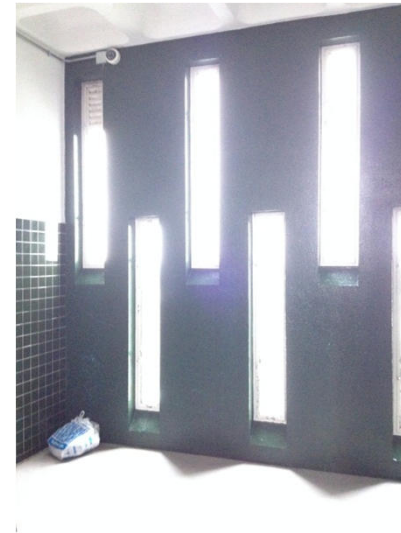
Photo 30 – Service tower window
