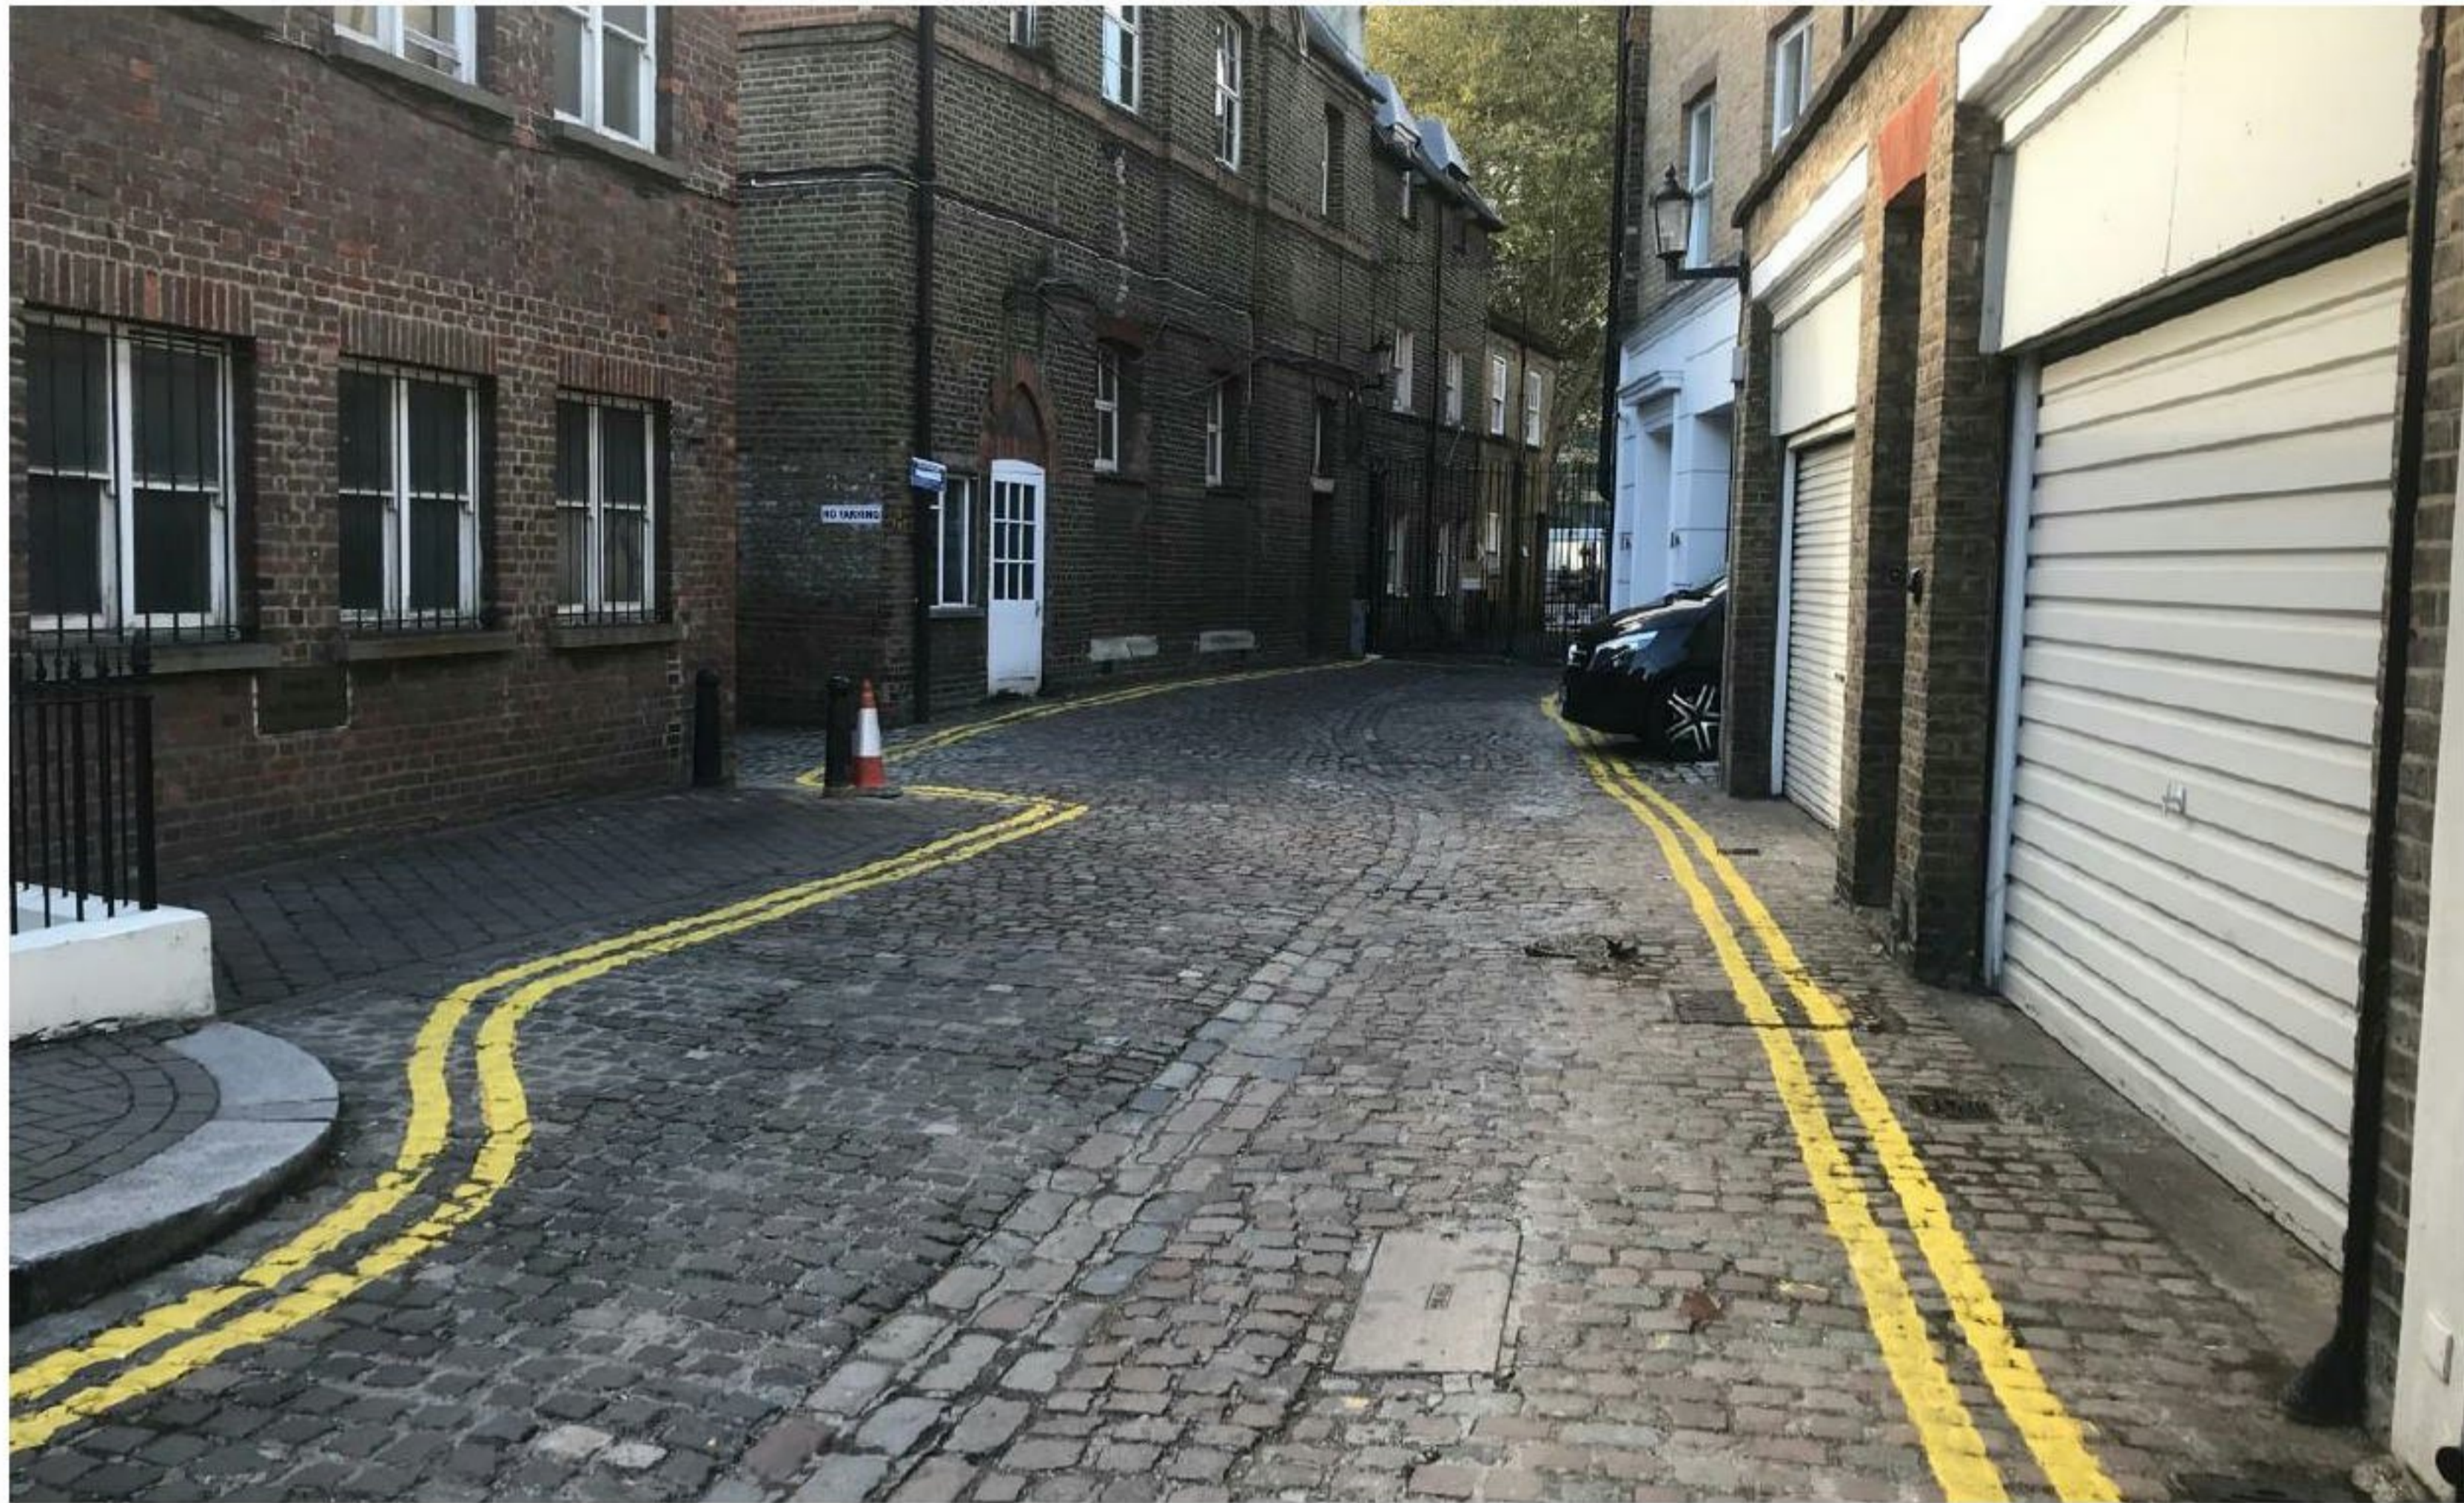
Plate 5: South End (facing west) – poor intervisibility to/from frontage properties
