Exhibition Road Monitoring

Report for Royal Borough of Kensington and Chelsea

August 2012

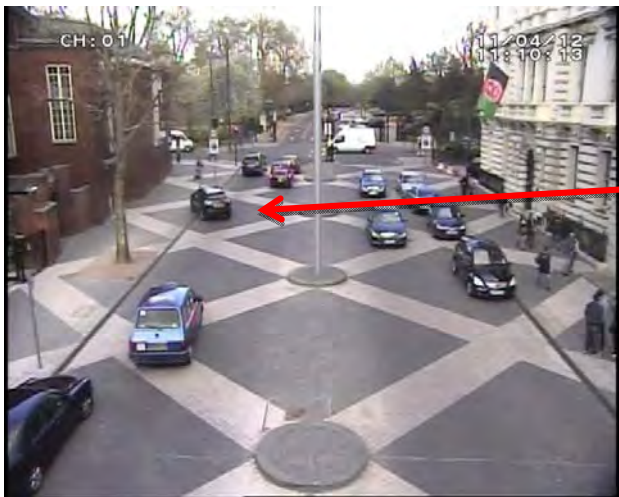
Figure 3.1 Prohibited movements within Section 1

Vehicles enter the safe zone on west side of Section 1.

- 3.3.8 Of the motorised vehicles making prohibited movements, the dominant vehicle type was cars, including private hire vehicles. The high incidence of vehicles running in the safe zone on the eastern footway, and lower levels on the western footway, relates in most cases to parking activity. As vehicles are manoeuvring into the parallel spaces they often cross the delineator paving. Many drivers also park their car straddling the parking area and the safe zone. Others were observed to pull into the safe zone and stop next to the building line in order to pick up/set down passengers. These movements are illustrated in **Figures 3.1 and 3.2**.

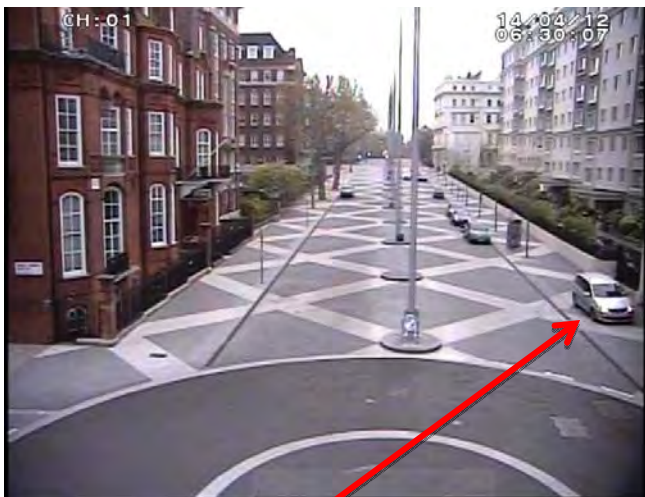
Figure 3.2 Prohibited movements within Section 1

Example of vehicles parking/dropping off passengers within the safe zone on the eastern side outside entrance to residential building.

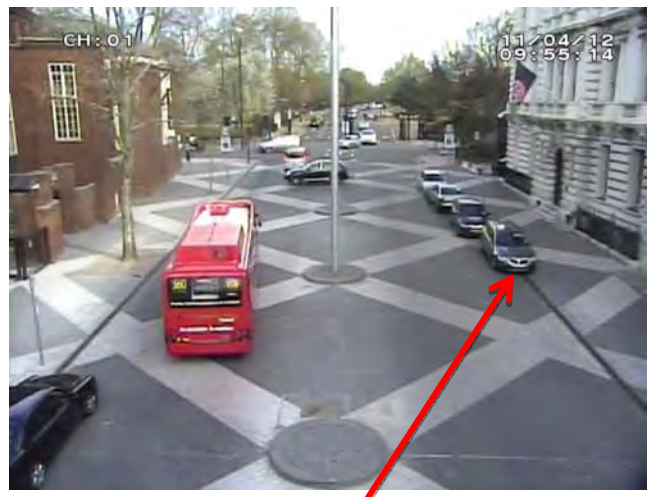
Parked cars often straddle the parking bay and the safe zone.

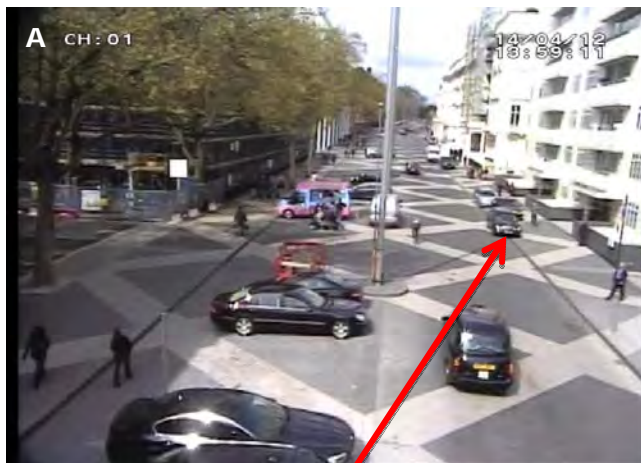
Figure 4.1 Prohibited movements within the safe zone

Vehicles parking or dropping off/picking up passengers from nearby residential buildings stop in the eastern safe zone.

4.3.5 A very high number of motorised vehicles were observed to enter the safe zone on the eastern side of Section 3. Many of these are due to vehicles parking or dropping off/ picking up passengers from nearby buildings in the eastern safe zone. A number of other such prohibited movements are linked to the building site opposite Imperial College where work vehicles were observed parking within the safe zone. Some of the vehicles recorded in the safe zone are legitimate movements as at certain points along Section 3 vehicles must cross the safe zone in order to access side roads, for example, vehicles accessing Watts Way. In general, vehicles only enter small sections of the safe zone i.e. and do not drive along its length

4.3.8 **Figure 4.1** illustrates some of the prohibited movements.

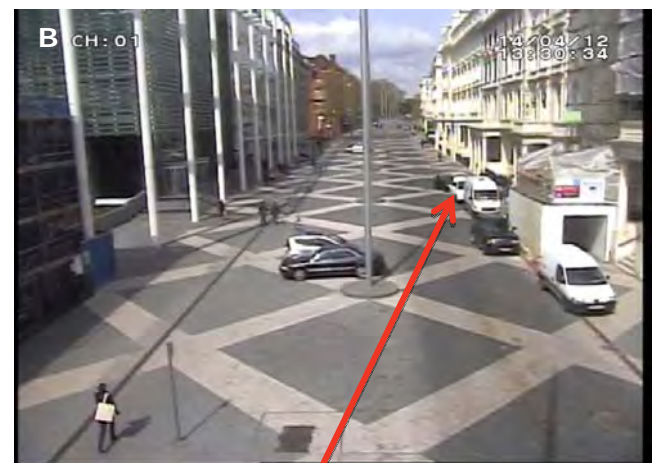
Vehicles parking or dropping off/picking up passengers and vehicles parked to access building site that crosses pavement contributing to high numbers of vehicles in eastern safe zone.

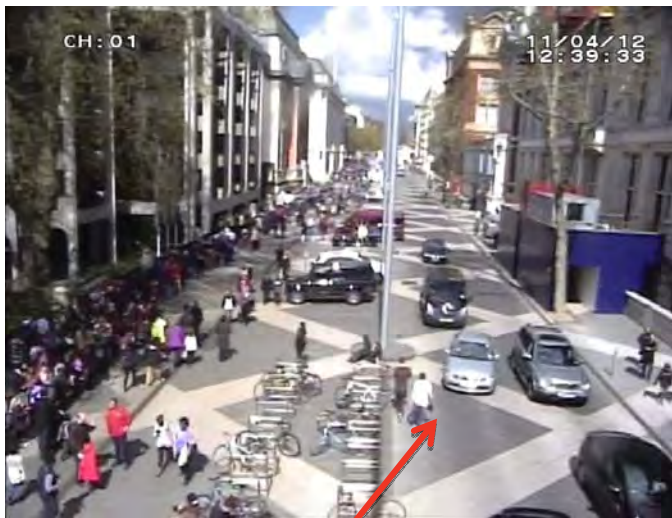
Figure 5.1 Section 4 - V&A Museum on right

Vehicles Driving the Wrong Way Southbound - A high number of vehicles are recorded driving the wrong way southbound on Exhibition Road as they try to overtake queued traffic tailing back from the junction with Cromwell Road

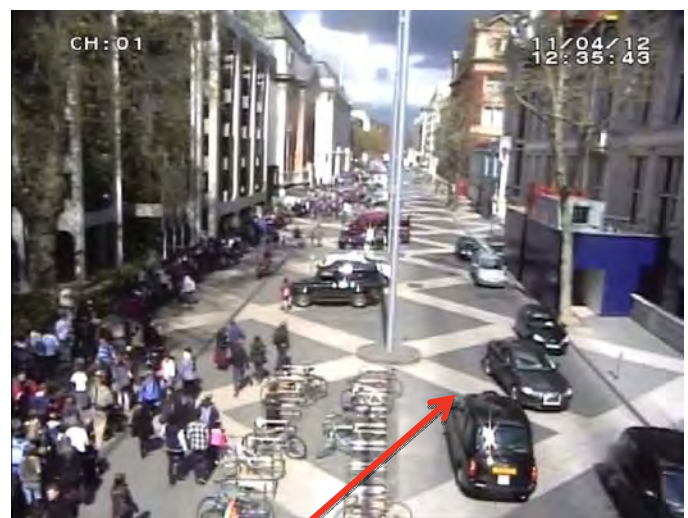
Vehicles travelling on the wrong side of the road southbound cause north bound vehicles to stop or change direction.

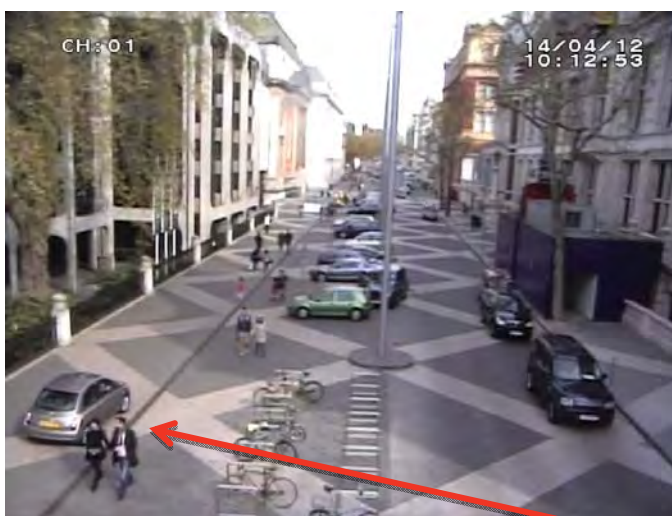
Figure 5.2 Section 4 - V&A Museum on right

Vehicle driving the wrong way northbound - Vehicles that have turned left from Cromwell Road enter via safe zone. Vehicle then crosses to join main carriageway.

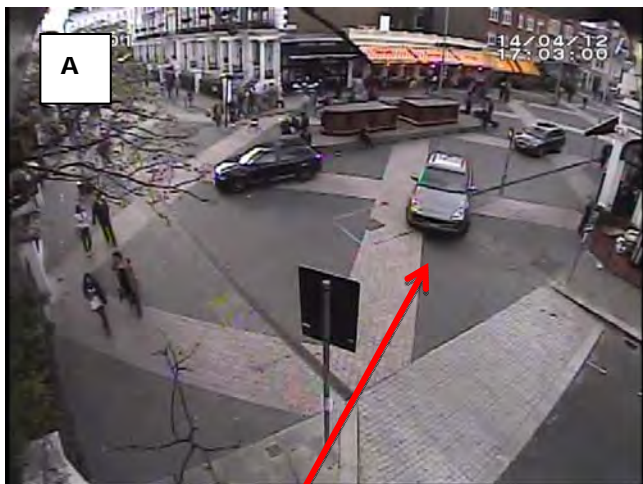
Figure 7.1 (a) Vehicles in eastern safe zone (b) Movements wrong way northbound

Right turning vehicles often cut the corner, entering eastern safe zone.

- 7.3.5 Of all vehicles recorded passing through Section 7, 27% of these made some sort of prohibited movement. Motor vehicles are responsible for most of the prohibited movements and account for 88% of those recorded. Motor vehicles moving within the safe zone on the eastern side are particularly high though it was found that this was mainly as a result of left turning vehicles into Thurloe Place cutting the corner and entering the eastern safe zone. This is illustrated in **Figure 7.1**.

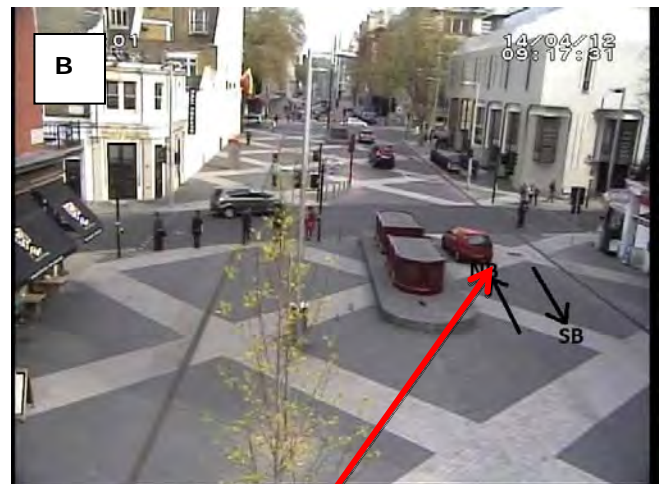
Wrong way northbound – A number of vehicles were observed travelling on the carriageway the wrong way north before exiting onto Thurloe Place or continuing northbound into Section 6.

- 7.3.6 A high number of motor vehicles were also recorded travelling the wrong way northbound. A significant proportion of these were observed to come from Thurloe Street which then travelled north and exited onto Thurloe Place. The high numbers classed as going the wrong way north also relate to vehicles which turned right into Thurloe Street (Section 8) without realising that it is not a through road. They then reverse north into Section 7. Some of the movements classed as prohibited movements northbound are also illustrated in **Figure 7.1**.

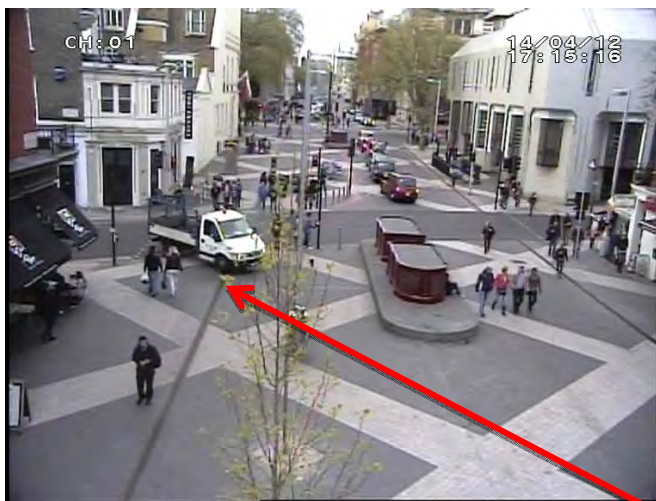
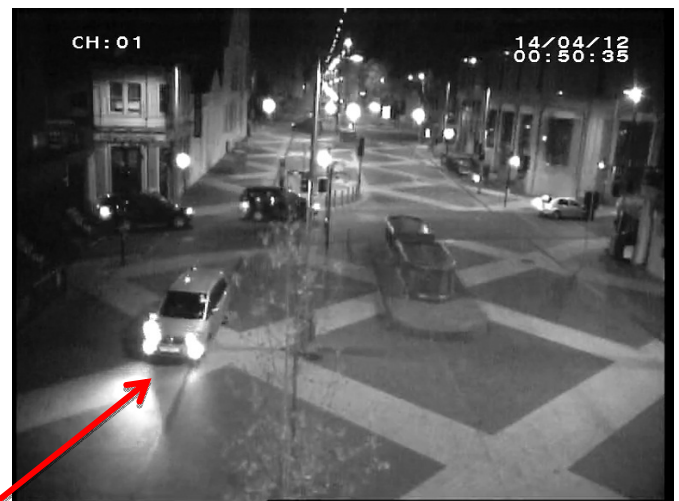
Figure 7.2 Movements in safe zone

A number of vehicles were observed entering Section 7 from the north via the western safe zone rather than via the carriageway.

- 7.3.7 A high number of vehicles within the western safe zone were observed to be vehicles which enter Section 7 from the north via the safe zone rather than via the carriageway as illustrated in **Figure 7.2**.
