## **Review of RBKC Basements Visual Evidence July 2013**

This review assesses the validity of the Council's basements visual evidence.

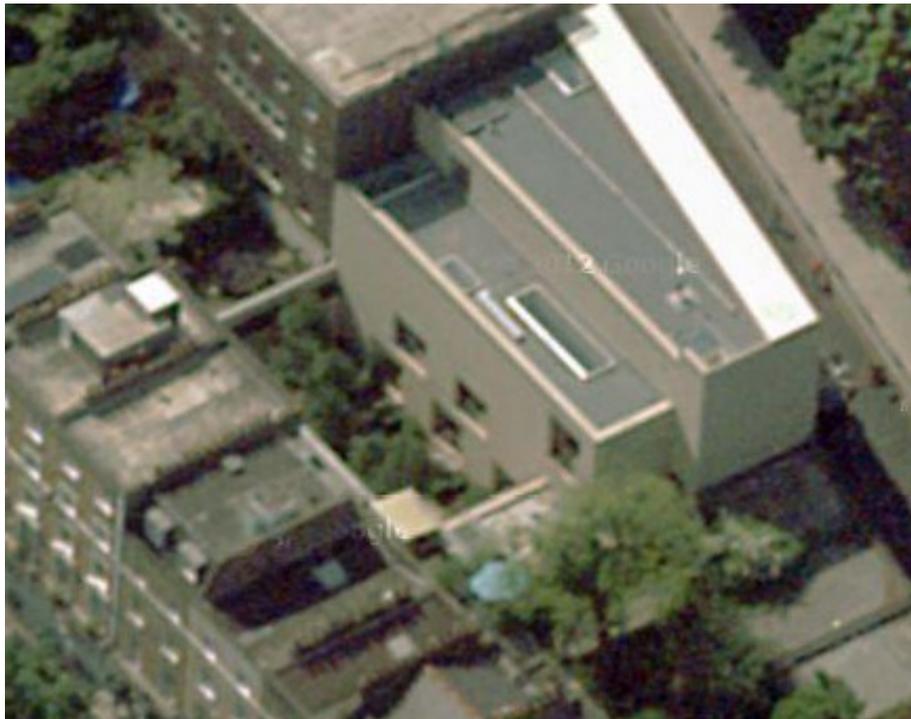
**7 - 10 Cottage Place**

The picture below shows that the rear garden is now planted with trees starting to grow to maturity.

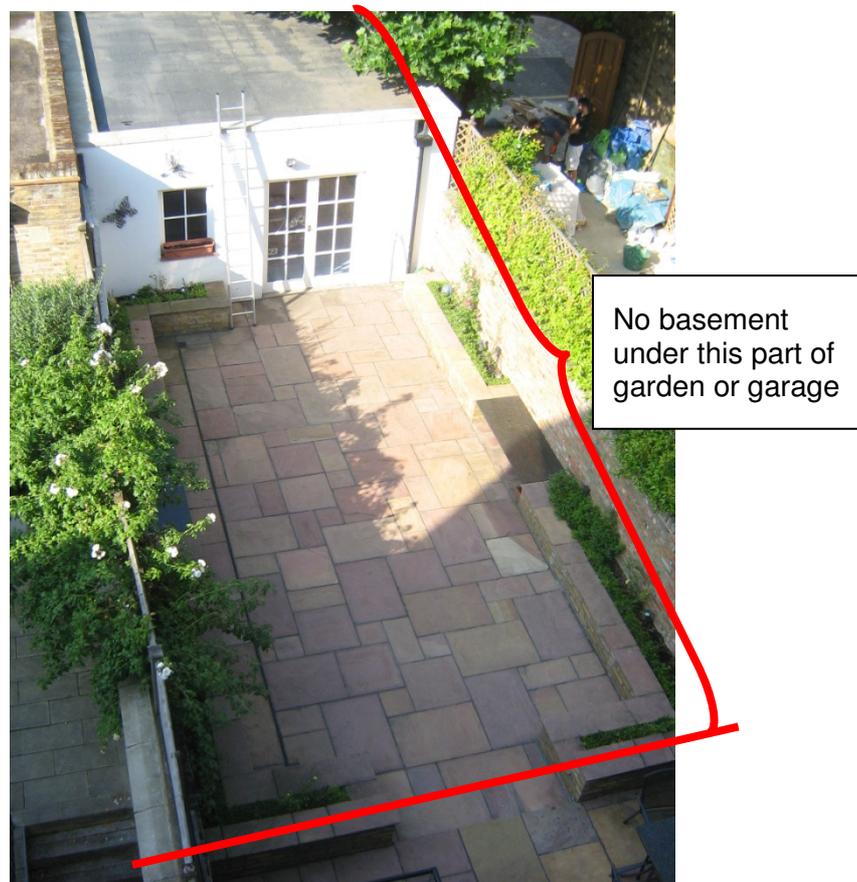
#### 48 Drayton Gardens

48, 50 and 52 Drayton Gardens do not have basements under the significant majority of their gardens.

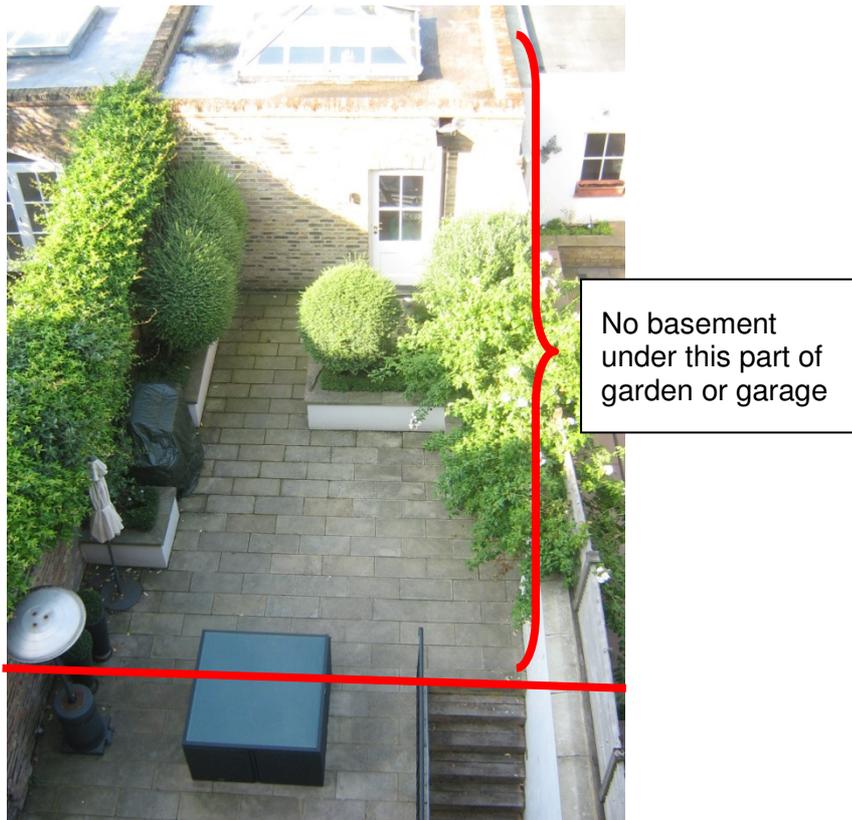
**50 Drayton Gardens**

The basement does not extend more than three metres from the rear face of the main house.

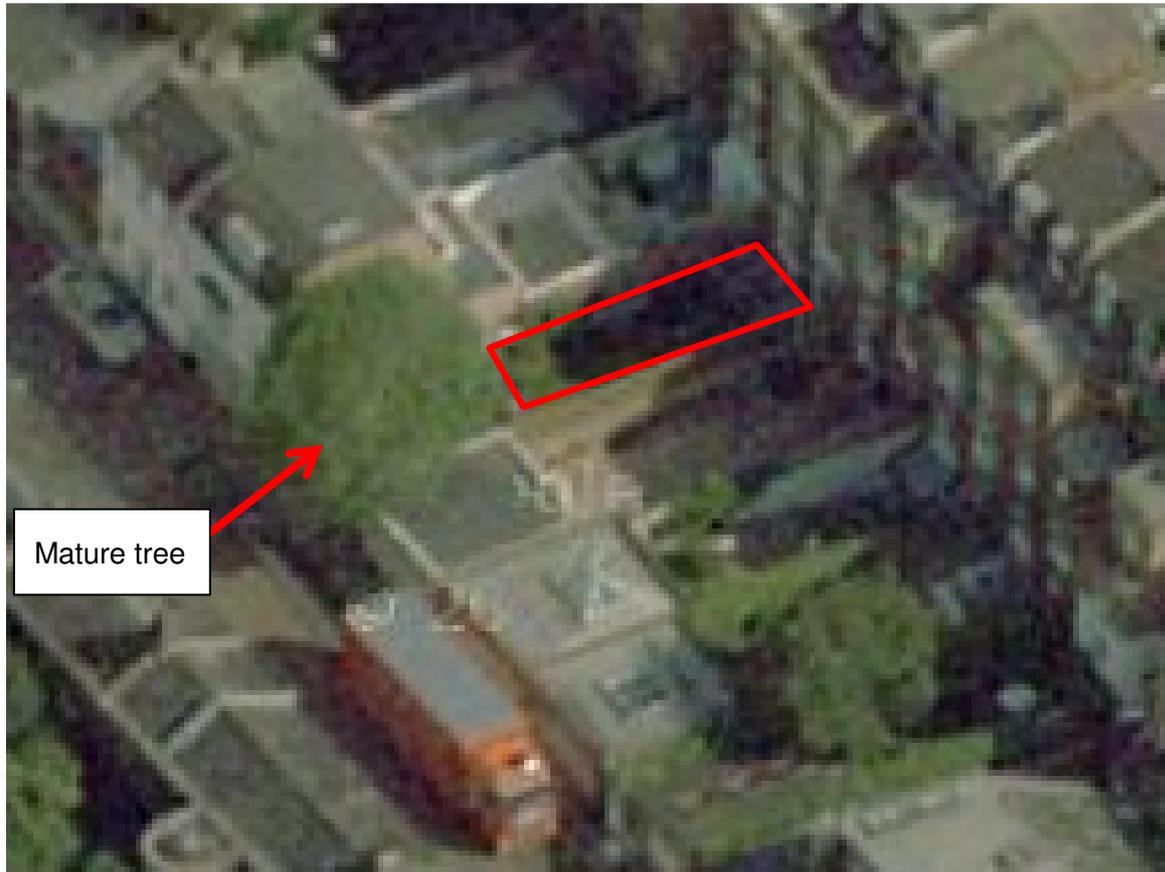
#### **46 Drayton Gardens**

46 Drayton Gardens has a basement - shown by red line but has a more green and leafy garden including a mature tree than the gardens of 48, 50 and 52 Drayton Gardens who do not have significant garden basements.

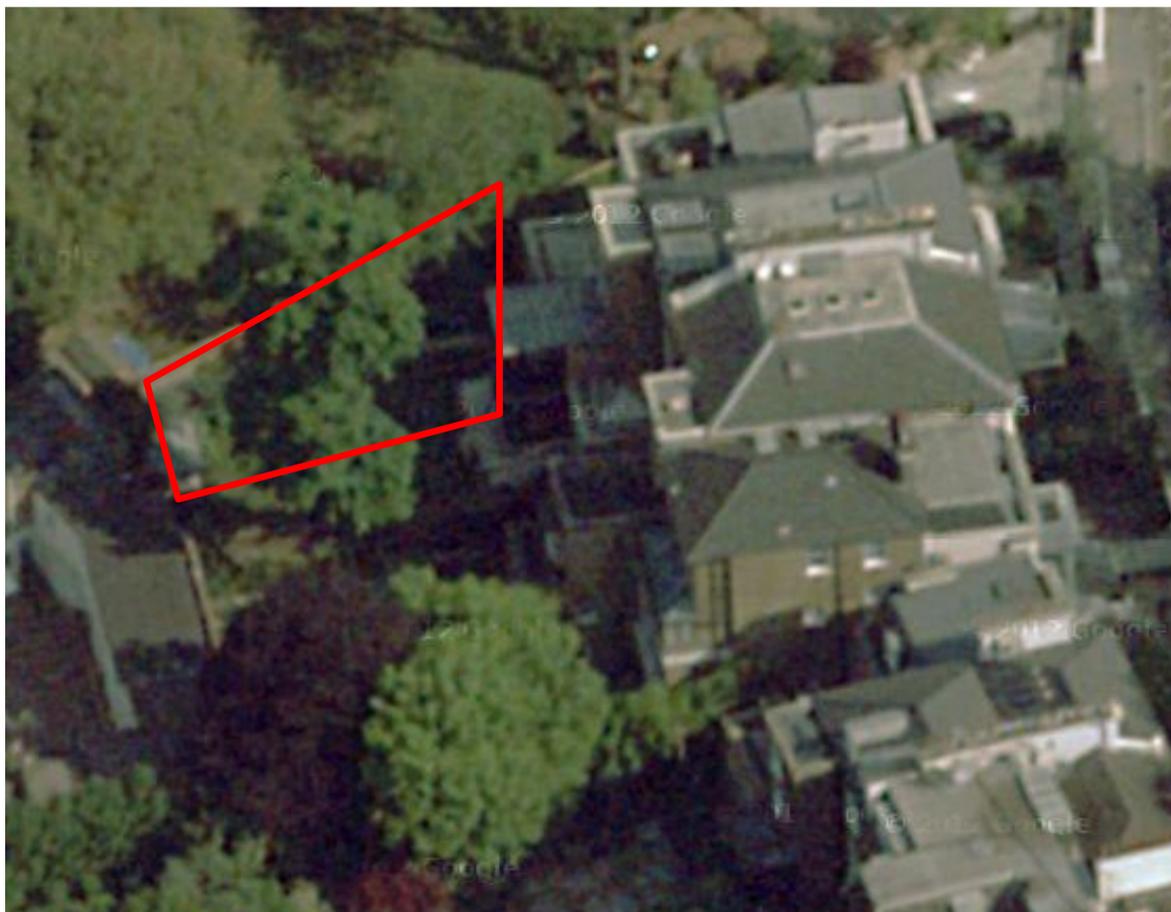
**16 The Boltons**

The rear garden has a basement underneath

Mature tree planting is evident. The trees on the garden basement roof were planted in accordance with the proposed landscaping plan.

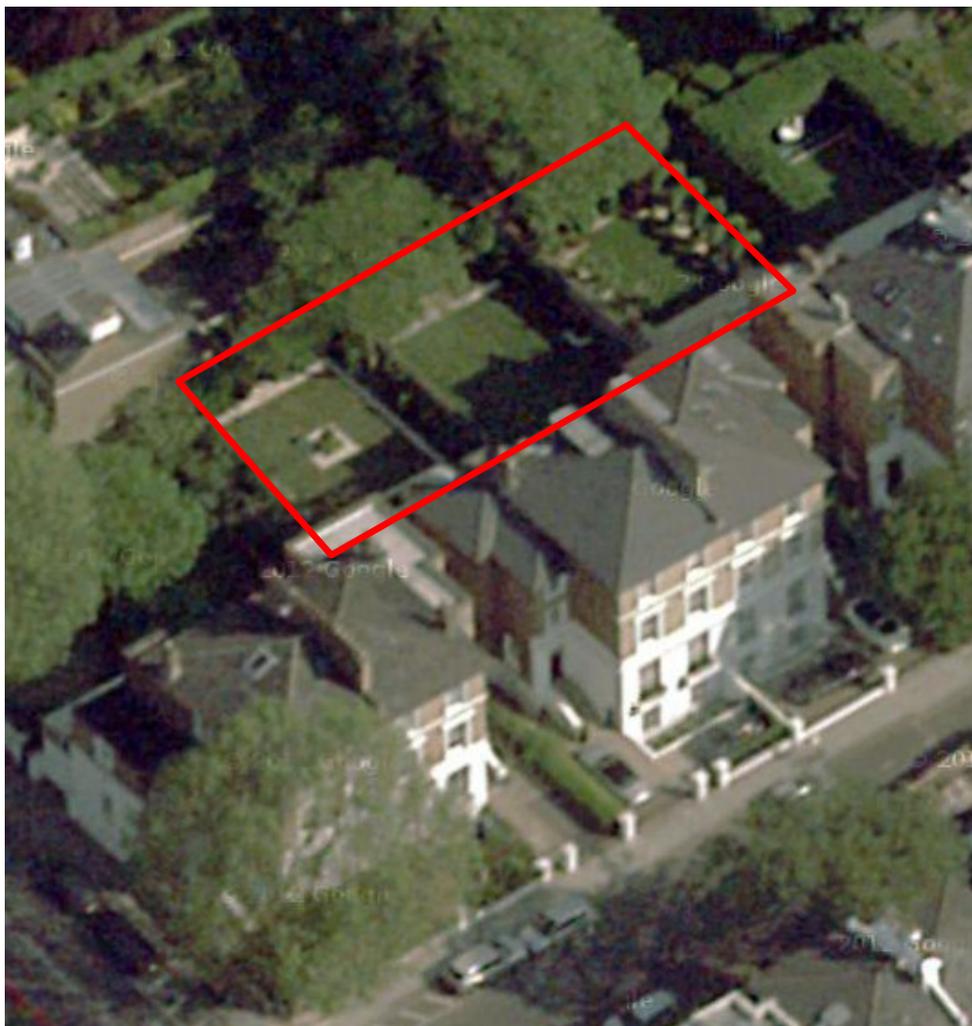
### **8, 10 and 12 Tregunter Road**

The rear gardens have no basement underneath them.

The planting is formal, with clipped border planting and without mature tree planting.

The appearance is similar to the gardens at 10 and 11 The Boltons which is within 200 metres of 8, 10 and 12 Tregunter Road.
