Lots Road Power Station And Chelsea Creek

**Lots Road Power Station
Contamination Issues**

Planning Permission Ref. PP/02/01324 – Submission of Details Pursuant to Condition 27

Condition 27 of Planning Permission Ref. PP/02/01324 covering the RBKC Site refers to the processes and information requirements of a ground contamination investigation, assessment and remediation before any part of the development commences. This document is submitted pursuant to the discharge of this condition.

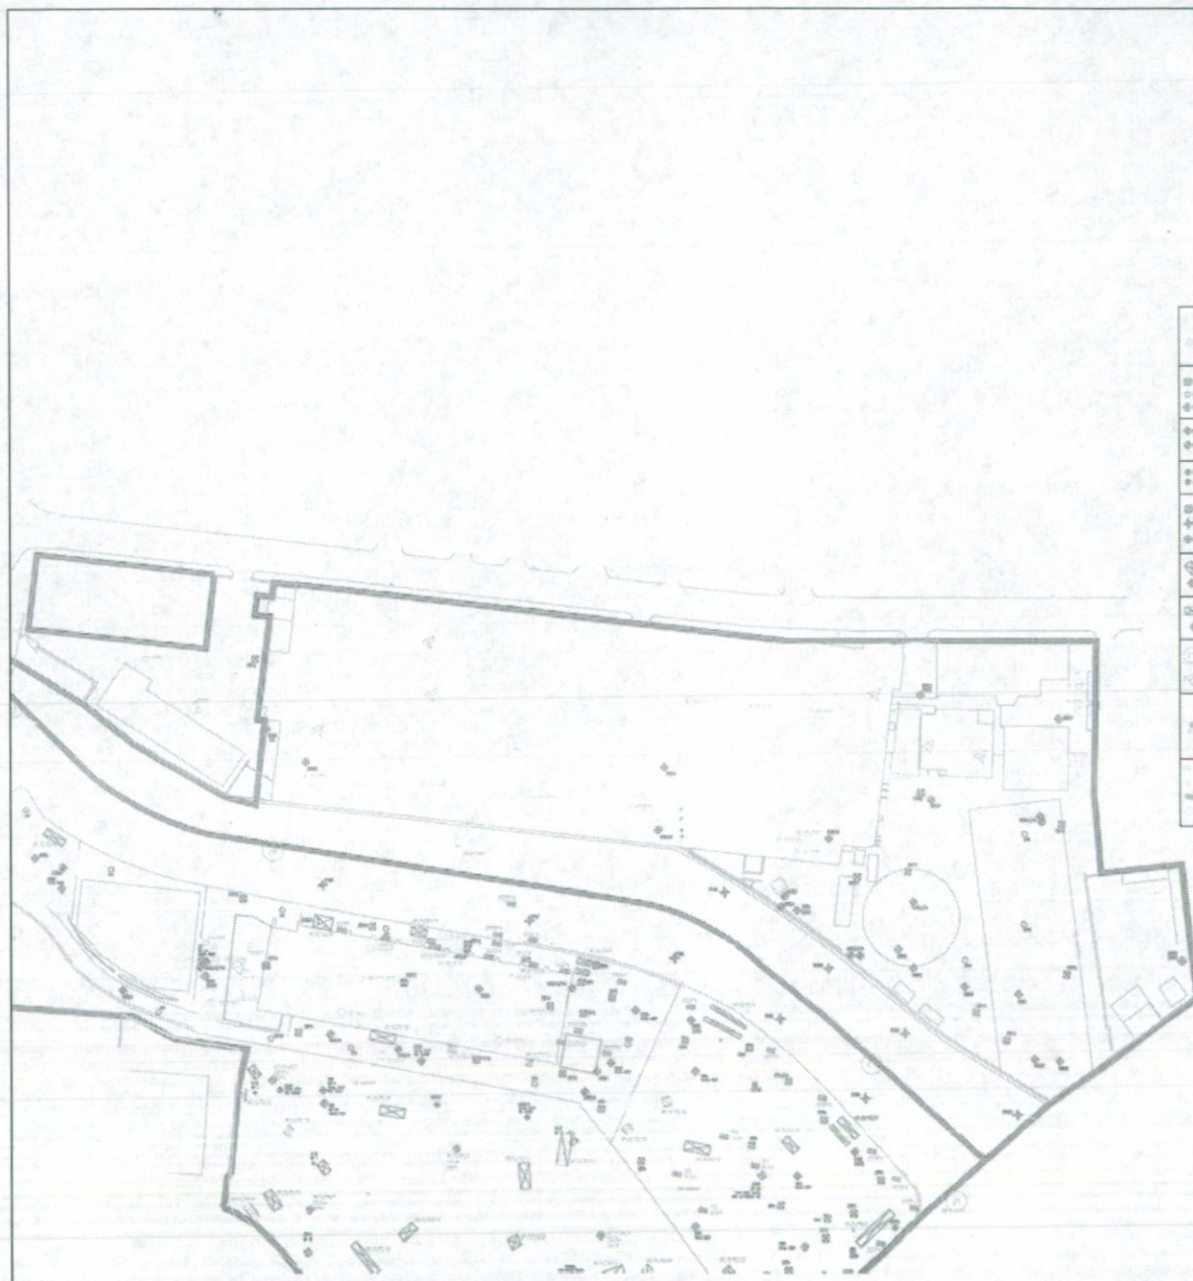
FIGURE

LOTS ROAD - PHASE 1
 RBKC - INDICATIVE EXPLORATORY HOLES

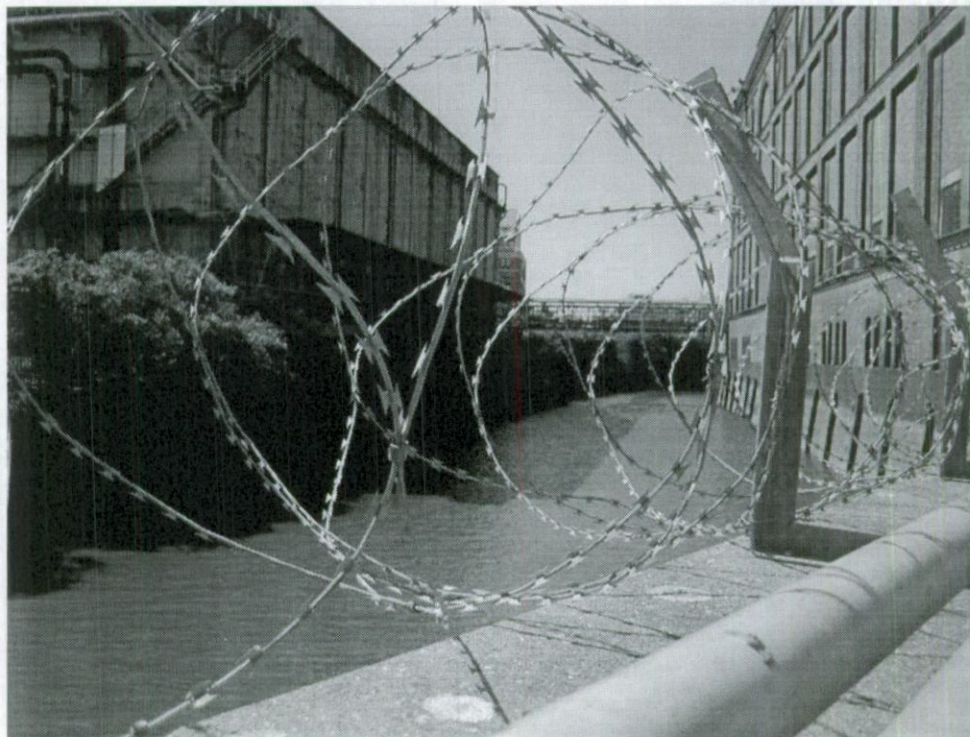
Photograph 1 RBKC Power Station Southern Boundary

The southern wall of the power station lies along the northern wall of Chelsea Creek (Photograph 1).

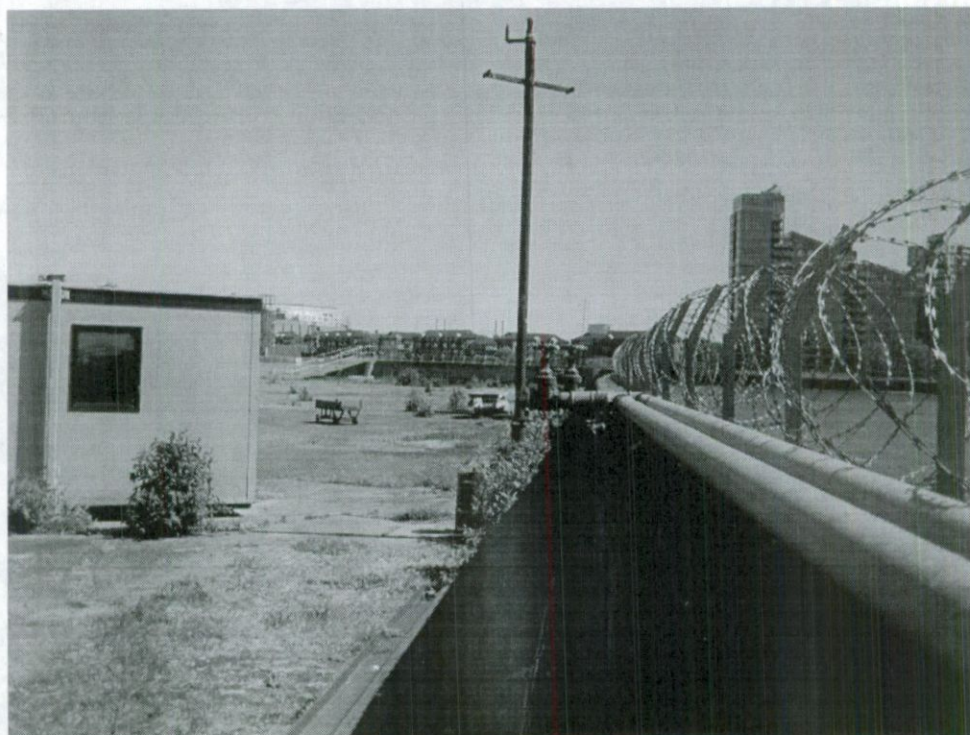
Photograph 2 RBKC Condition of East Yard Tarmac, View Looking Southeast

The RBKC site contains the main Power Station building along with ancillary buildings including the former pump house, a workshop, chemical stores and offices. In addition, at the eastern end of the site is the trash screening area for the surface water abstraction point. Between the trash screen and Power Station/stores buildings is the East Yard a concreted/tarmac area for parking. Areas of this tarmac are in poor condition with vegetation breaking the ground surface. This is illustrated in Photographs 2 & 3.

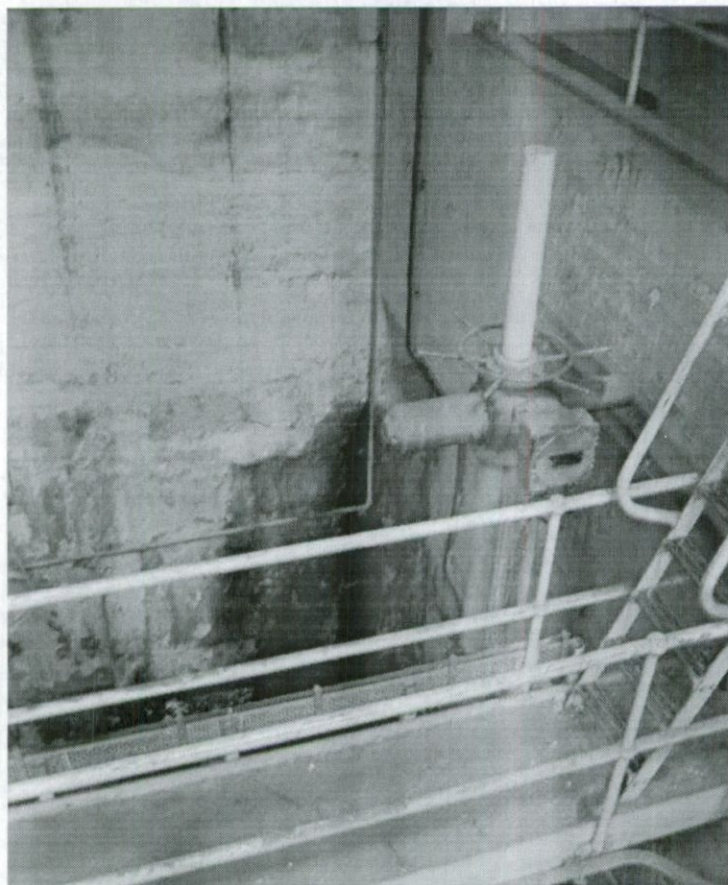
Photograph 6 RBKC Water Ingress within the Deep Trench of the Turbine Hall

building materials and services (P15) as being potential receptors, I could not see any assessment of potential risk. Photograph 6 shows water ingress within the deep trench containing pipework. Where do these pipes lead? Is this water likely to be contaminated, what is the condition of the pipework?

The present layout within the Power Station building is multiple levels, as indicated in Photograph 5, including a deep service trench at approximately 9m below road level, which runs east to west containing pipework. The main pipes are water inlet pipes which draw water from the River Thames and traverse the site extending to the Pump House, before looping round to discharge back to the river. Water ingress was noted in to this area during the site walkover, with evidence of staining on the wall and noise of trickles of water (Photograph 6).

<p>services (P15) as being potential receptors, I could not see any assessment of potential risk. Photograph 6 shows water ingress within the deep trench containing pipework. Where do these pipes lead? Is this water likely to be contaminated, what is the condition of the pipework?</p>	<p>The deep trench contains the water inlet pipes which draw water from the River Thames and traverse the site extending to the Pump House, before looping round to discharge back to the river.</p> <p>The water ingress shown in to the trench, based on the depth, is likely to be from groundwater within the River Terrace Gravels and could potentially contain contaminants.</p> <p>The condition of the pipe work is unknown, but it is known that it was sealed and vented as part of the decommissioning works</p>	
Contam	27	<p>I would like to request that an additional borehole is dug, and samples taken in the area that is to become a lawn, given its proximity to the coal pit and East yard.</p>	<p>Maritime / geotechnical trial pit and borehole TPN402A and BHN311 can provide this information.</p>	Figure 8.1 of PRA
