Review of RBKC Basements Visual Evidence July 2013

This review assesses the validity of the Council's basements visual evidence.

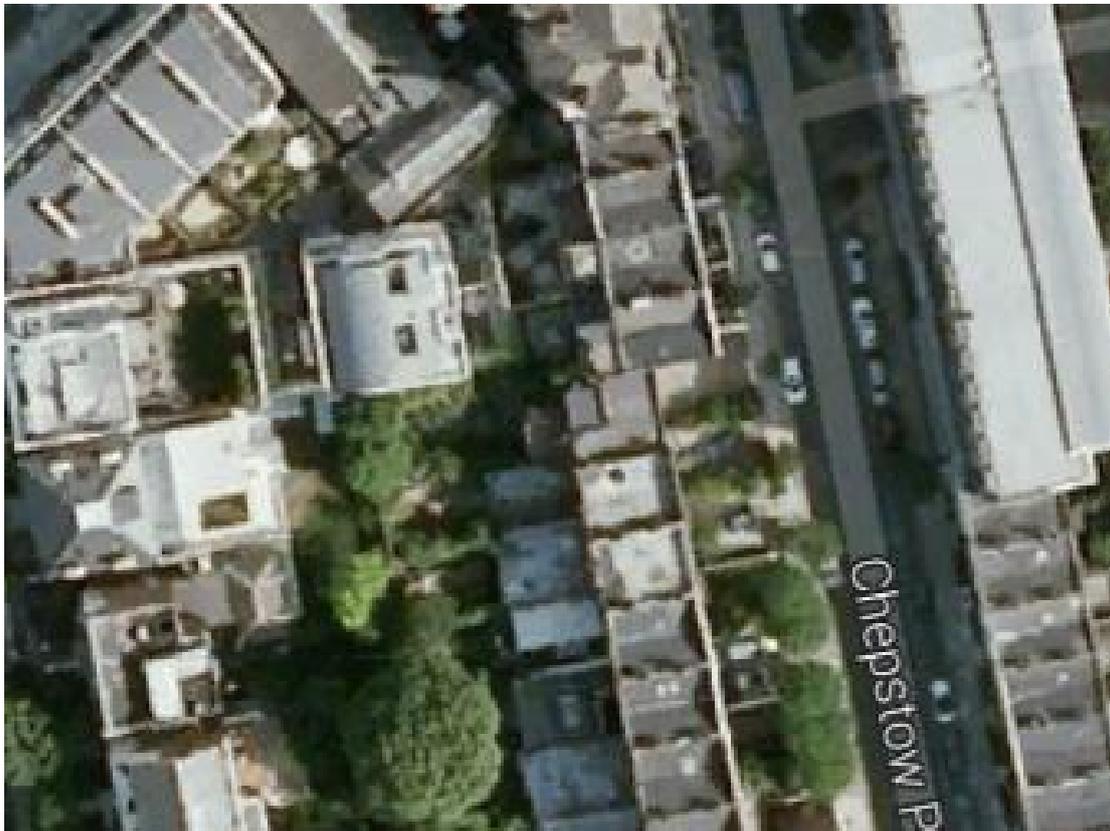
Planning permission was granted in 2012 and the Council's 2012 picture shows construction in progress.

The picture below from Google maps, taken after 2012, shows that the tree planting in place prior to construction remains in place now. i.e. there has been no negative change in mature tree planting or greenification. The detailed landscaping to the garden cannot be seen.

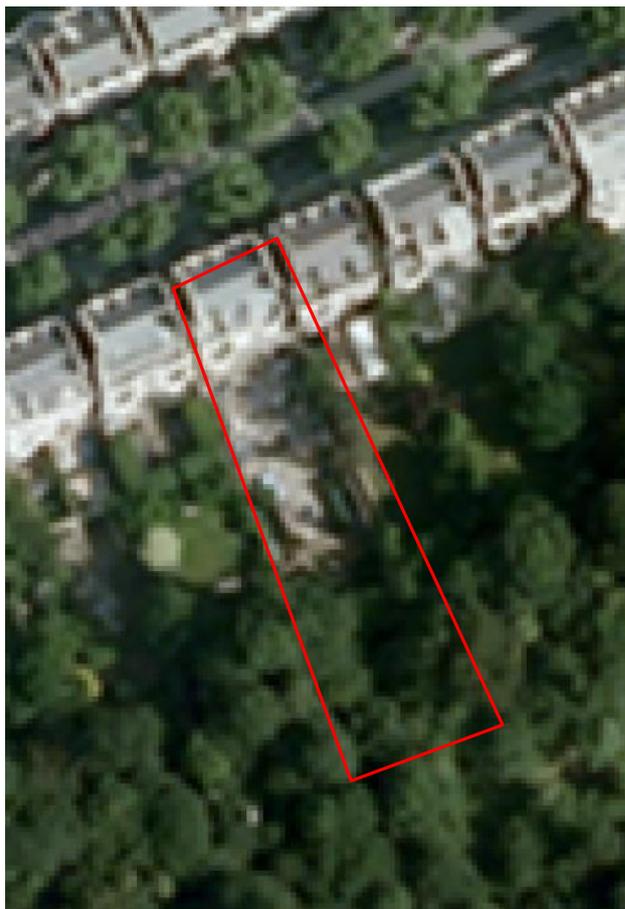
It is also worth noting that on the Google maps 2014 picture below the extent of planting looks similar to the planting in the Council's 1999 and 2004 pictures taken before construction of the basement.

9 Holland Park - 2014 picture from Google Maps showing good recent planting

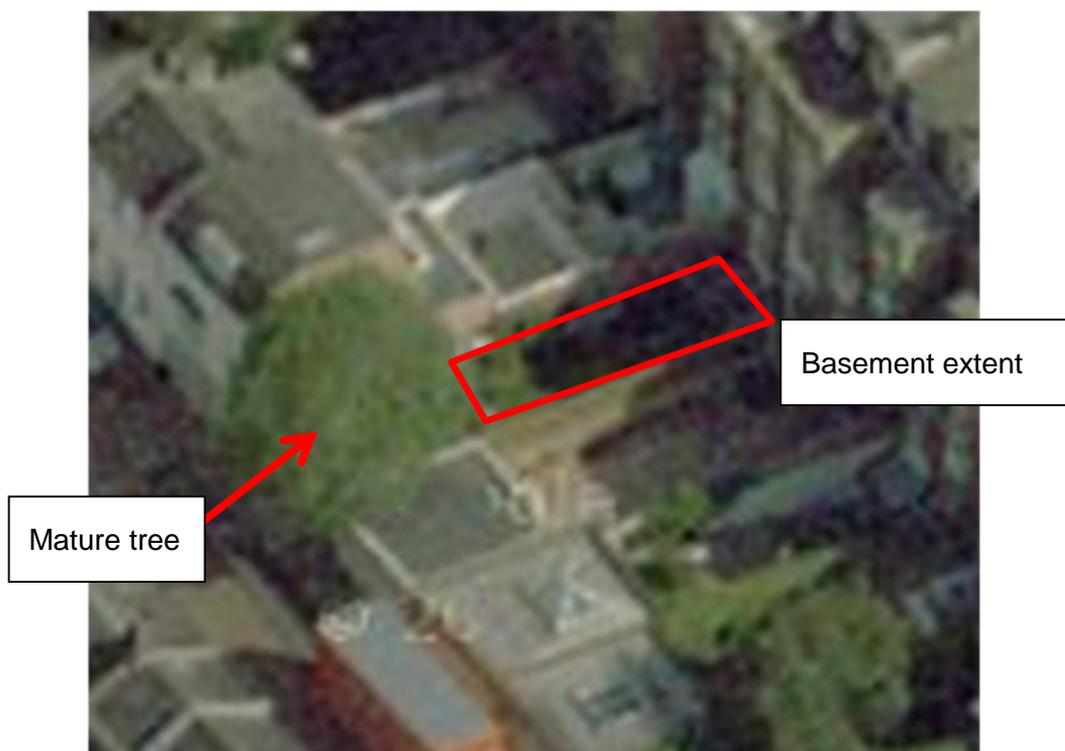
46 Drayton Gardens has a basement - shown by red line but has a more green and leafy garden including a mature tree than the gardens of 48, 50 and 52 Drayton Gardens which do not have significant garden basements.

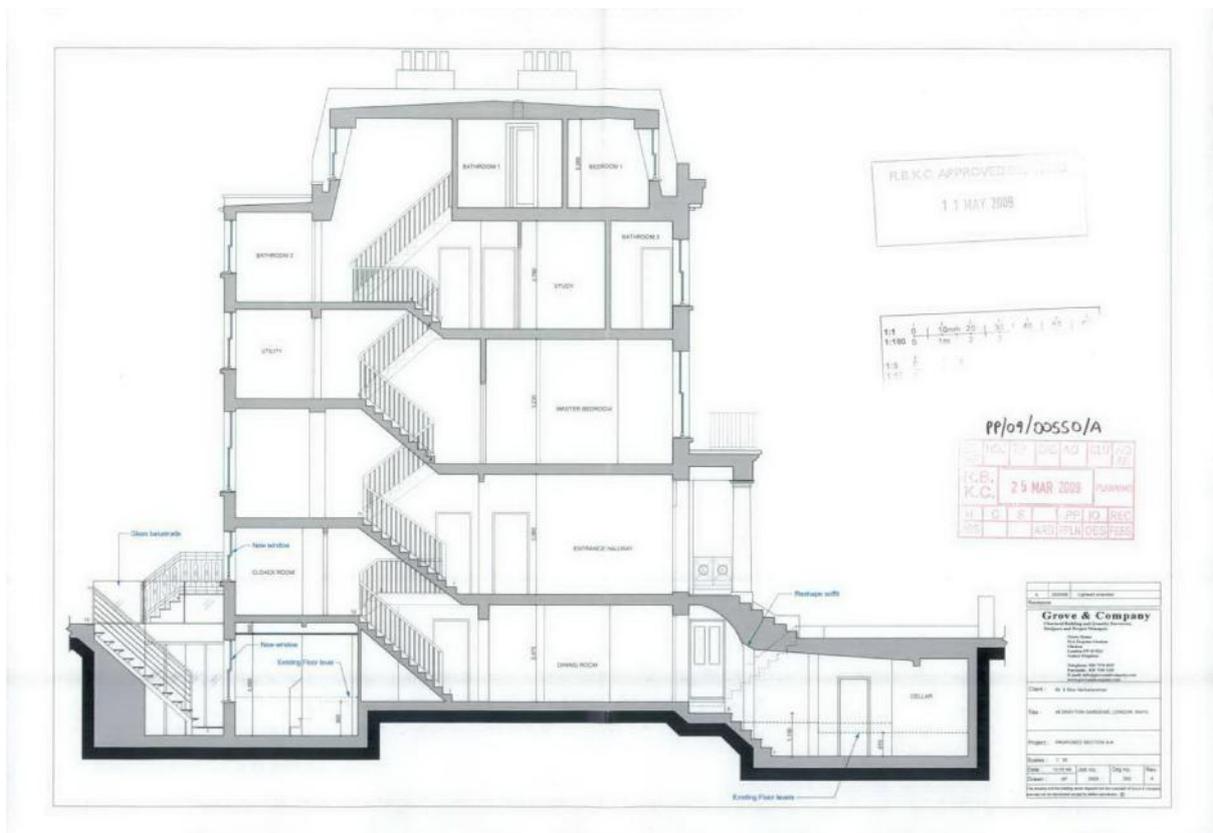
There is no basement under the majority of the rear garden and no basement under the garage.

We included below the long section of the proposed planning drawings and a photograph showing the area of the garden that does not have a basement underneath it. The basement extends out from the house by one approximately three metres. The rest of the garden has been paved by choice of the owners. There is not basement under the garage.

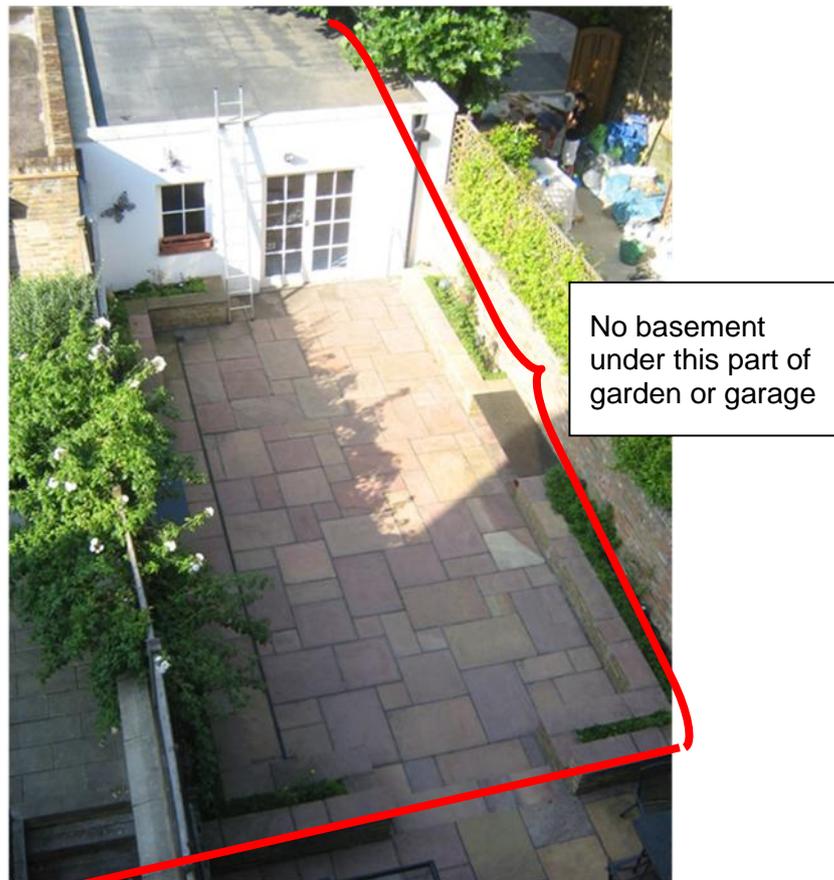
The rear of the property and the rear garden are to the left of the drawing. It can be seen that there is no significant rear garden basement.

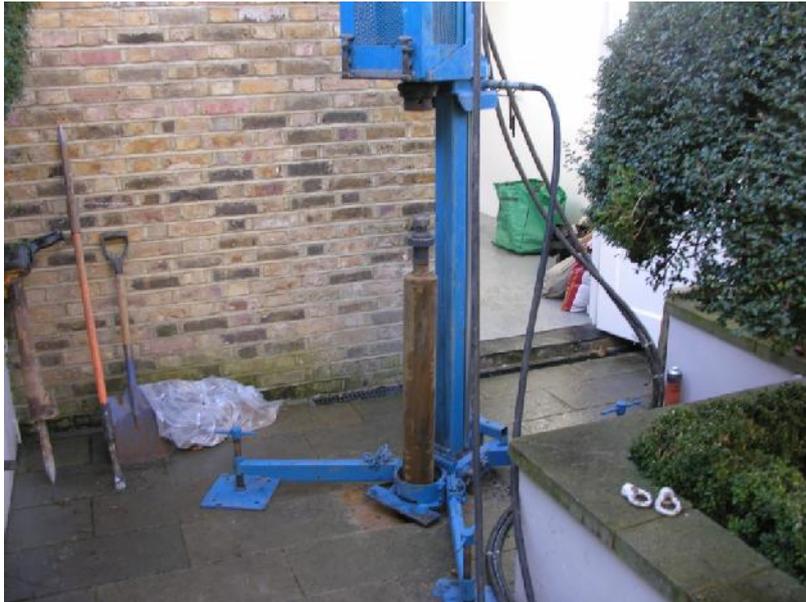
Borehole being drilled in rear garden of 50 Drayton Gardens - Jan 2013

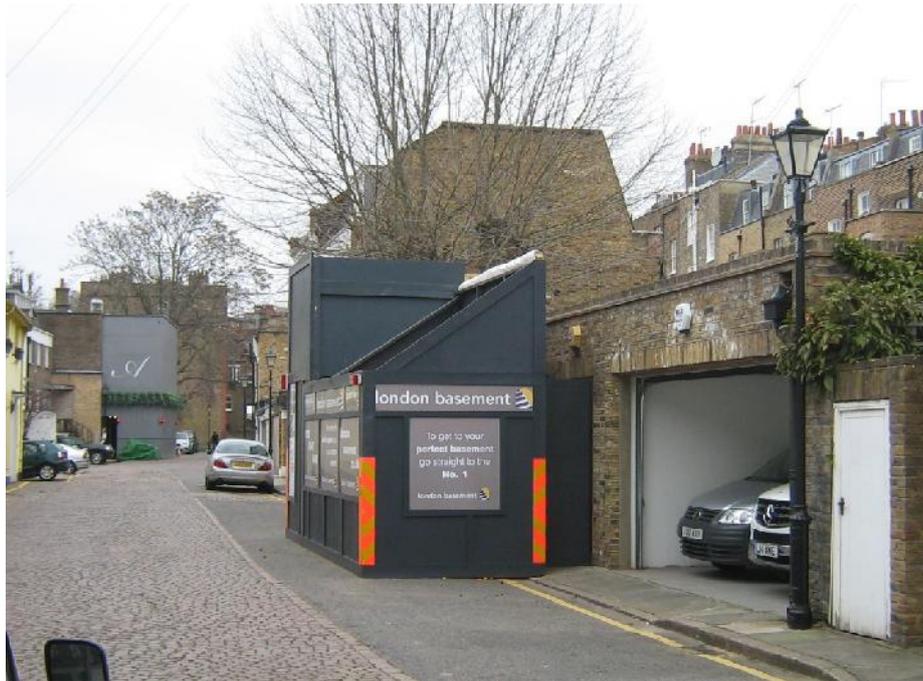
Basement under construction in rear garden of 50 Drayton Gardens - March 2014

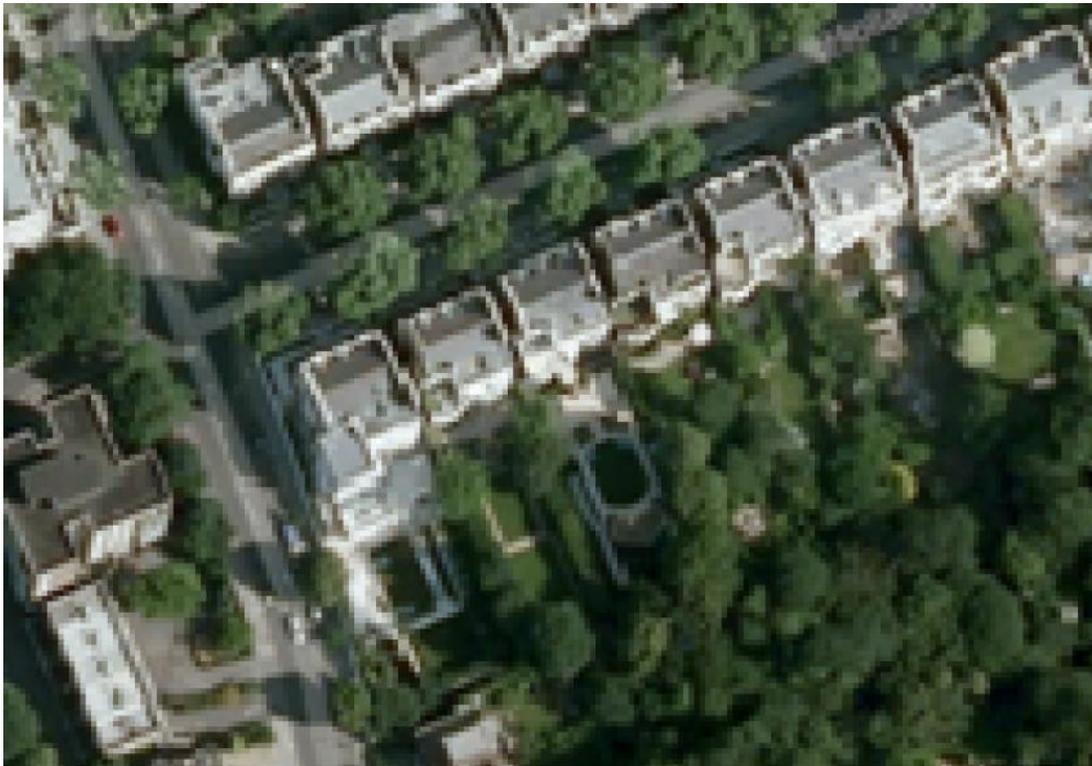
- The 2013 aerial photograph having been taken in winter. The picture from Google Maps below shows a far greener and better planted view than any of the Council's photographs. Arguable the picture below is greener than the Council's 1999 original picture.

Rear gardens of 11, 12, 14, 15 and 16 Holland Park

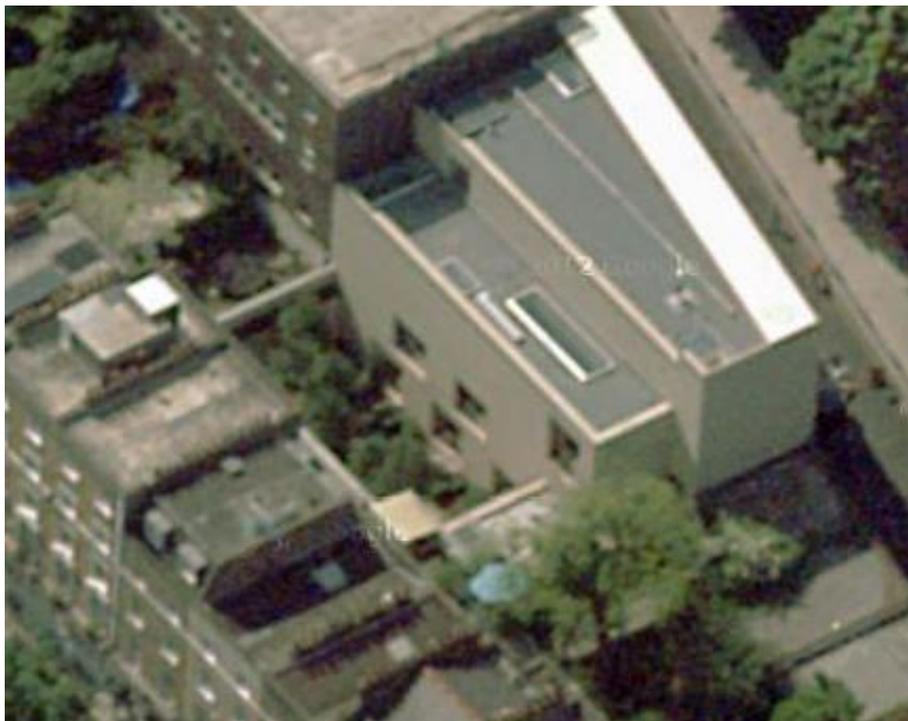
- The failure of the Council to impose a suitable landscaping and ecological condition on planning.
- The failure of the council to enforce a suitable landscaping and ecological condition.
- The new planting not having had sufficient time in which to grow and mature.
- The 2013 aerial photograph having been taken in winter. The Council's 2012 picture appears to show some trees though they are in shadow when the picture was taken and are hard to see. The 2013 picture appears to show no trees. Our picture below shows good young tree growth.

It seems most likely that good planting has been included in the development but that the planting has not had time to reach maturity. In time full mature tree planting will be achieved. This is therefore a good example of what is possible and supports the case for development under rear gardens that allows for future flexibility in planting.

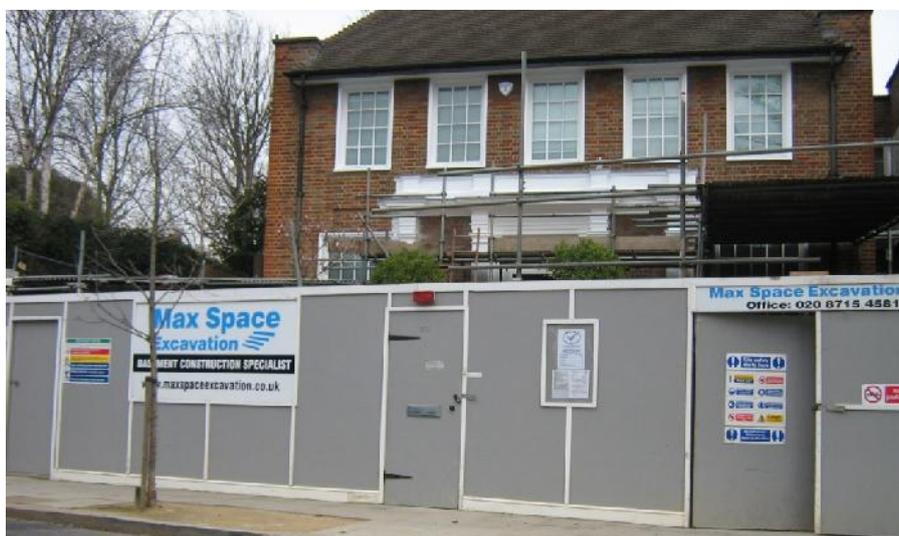
The basement construction has been ongoing over the last months and the structural works appear to have just been completed, that is completed in March 2014 so at least nine months after the Council's last picture.

28 Abbotsbury Road showing basement under construction in March 2014

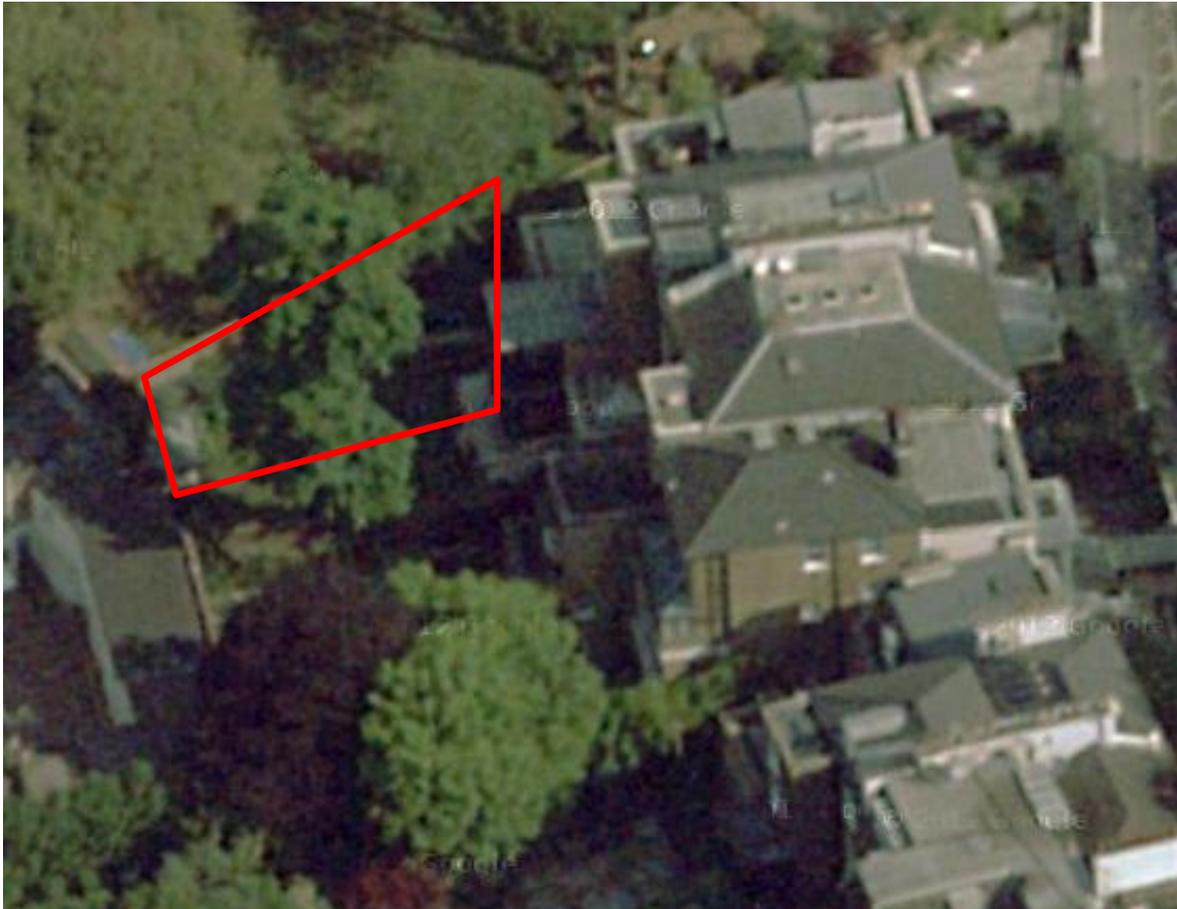
The rear garden has a basement underneath

Mature tree planting is evident. The trees on the garden basement roof were planted in accordance with the proposed landscaping plan.

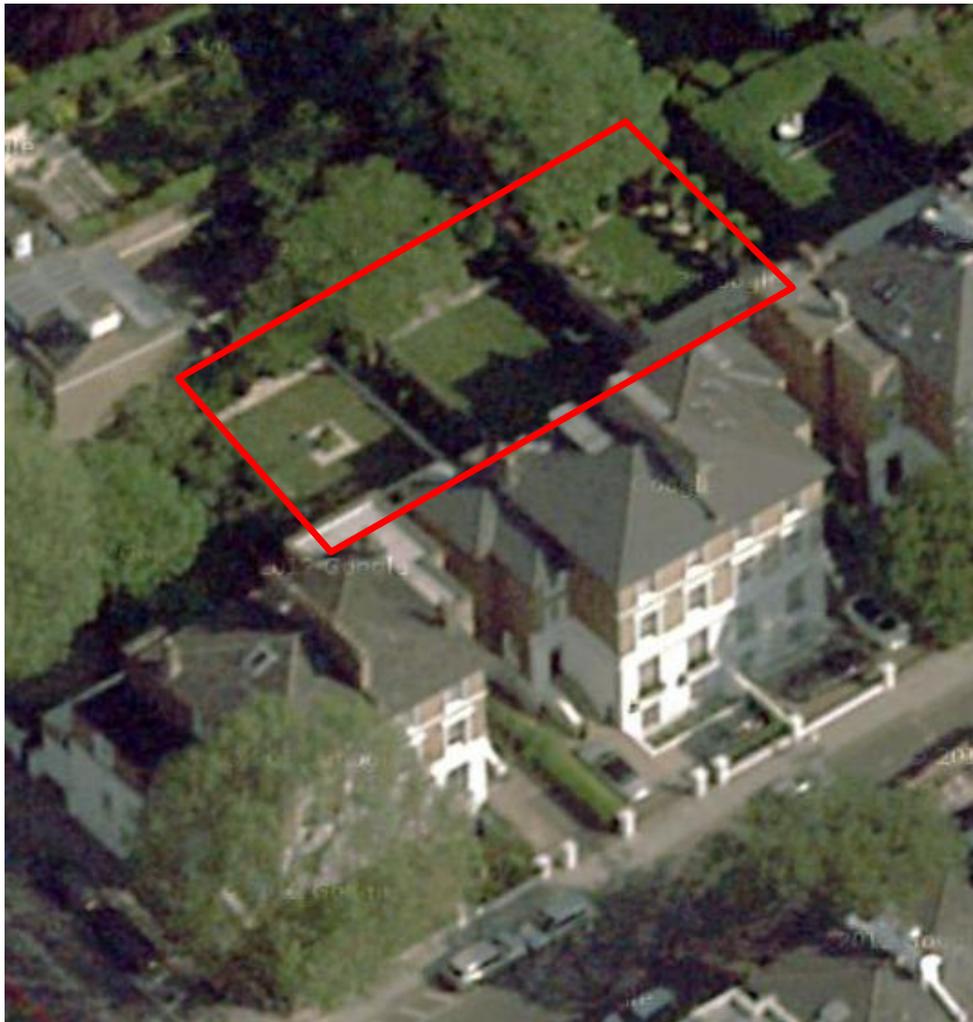
The planting is formal, with clipped border planting and without mature tree planting.

The appearance is similar to the gardens at 10 and 11 The Boltons which is within 200 metres of 8, 10 and 12 Tregunter Road.
