TREE REPORT

29 PEMBROKE RD
LONDON
W8

MAY 2000

REF: IBR125001

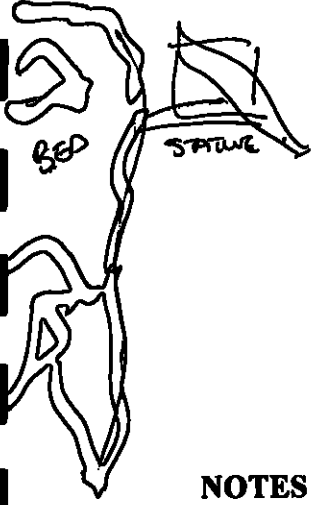
CROWN SPREAD

From a ground based inspection of the tree we note that the main trunk is in good order, there is no decay at any point within the tree, and that minor old pruning wounds are healthy and well calloused. At approximately 15m there are bollings resulting from former pollarding works, all of which are sturdy and well formed with no evidence of decay present. Arising from these are another 15m of new growth, all of which is healthy and well formed.

The crown overall is well balanced and healthy and shows evidence of previous thinning works. No works, which would have been detrimental to the tree's root system, have been carried out within the garden. The containing walls to the basement levels show no signs of distortion, cracking or evidence of root invasion.

The only concern we have is that during construction work the highest consideration is given to the tree's well being. To this end, we would recommend that the excavation and removal of the existing patio area immediately around the tree is done entirely by hand, and that the subsoil beneath this layer is also excavated by hand down to the point at which the major tree roots are identifiable. It is only at this point through careful hand removal of soil, that piles can accurately be drilled to avoid major structural roots.

Following initial works, the subsoils should be remade, ideally with the original spoil removed from the excavations, and the surface immediately beneath the foundation beams is re-laid with a free draining medium, able to provide soil gas/air exchange.
