Repair & Redecoration at
 16 Holland Park, London W14 3TH
 for A A Dantata

GREGORY MUNSON ARCHITECT MA(Cantab) DipArch RIBA @ TAYLOR LIVOCK COWAN
 199 PICCADILLY, LONDON, W1V 9LE. Tel. 020 7287 2055 Fax. 020 7734 2701

16 Holland Park, London W14 3TH
 for A A Dantata
 Drawing 1 Location Plans from F.H.W. Sheppard, Survey of London (University of London, 1973) Volume XXXVII, Chapter Seven "Northern Kensington", figs 15 & 19 & Ordnance Survey @ 1:1250
 (facing page: Photographs of facades to streets)

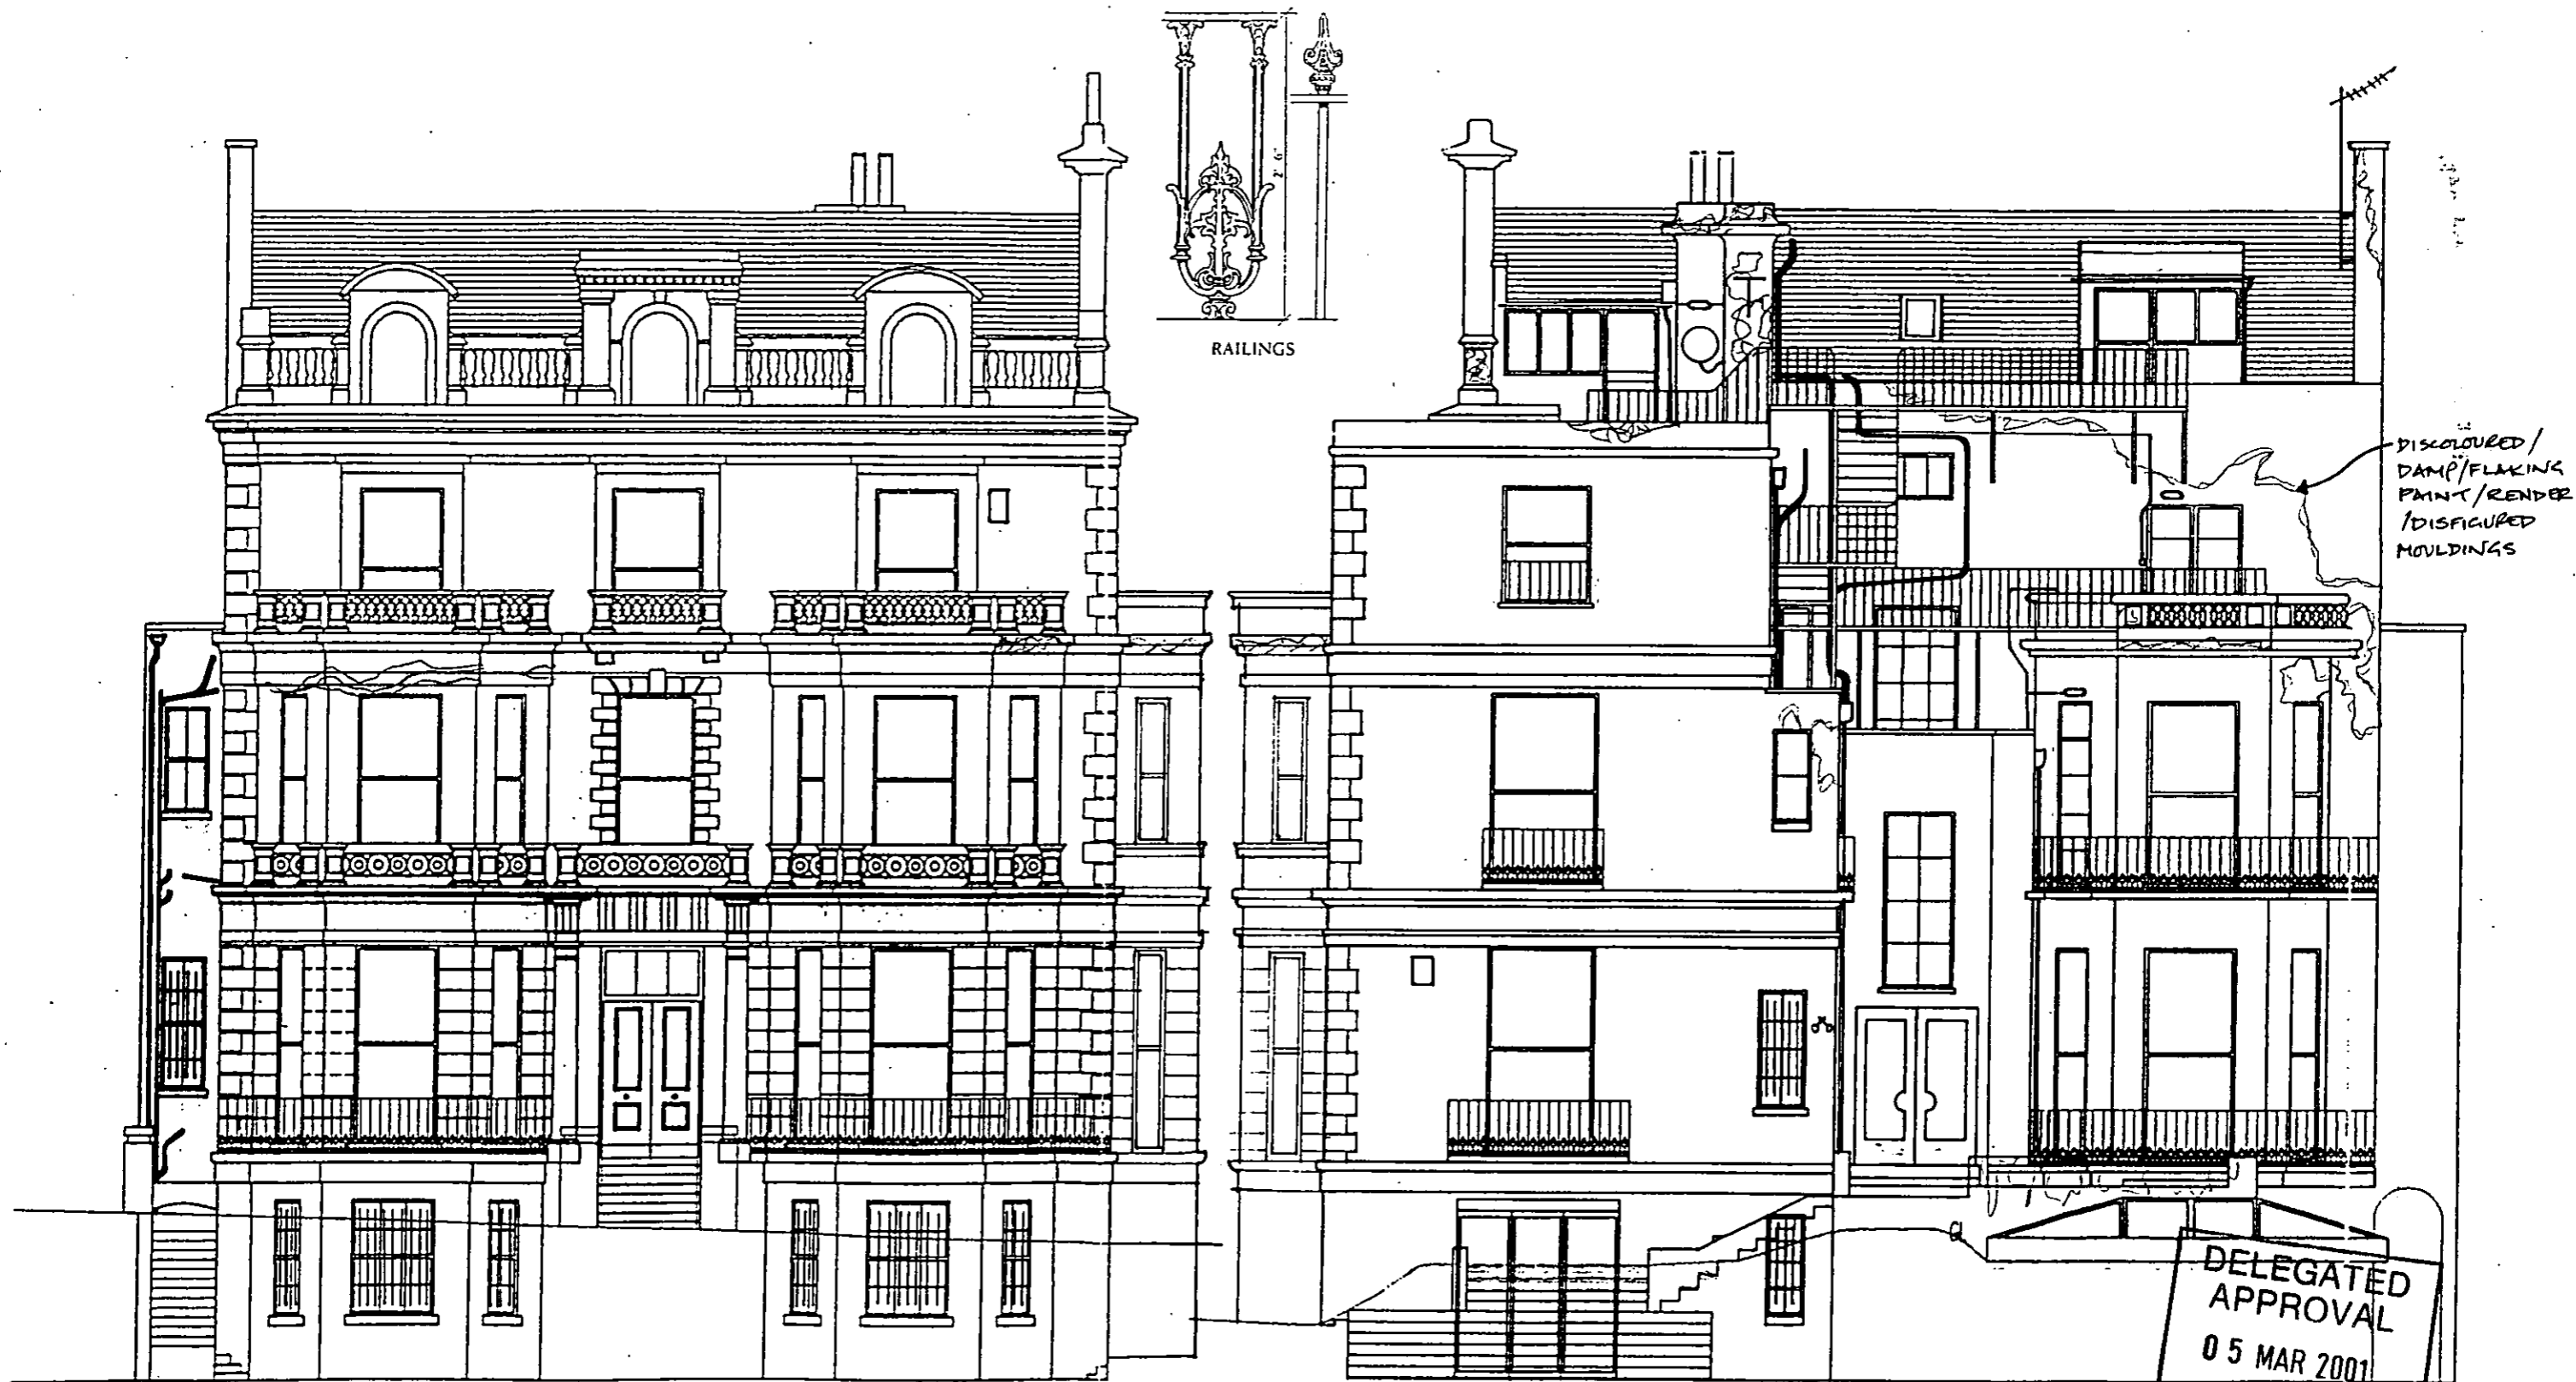
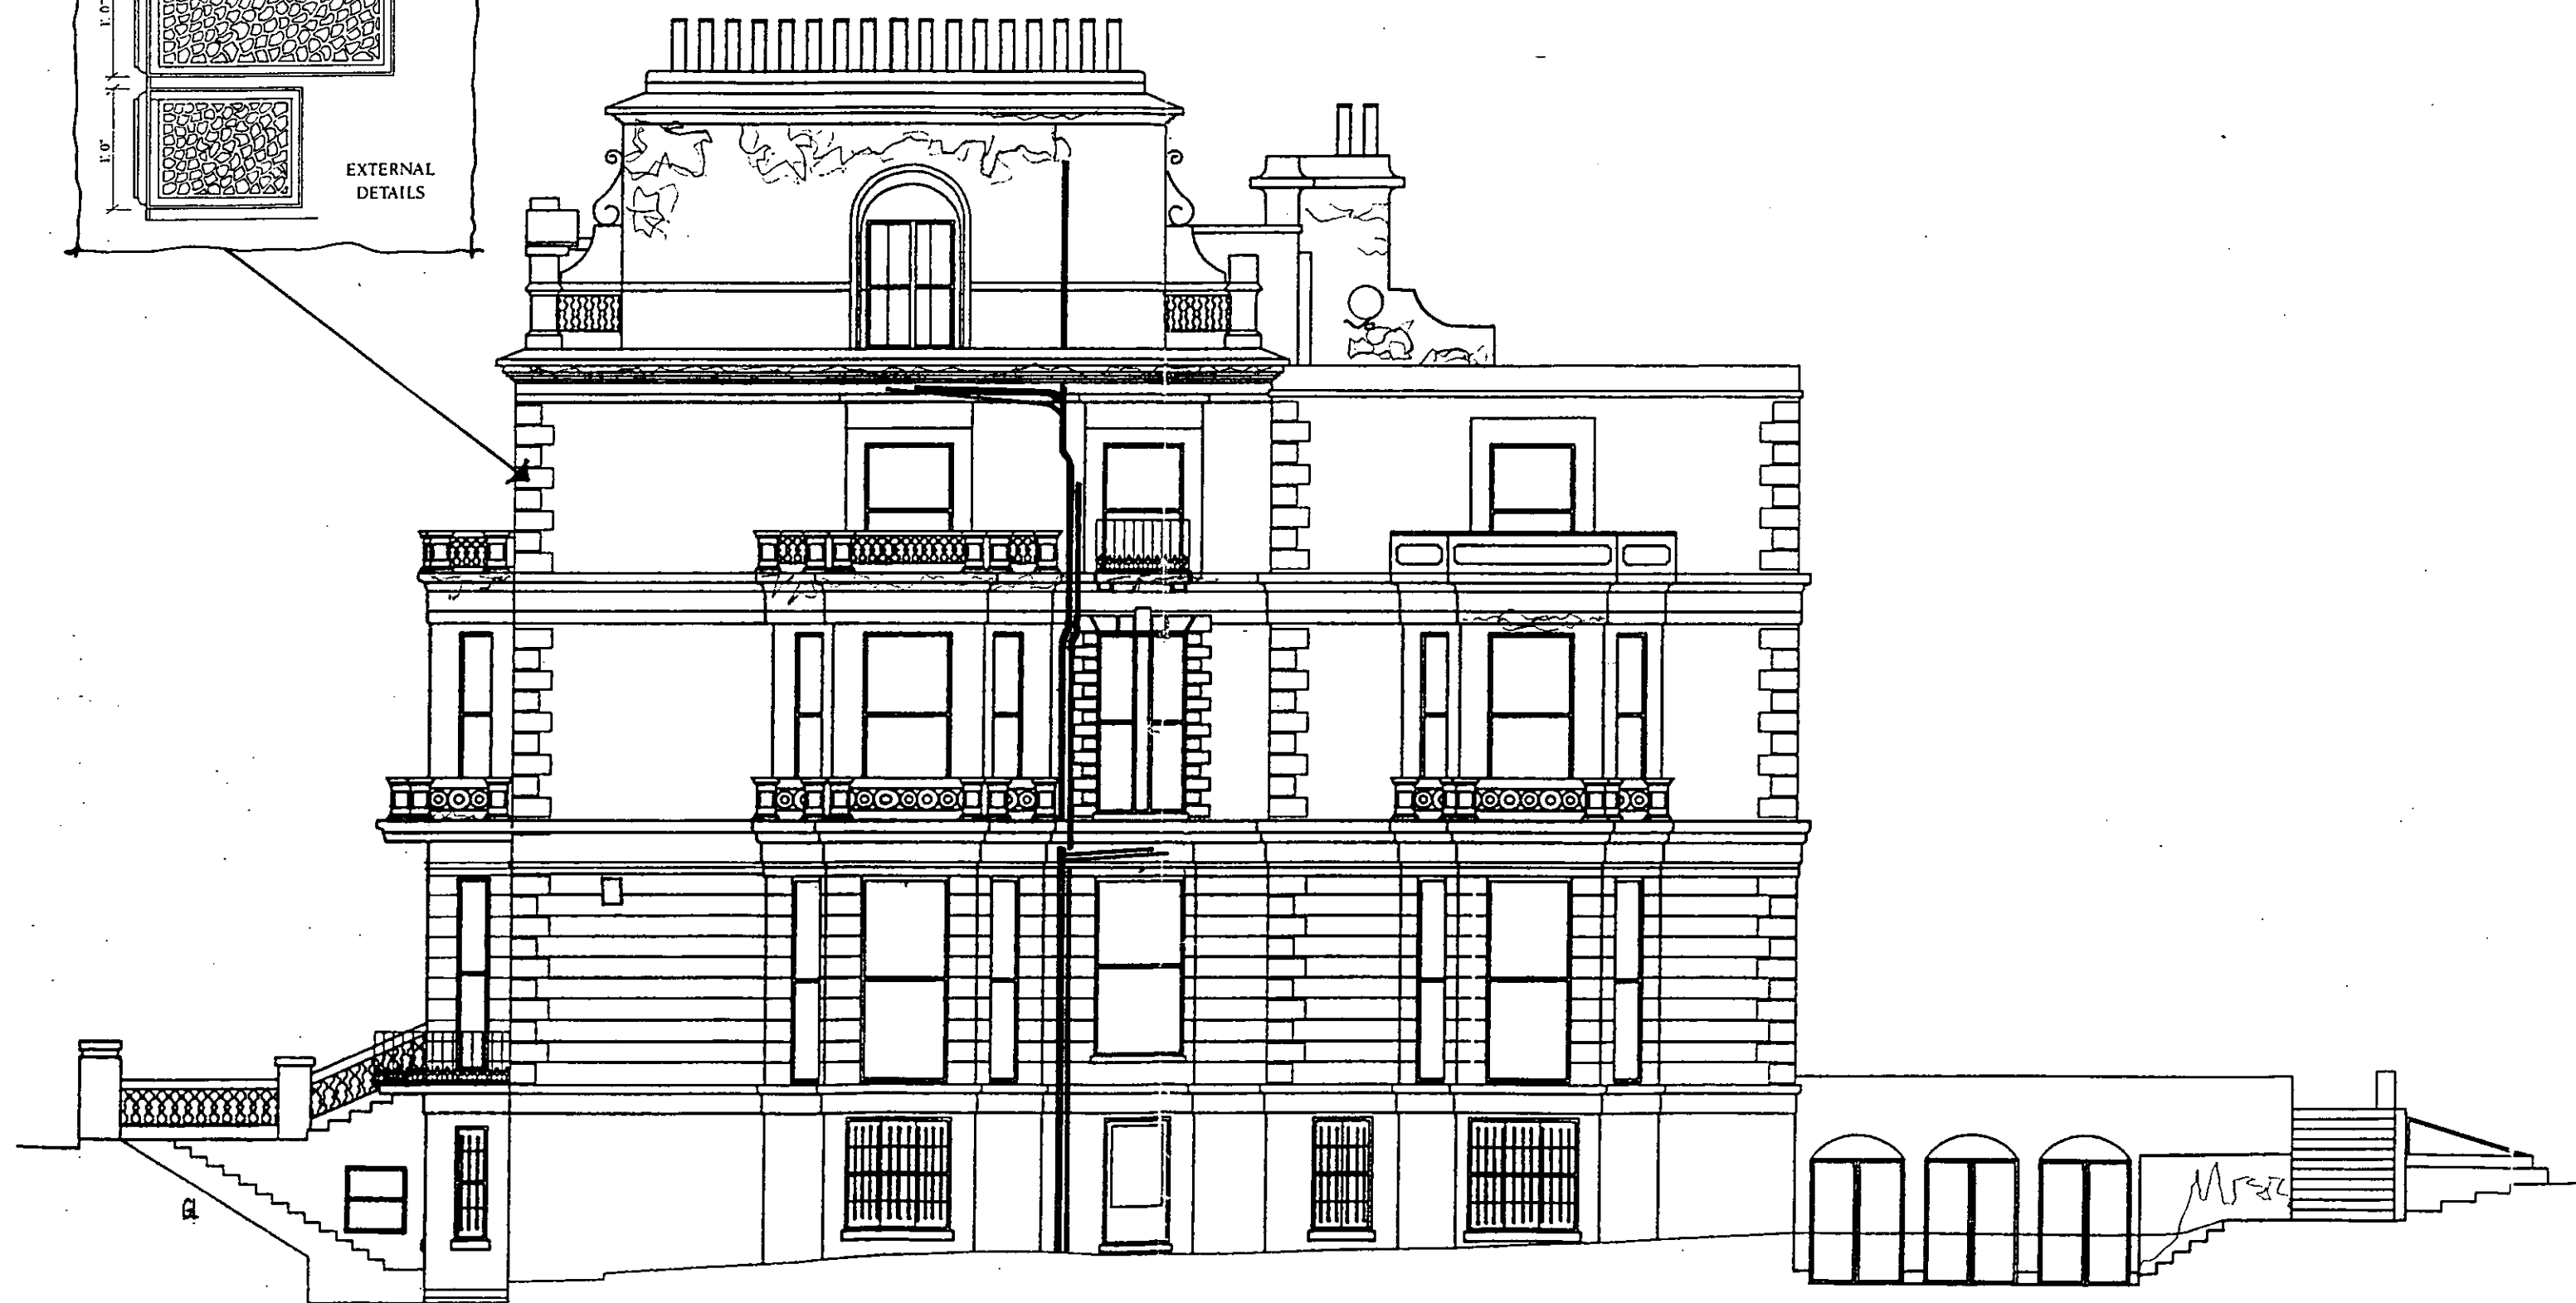
Drawing 3 Existing Front & Rear Elevations @ 1:100
(facing page: Photographs of Rear Escape Stair)

DISCOLOURED /
DAMP / FLAKING
PAINT / RENDER
/ DISFIGURED
MOULDINGS

FRONT ELEVATION

REAR ELEVATION 16 Holland Park, London W14 3TH
for A A Dantata

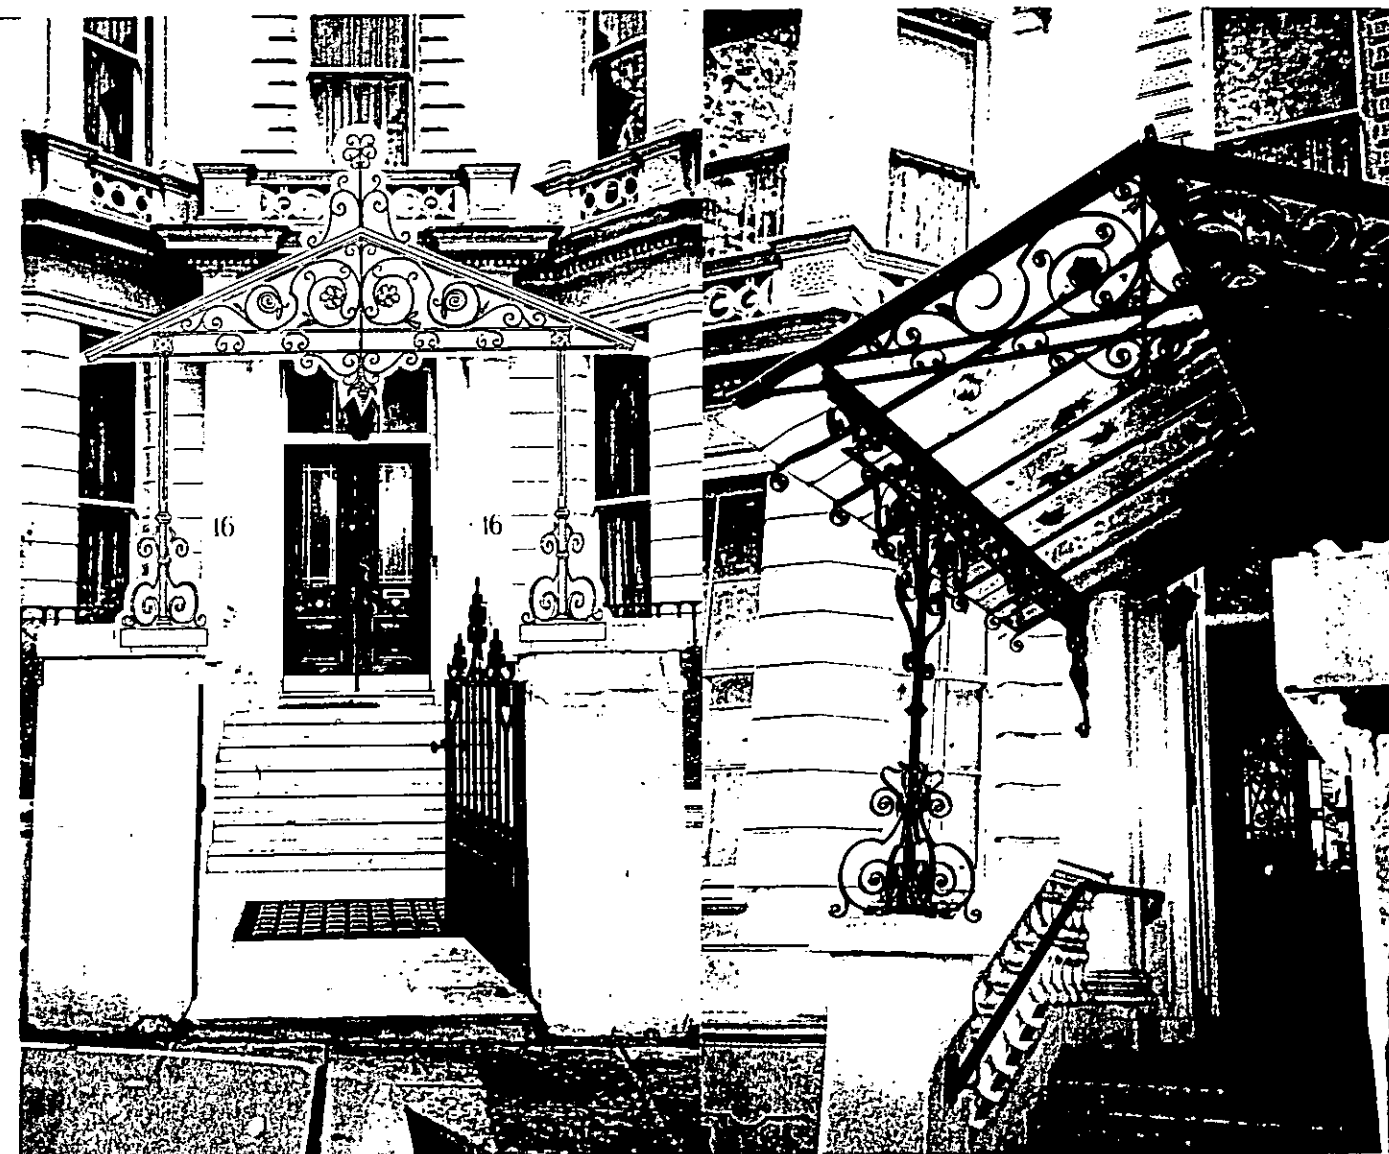
Drawing 20 Proposed Entrance Canopy
(facing page: Photographs of Holland Park Entrance Canopies)

Three quarters of the eighty nine houses at Holland Park have wrought iron and glass canopies sheltering the front steps (see photographs opposite).

These canopies have duo-pitch glazed roofs (clear or diffused) behind gables of great variety (except nos.58 & 79). Supporting columns bear on piers at the foot of the steps. Ridges are straight (except no.22 which is stepped at a porch), and horizontal (except no.79 which rises with the steps). Two thirds of canopies have wrought eaves; the rest are glazed. No.78 is both.

Canopies with glazed eaves are less elaborate. They are not bracketed off the columns (except for no.83) and have one basic ridge style only shown by no.59 shared by nos. 5, 9, 11, 13, 19, 24, 29, 31, 34, 50, 53 & 4, 61 & 66. Variations of this style are more wholesale e.g. no.7 and nos. 8 & 10 have recessed gables, glazed wings, unusual finials, ridges and inverted pelmets. Clear glass seems nicer than diffused (no.23) and greater pitch is necessary than if the eaves is wrought (vs. no.5). Nos. 5 & 65 replicate the style.

Distribution of these types follows no discernible pattern so the canopy to no.16 will have clear glass, be patterned as the Survey of London; i.e. installed in all respects as no.17 (detailed photo above shows relationship with existing doorway & balustrade only); specialist to submit shop drawings.
