Site Number	03
Site Name	Land adjacent to Trellick Tower
Grid Reference	524590, 182010
CDA	This site does not fall within a CDA
Location Plan Site Boundary Watercourse	Land'adjacent to Trellick Tower
Size of site (ha)	0.8
Description of Existing Flood Management Infrastructure (and condition)	NFCDD does not contain any information on any structures or defences at the site.
Existing Land use	The site encompasses the former Edenham Care Home and land adjoining Trellick Tower, which is located in the north-east of the Borough and is situated in Golborne Ward. The site largely comprises of car parking and recreational area and gardens.
Proposed Land use	The development of the site to include: - new residential units [more vulnerable land use] - improvements to social and community facilities and housing
Topography	> Ground levels on the site vary. The gardens around the base of Trellick Tower are at elevations of approximately 29m. The basket ball court, playground and west car parking area which are at lower elevations compared to the rest of the site (approximately 23m to 23.5m). The car park area in the south of the site is approximately 25.5m

Site Number	07	
Site Name	Earl's Court

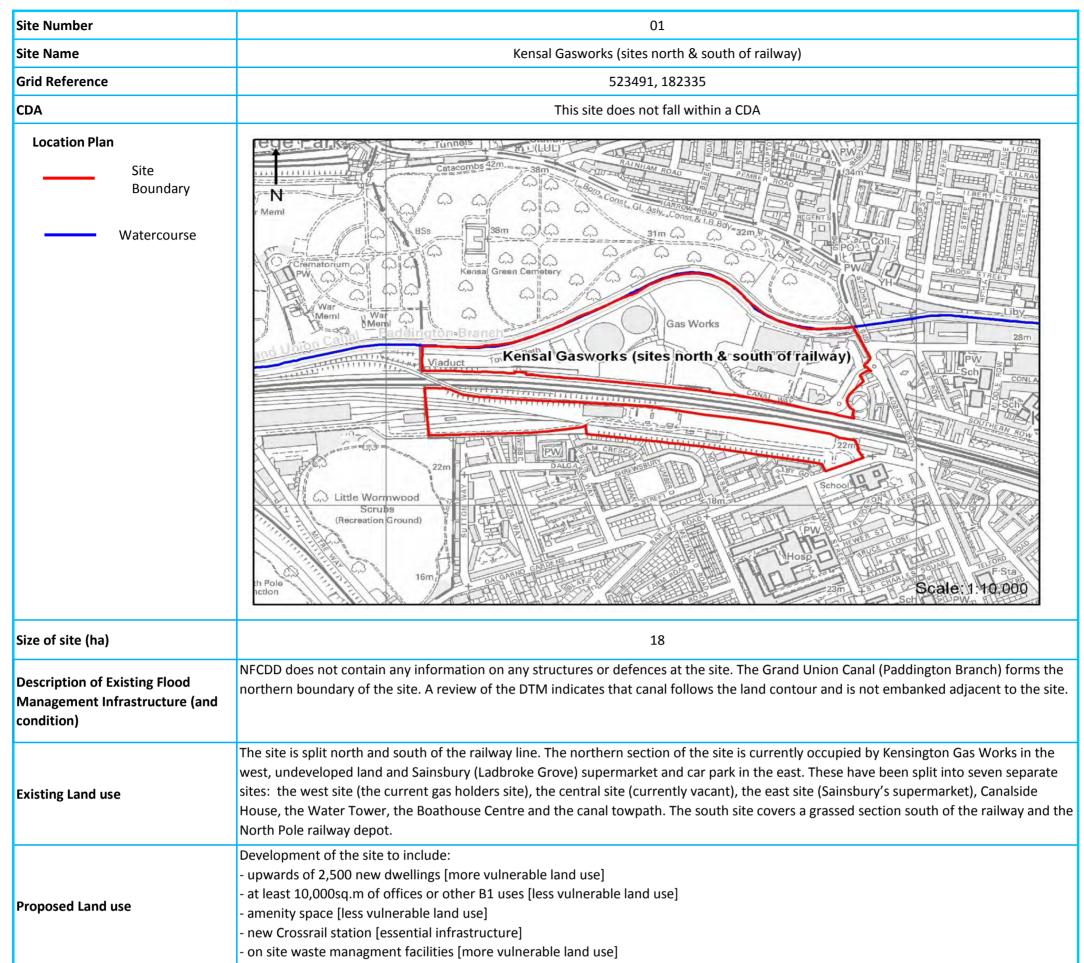
Topography	> Ground levels on the site range between 25mAOD and 30mAOD
Risk Assessment	
Flood Zones	Proportion of the site located in:-
	Flood Zone 1 = 18ha (low risk of flooding)
	Flood Zone 2 = 0ha
	Flood Zone 3a = 0ha
	Flood Zone 3b = 0ha
Surface Water (Pluvial)	Surface water modelling undertaken for the Royal Borough of Kensington and Chelsea Surface Water Management Plan predicts some areas of ponding on the site during the 1 in 100 year rainfall event with an allowance for climate change. These areas of ponding are associated with a moderate (danger for some) and significant (danger for most) hazard rating. Refer to the figures below for the 1 in 100 year rainfall event with an allowance for climate change.
Flood Depth (m)	
< 0.1m

0.1m to 0.25m	
0.25m to 0.5m	
0.5m to 1.0m	
1.0m to 1.5m	Crematorium College Constant
> 1.5m	
	Gas Works
	Vieture 10 Kensal Gasworks (sites north & south of railway)
	Vieduct Torrensal Gasworks (sites north a south of failway)
	h Pole

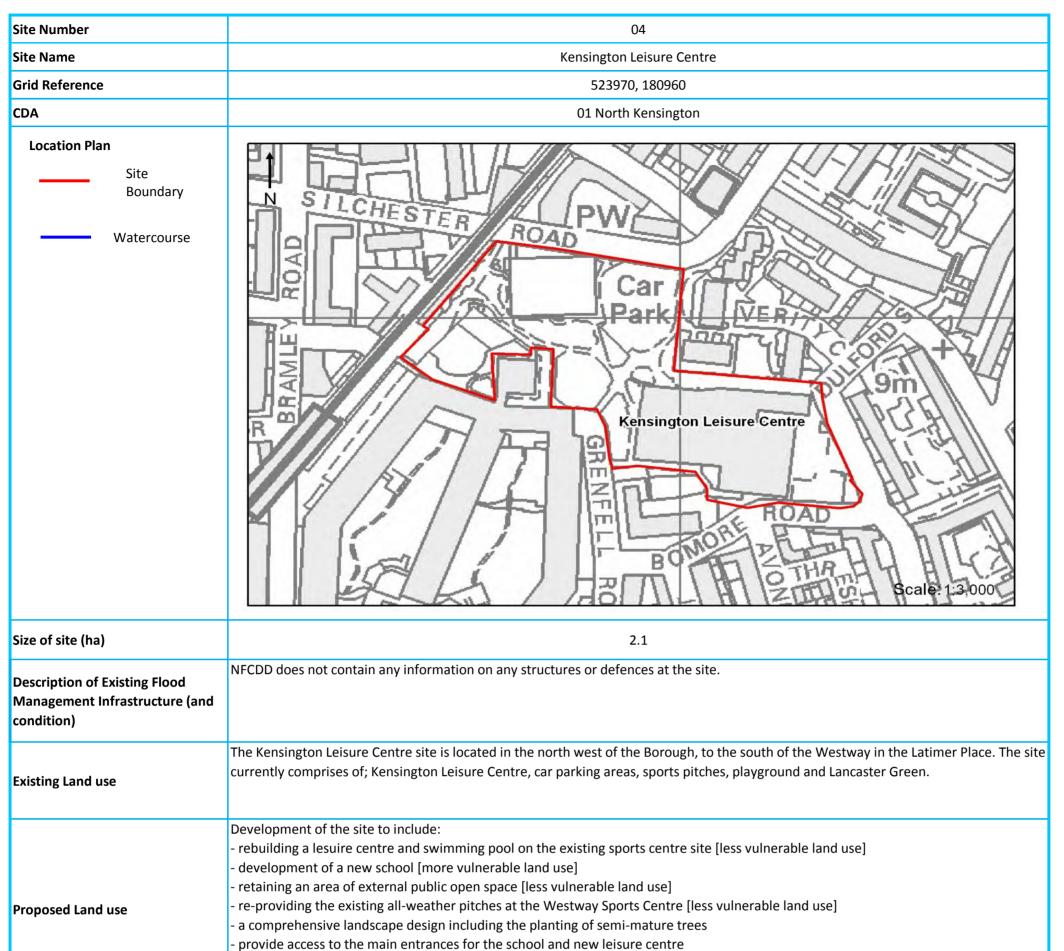
provide access to the main entrances for the school and new leisure centre new housing, so long as the housing does not compromise any of the other objectives for the site [more vulnerable land use]
Topography	> Ground levels on the site range between 6mAOD (in the south west of the site) and 9mAOD
Risk Assessment	
Flood Zones	Proportion of the site located in:- Flood Zone 1 = 2.1ha (low risk of flooding) Flood Zone 2 = 0ha Flood Zone 3a = 0ha Flood Zone 3b = 0ha
Surface Water (Pluvial)	Surface water modelling undertaken for the Royal Borough of Kensington and Chelsea Surface Water Management Plan predicts ponding on the site during the 1 in 100 year rainfall event with an allowance for climate change. The deepest areas of ponding occur in the lower elevations in the south west area. Surface water flooding on the site is associated with a moderate (danger for some) and significant (danger for most) hazard rating in the south west area. Refer to the figures below for the 1 in 100 year rainfall event with an allowance for climate change.

Flood Depth (m) < 0.1m	Resington Leisure Centre Kensington Leisure Centre Scal et 1:3:000

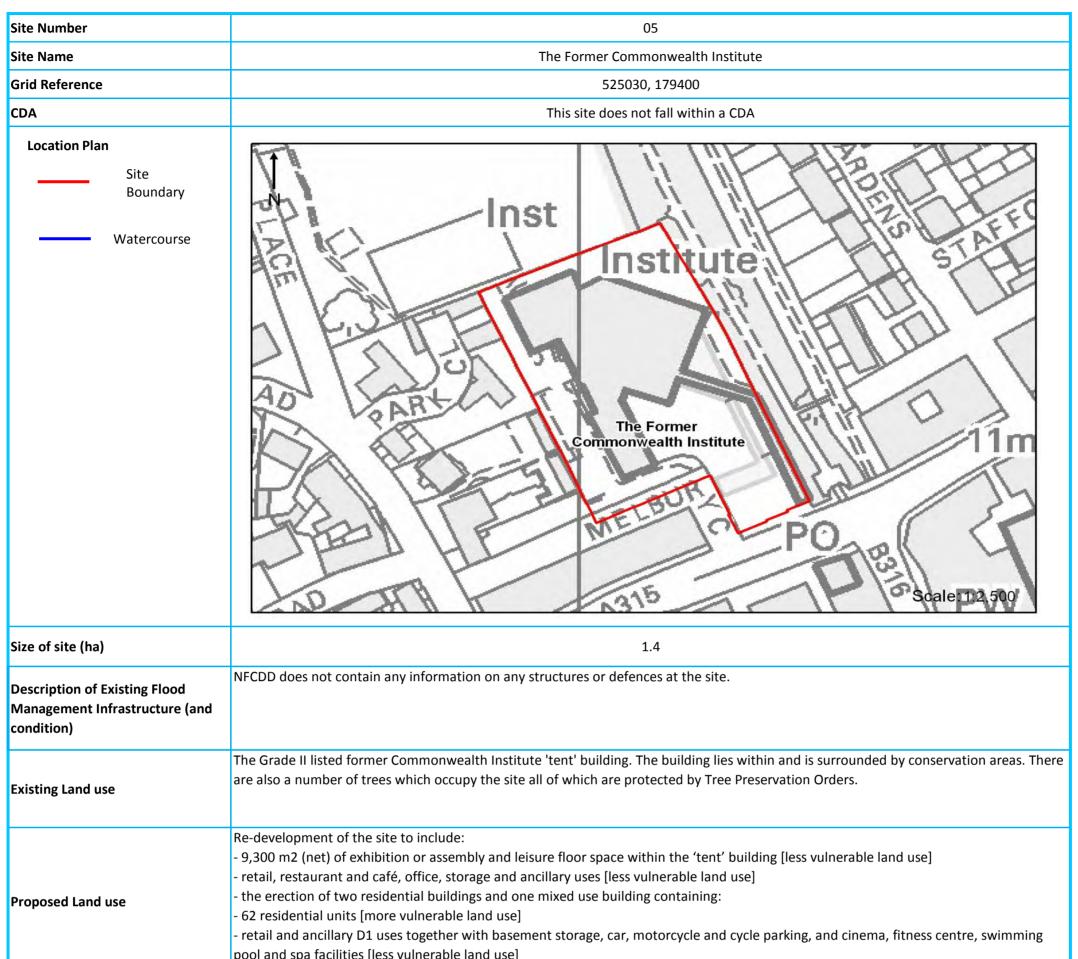
pool and spa facilities [less vulnerable land use]
Topography	> Ground levels on the site range between 9mAOD and 15mAOD
Risk Assessment	
Flood Zones	Proportion of the site located in:- Flood Zone 1 = 1.4ha (low risk of flooding) Flood Zone 2 = 0ha Flood Zone 3a = 0ha Flood Zone 3b = 0ha Surface water modelling undertaken for the Royal Borough of Kensington and Chelsea Surface Water Management Plan predicts deep
Surface Water (Pluvial)	ponding in the central area of the site (on the west side of the building) during the 1 in 100 year rainfall event with an allowance for climate change. This area of ponding is associated with a significant (danger for most) hazard rating. Refer to the figures below for the 1 in 100 year rainfall event with an allowance for climate change.
Flood Depth (m) 0.1m 0.1m to 0.25m 0.25m to 0.5m 0.5m to 1.0m 1.0m to 1.5m > 1.5m	Inst Inst Unstrute The Former Commonwealth Institute

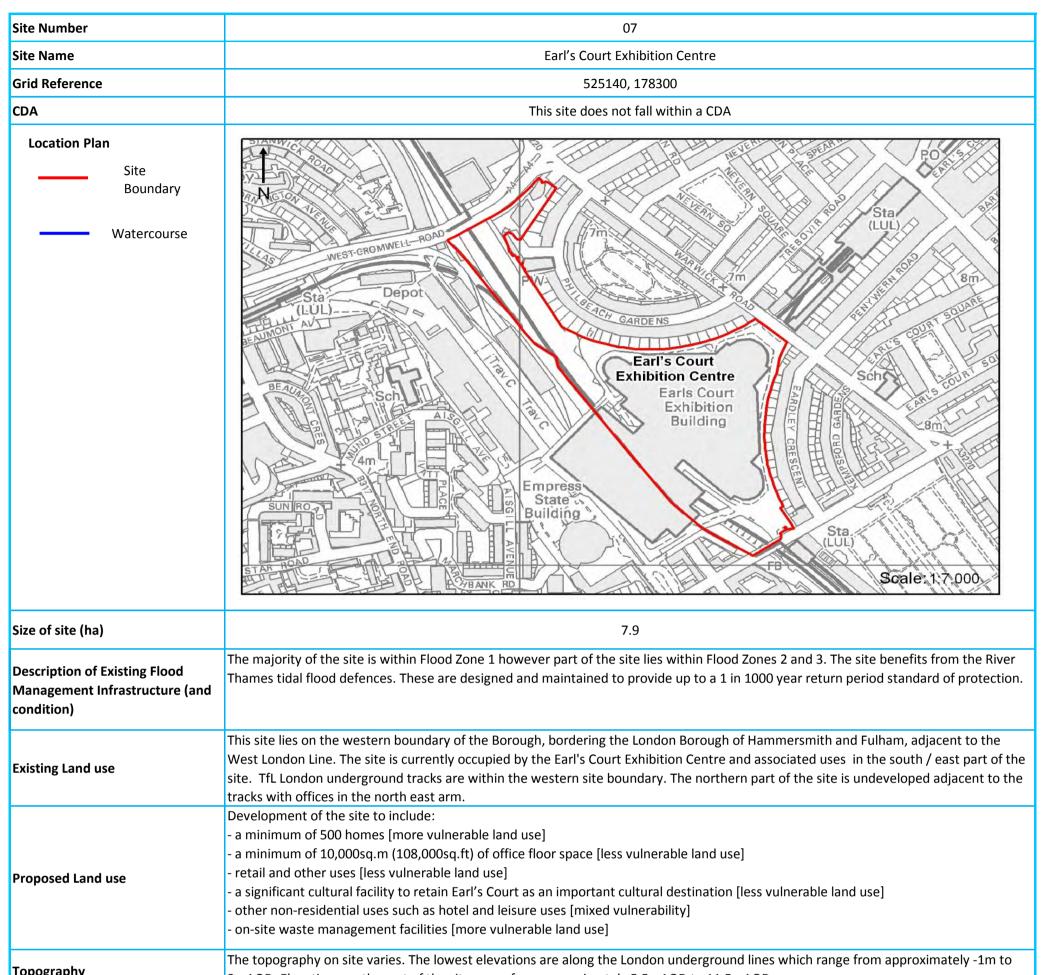
Topography	3mAOD. Elevations on the rest of the site range from approximately 5.5mAOD to 11.5mAOD.
Risk Assessme	
Flood Zones	Proportion of the site located in:-
	Flood Zone 1 = 6.1ha (low risk of flooding)
	Flood Zone 2 = 1.8ha
	Flood Zone 3a = 1.5ha
	Flood Zone 3b = unknown
	(3) The site is predominantly located in Flood Zone 1, the north / west area is within Flood Zone 3 and a small area in the south of the
	site is within Flood Zone 2 (refer to the figure below). The site benefits from the River Thames tidal flood defences. These are
	designed and maintained to provide up to a 1 in 1000 year return period standard of protection.

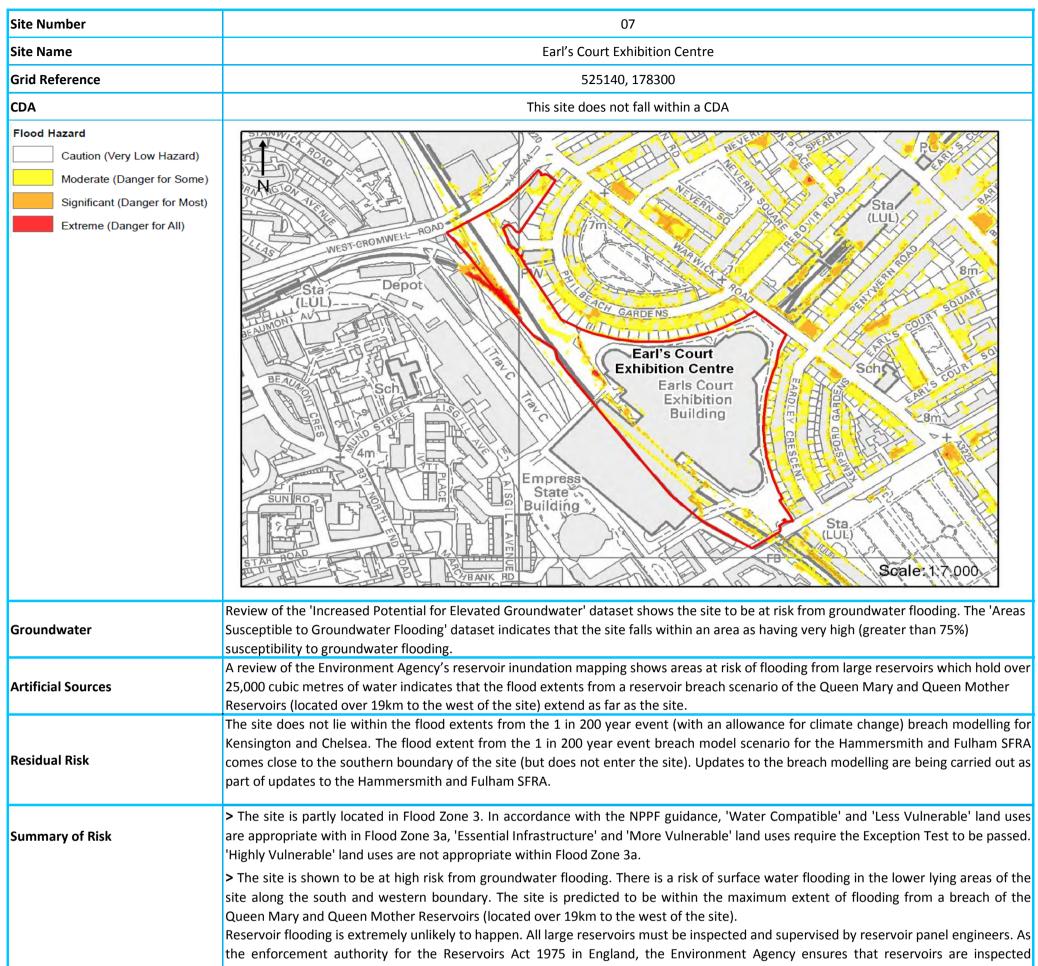
regularly and essential safety work is carried out. The site is considered to be at 'low' actual risk from reservoir flooding and at 'medium' residual risk from a reservoir breach scenario of the Queen Mary and Queen Mother Reservoirs.
	> The flood extent from the 1 in 200 year event breach model scenario for the Hammersmith and Fulham SFRA comes close to the southern boundary of the site (but does not enter the site). The site is currently considered to be at 'low' actual risk from a breach of the Thames flood defences, however updates to the breach modelling for the Hammersmith and Fulham SFRA should be consulted as part of a site specific flood risk assessment.
Risk Management	
Flood risk management recommendations	A flood risk assessment will be required to support the planning application for this site. The Sequential Test will need to be applied for all types of development within the development site, however, if there is More Vulnerable development proposed within the 1% AEP flood extent the Exception Test must also be applied. Substitution of More Vulnerable development for any Less Vulnerable development within the 1% AEP development within the 1% AEP flood extent the 1% AEP flood extent is recommended wherever possible. Replacing More Vulnerable uses on the ground floor with Less Vulnerable uses on the ground floor may also be appropriate.
